Feasibility and Space Needs Study

# HARVARD FIRE HEADQUARTERS

HARVARD, MASSACHUSETTS

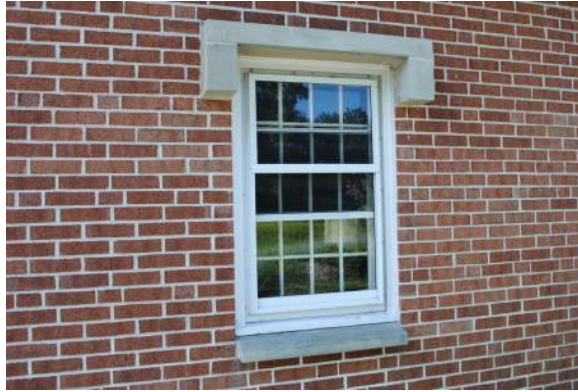
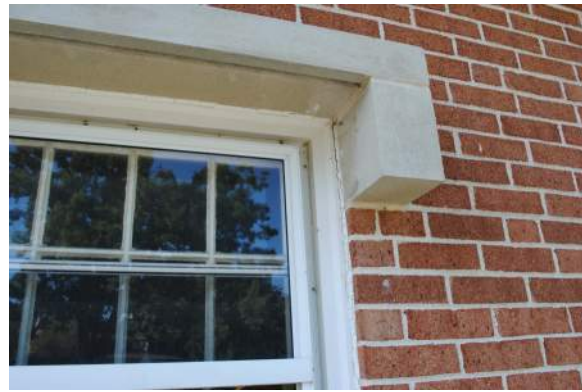
The exterior wood windows are true divided lite with single pane glass. Aluminum storm windows have been added to help with energy efficiency. While these windows are in good condition, they do not comply with current State energy code requirements. The wood frames need to be scraped, repainted and the perimeter caulking needs to be replaced.

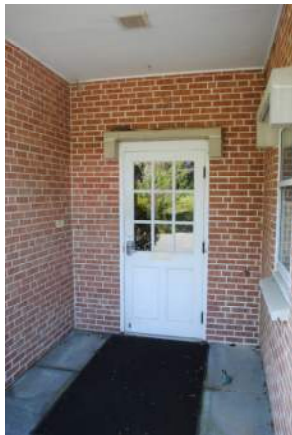
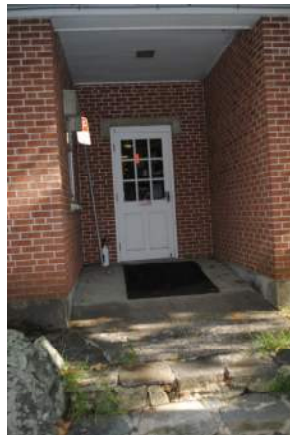
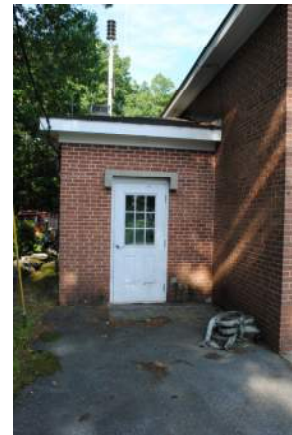
There are five exterior man doors in the fire station: one at the main entrance one at the firefighter's dayroom/kitchen, one directly into the apparatus bay near the administrative & bunk rooms, and one each into the mechanical and work rooms. All doors are painted wood in hollow metal frames. They are generally in good condition and need to be scraped and painted. None of these doors has accessible hardware or code compliant level areas at the front approach. None of the doors have been outfitted with a "crash-bars"; though many of the doors are typically equipped with lever handles.

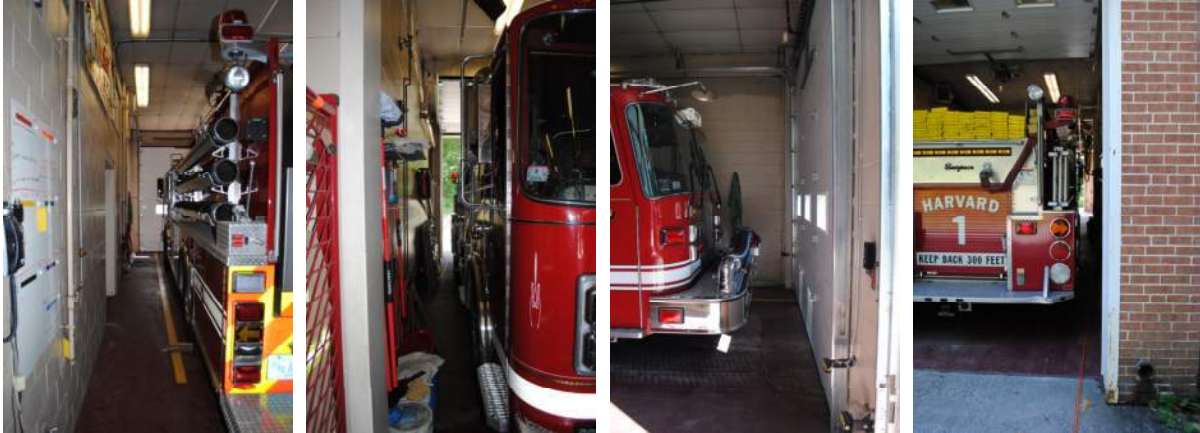
Overhead doors to the apparatus bays are the same size. Facing Ayer Road, there are four sectional overhead doors that are 12'-0" wide and 12'-0" tall. These doors are too small for current fire apparatus and evidence of the rear door frame having been scraped by the engines pulling in and out of the bay. It was also reported that a number of years ago an apparatus struck the front of the building requiring the front of the apparatus

bay to be rebuilt. Compounding the problem with the width of the bay door is that three of the bays on the front of the building are back-in bays which require the apparatus to back in from the apron.

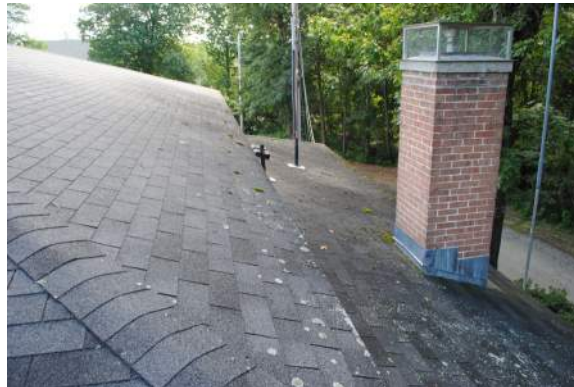
Steep sloped roofing is asphalt shingles. The asphalt shingles appear to be in good condition although areas of moss was observed on the south side.

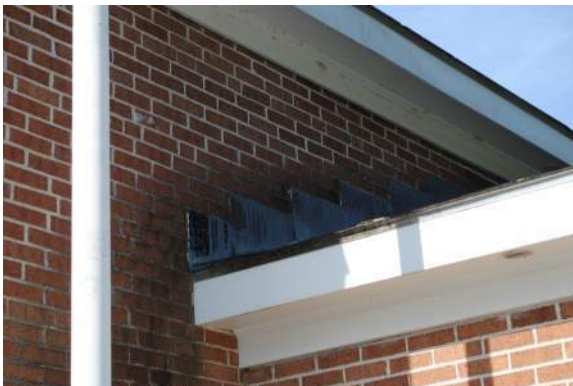
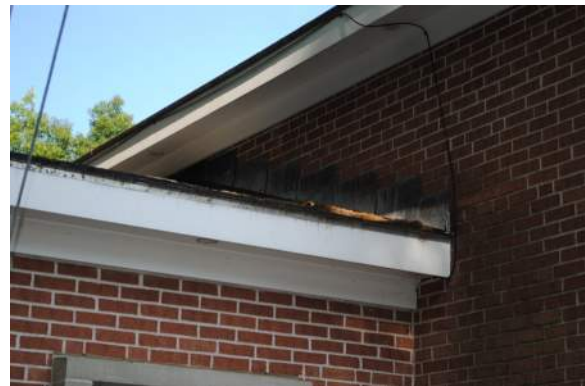
Step flashing at roof to wall locations appears to be in good condition, however, the face is not sealed in a reglet and water can readily infiltrate the roof and building.

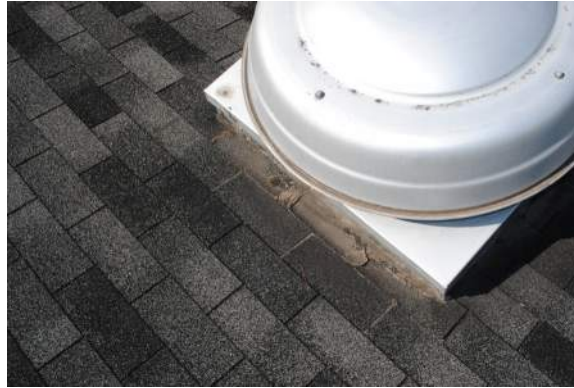
Caulking at mechanical curbs was observed to be failing and needs to be replaced.

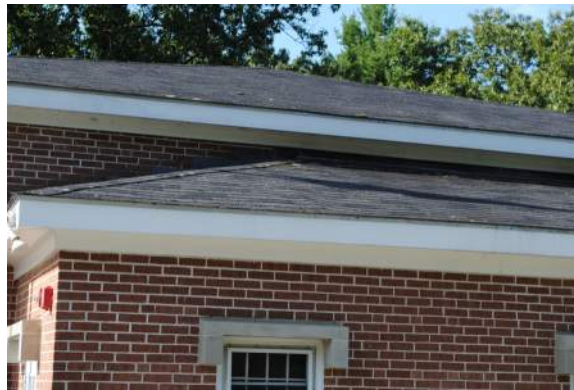
Waves in the shingles were observed on the north side. It appears that the roof deck may have begun to delaminate. Further investigation is required.

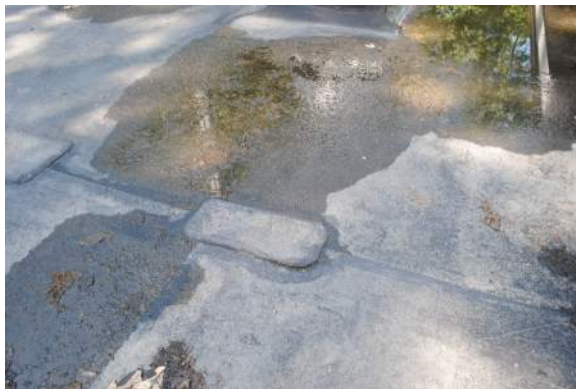
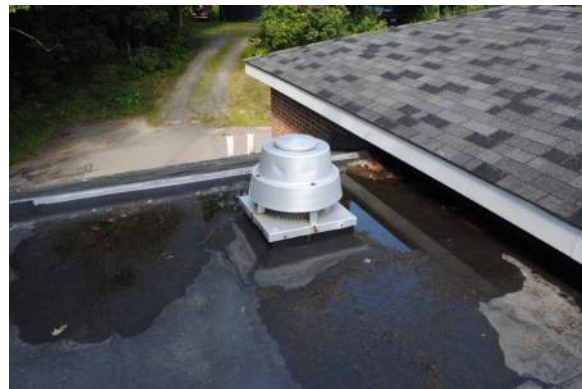
Low slope roofing is a single ply membrane roofing that appears to be EPDM on tapered rigid insulation, which is nearing the end of its useful life. At the single ply roof areas, patches were observed and the roof was soft and spongy indicating water saturated insulation trapped beneath the membrane. The moisture is a problem which could lead to the growth of mold and mildew. In these spots, standing water was also observed. Additionally, there were a few patches observed.

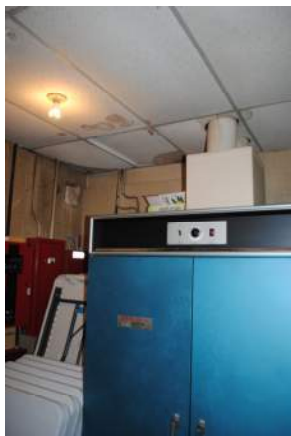
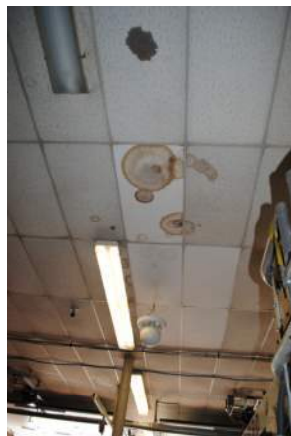
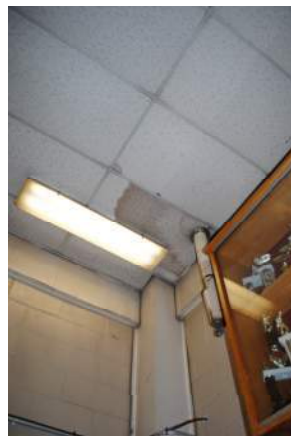
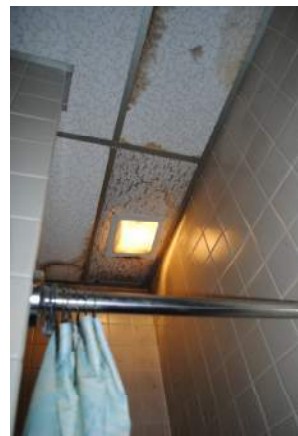
**Walls:** Interior wall finishes are mostly painted masonry, with some painted drywall/plaster in occupied spaces. These surfaces appear to be in good condition but require some patching at gouged/water damaged finishes and corners. Wood trim is generally in good condition but exhibit ware and need to be painted.

**Flooring:** The concrete floor slab on grade in the Apparatus Bays is painted and appears to be in good condition. Finish flooring in offices is carpet and is in poor condition. In the toilet rooms, the floor appears 12"x12" vinyl tile and in poor condition. The shower area is ceramic porcelain tile and in poor condition. The kitchen, dayroom, bunks and corridors are also 12"x12" vinyl in poor condition.

**Ceilings:** Ceilings in most of the building, including the Apparatus Bay, are a 2x4 suspended acoustical tile system with surface or recessed mounted lighting fixtures. In general, most of the ceiling grids exhibit signs of age or rust in some locations, and tiles exhibit physical damage from water/moisture. Moisture problems and/or leaks from the roof system are the cause of this damage. The lighting seems inadequate in general and the light fixtures are in poor condition. Refer to the electrical section of this report for more information.

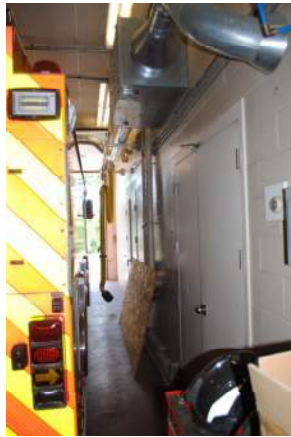
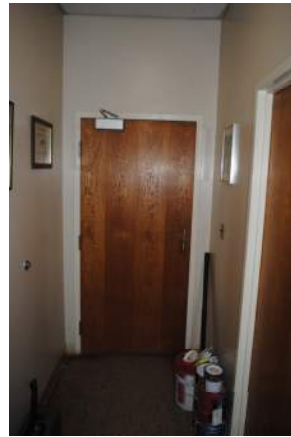
**Interior doors and windows:** Throughout the building, original doors (36" wide), are varnished flush wood doors in painted hollow metal frames and window casings and sills are wood. Doors to and from the Apparatus Bay are flush hollow metal with hollow metal frames, are exhibiting wear and need to be painted. Most interior doors have doorknobs and have not been outfitted with ADA compliant lever-style handles. The doors hardware is worn and will require new hardware and refinishing. Doors and windows are worn and in fair condition.

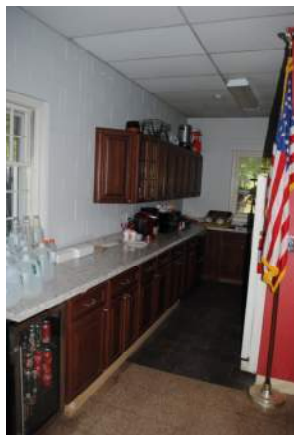
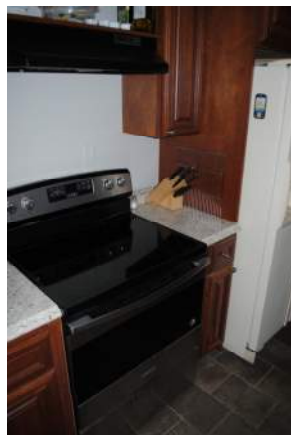
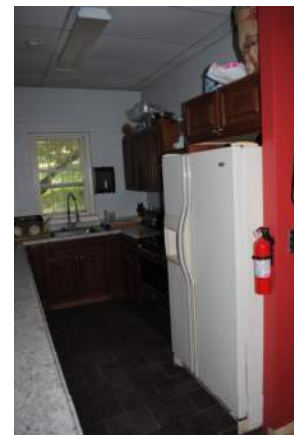
**Kitchen/Dayroom:** Located in the rear of the building and utilizing painted cmu and gypsum walls, with vinyl composition tile flooring and suspended acoustical tile ceiling with recessed and surface mounted lights. All finishes are in fair condition and should be replaced. Cabinets and counter tops exhibit some wear. Appliances appear to be in good condition.

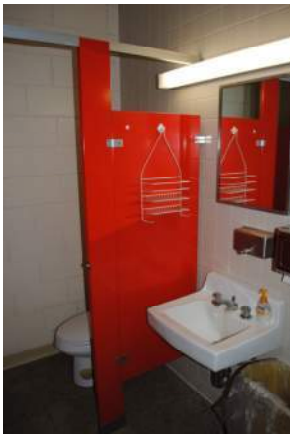
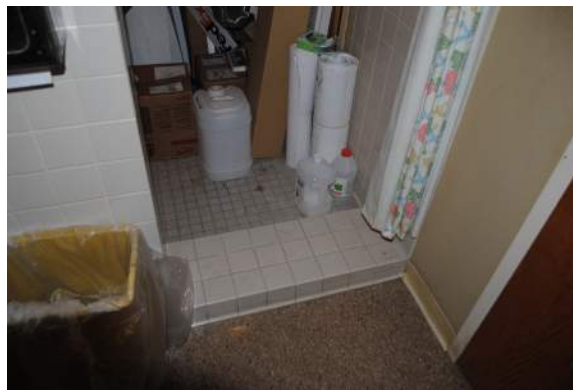
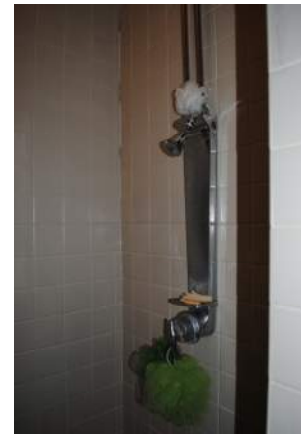
**Toilet Rooms:** The toilet rooms utilize painted gypsum walls, with vinyl composition tile flooring and suspended acoustical tile ceiling.

The shower room adjacent to the bunk room utilizes ceramic tile walls, with ceramic tile flooring. Shower compartments have ceramic tile walls and suspended acoustical ceiling tile. All of these finishes are worn and are at the end of their useful life.

The fixtures do not meet ADA requirements. The sinks do not have insulated drain piping or approved lever style faucets handles and thus are non-complaint. The toilets do not have proper grab bars and or clearances. Additionally, there are no separate toilet/shower facilities for male and female use.

Our recommendation would be to execute a total renovation of these spaces. The fixtures, partitions and accessories should be replaced with new.

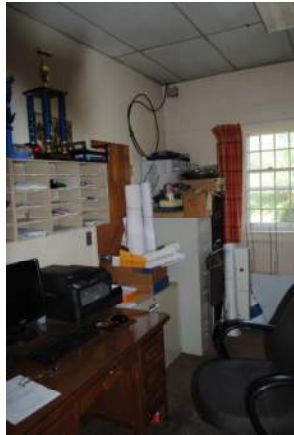
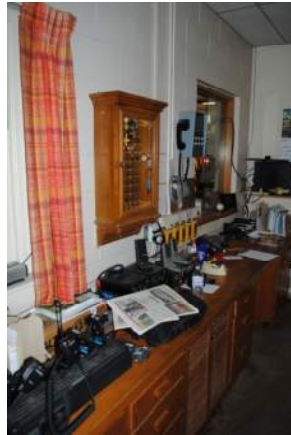
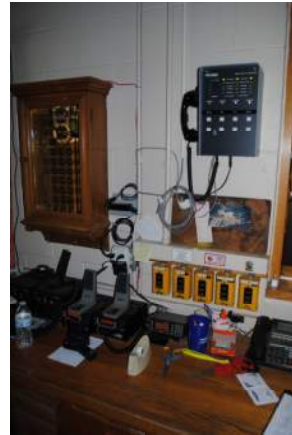
**Communications Center:** The dispatch center/radio room does not comply with NFPA 1221 which sets the design standard for emergency dispatch centers. This code requires two-hour fire separation from the remainder of the building, protection against civil unrest and an isolated air handling system among many other requirements. Neither an isolated air handling system nor two-hour fire separation assemblies were

not evident. Additionally, this room appears to be used for a variety of other programmatic functions including report preparation and multi-purpose room. These functions are not conducive to providing an appropriate environment for dispatchers to communicate with citizens in emergency circumstances.

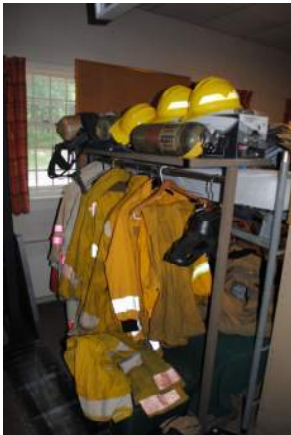
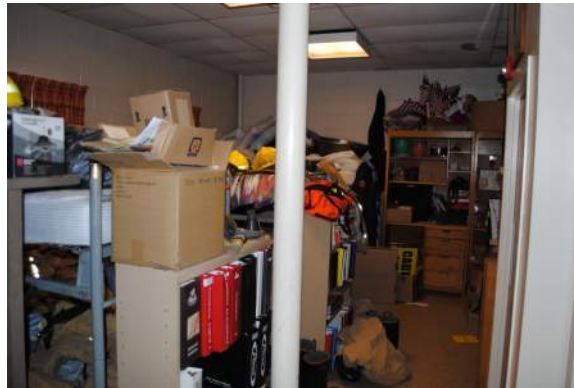
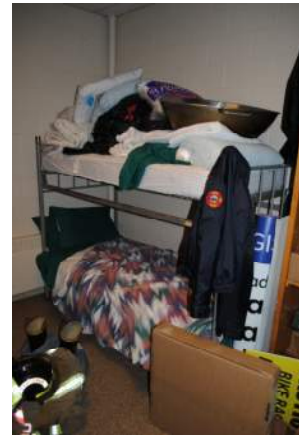
***Bunk Rooms:*** There is one bunk room with bunk beds to sleep six (6), but is currently used for storage of miscellaneous materials. They utilize painted cmu and gypsum walls, suspended 2x4 acoustical tile ceiling in a metal ceiling grid with surface mounted lights and VCT floor tile. All the finishes are in poor condition and need to be replaced.

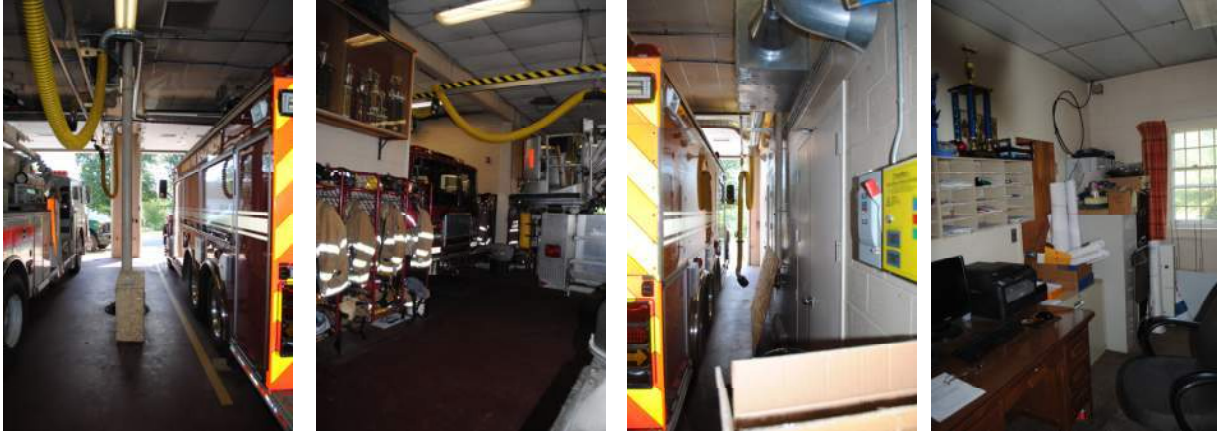
***Apparatus Bays:*** The apparatus bays utilize painted cmu walls, suspended acoustical tile ceiling with surface mounted lights and stained/painted concrete floors. All of the finishes are in fair to poor condition. The ceiling exhibits signs of water damage, most likely the result of current and/or past roof leaks. The overhead door openings are too narrow & short and barely allow passage of the current apparatus. The circulation space around the apparatus is too narrow per recognized fire station facility design standards. The apparatus doors are insulated metal clad pre-finished sectional overhead doors, which were installed in 2019 and are in like new condition. The vehicle exhaust system was installed in 2004, and is in excellent condition. Additionally, the bays house the turnout gear lockers, decontamination area, hose/supply storage and work areas. All these spaces should be in their own spaces.

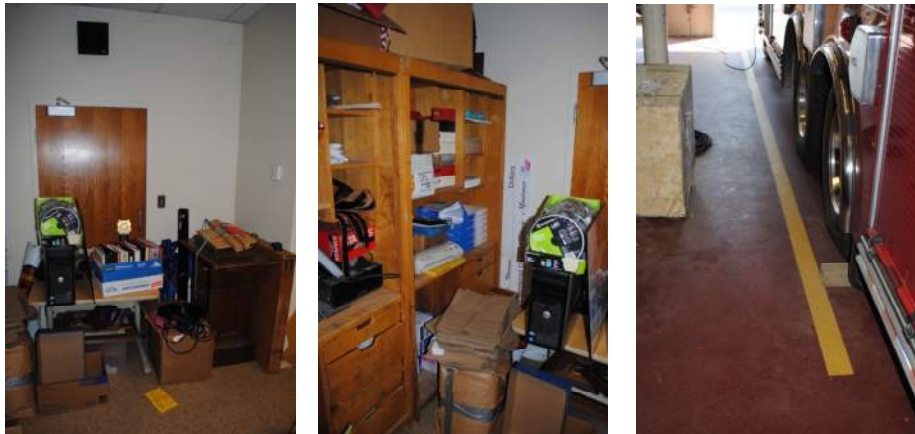
***Storage Facilities:*** There appears to be inadequate storage facilities for archival records, training materials, department equipment, and supplies.

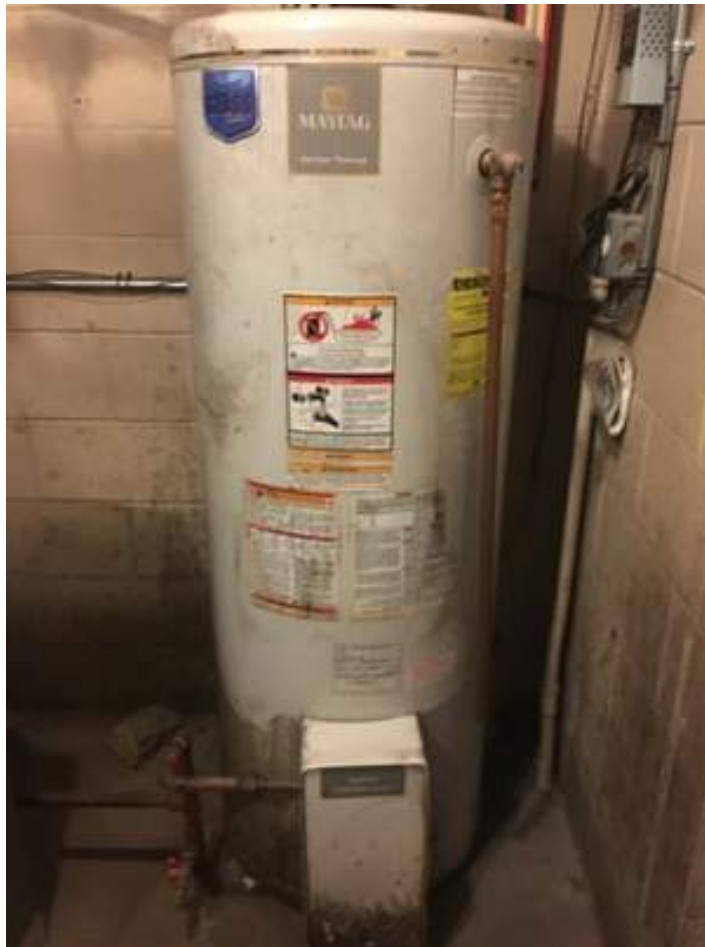
Hot Water Tank

- a. The existing building plumbing systems consist of the following:
  - 1) Water Service – The existing water service enters the building in the Work Shop. A water meter could not be located. Currently there is an existing gate valve for the main shut-off.
  - 2) Sanitary System – The sanitary piping is cast iron piping which runs underground.
  - 3) Domestic Hot Water – The domestic water heater is located in the mechanical room. The water heater is a Maytag 50 gallon, 40,000 btu gas fired water heater. The water heater was manufactured in May of 2005, and is in fair/poor condition. Hot and cold water piping in the boiler room is not insulated.

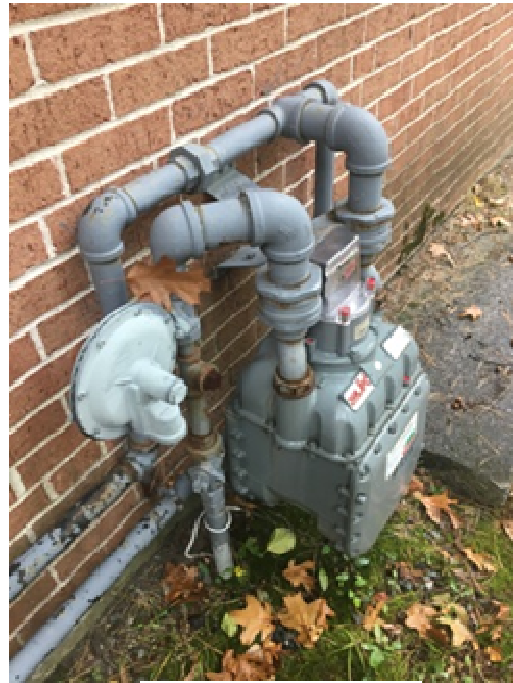
Gas Service/Meter

- 4) Fuel Source – The natural gas service/meter assembly is located on the exterior of the building. A 2" low pressure gas line enters the building at the mechanical room. The gas line serves the heating boilers and water heater located in the mechanical Room. No deficiencies were observed on the gas piping.

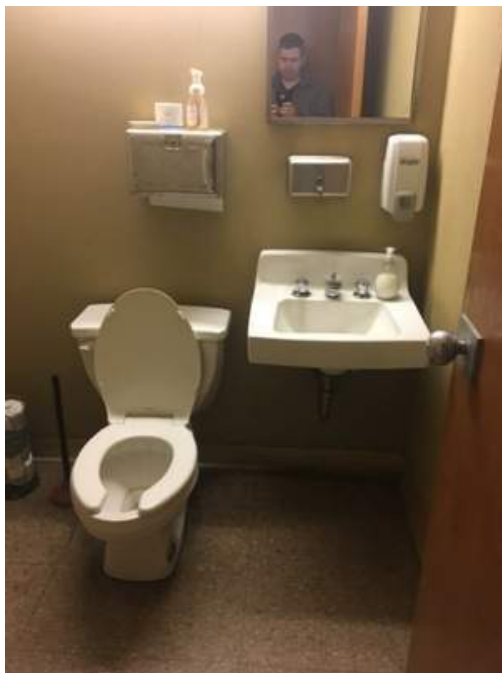
Plumbing Fixtures

- 5) Fixtures – The plumbing fixtures are not ADA compliant. Toilets are tank type floor mounted. The locker rooms contain one (1) shower in each room (male and female). The plumbing fixtures should all be replaced with low flow, ADA compliant fixtures, per current Code.

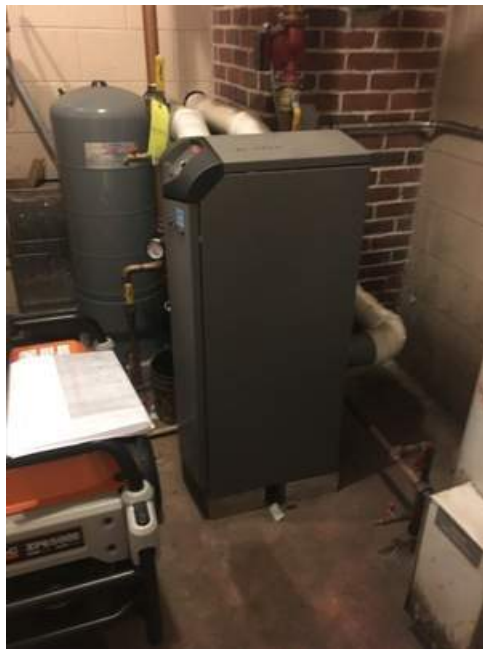
- a. The HVAC system serving the building is a heating only hot water system consisting of a boiler, pumps, piping, hot water base board, and unit heaters. The boiler, pumps, and main distribution piping is located in the mechanical room.
  - 1) Boiler was manufactured by Lochinvar and is approximately 5 to 7 years old. Name plate information with model number and capacity could not be located. Boiler appears to be in
  - 2) good condition.
  - 3) Primary and secondary pumps appear to be in fair condition. Manufacturer, model number and age unknown.
  - 4) Main piping distribution in the boiler room is in fair condition. Piping insulation is missing in many locations.
  - 5) Distribution piping located above the ceiling throughout the building is in fair condition. Piping insulation is in disrepair and missing in many locations.

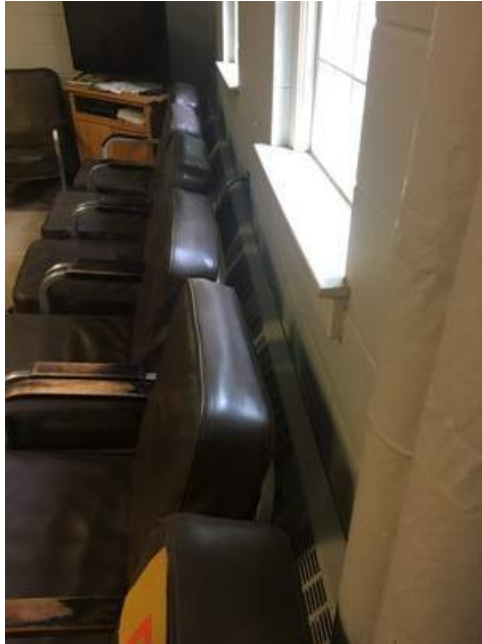
- 1) Baseboard heaters throughout the building are damaged and covers are missing in several locations. Heating elements are very dirty and covered with debris. Control valves and thermostats appear to be operational but are in poor condition.
- 2) Unit heaters throughout the building are in poor condition with access doors missing or damaged. Heating elements are very dirty and covered with debris. Control valves and thermostats appear to be operational but are in poor condition.

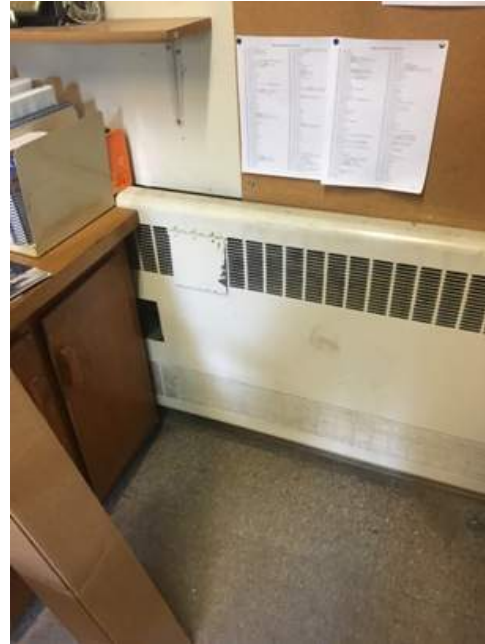
Unit Heater

- b. Heating elements throughout the building are in poor condition.

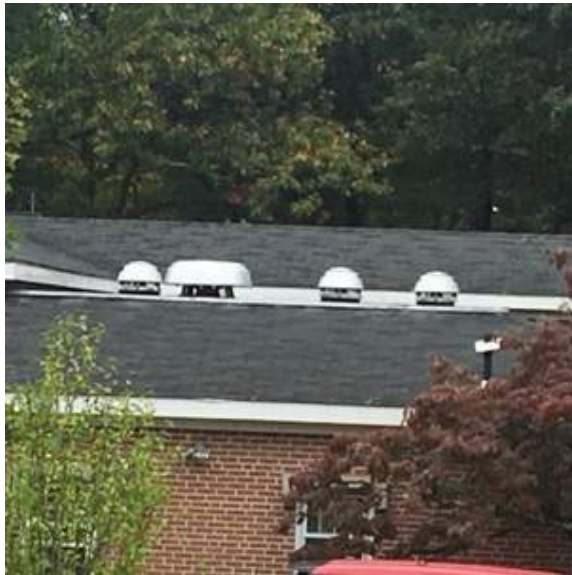
Roof Fans

- 3) Roof exhaust fans are in varies states of operation and disrepair.
  - a) Bathroom exhaust fans appear to be working but are in poor condition.
  - b) Kitchen exhaust fan appears to be operating but at very low airflow. Fan is in poor condition.
  - c) Multi-purpose room exhaust fan is operating but in poor condition.
  - d) Work room exhaust fan is not operational.
  - e) Apparatus bay CO/NO2 emergency exhaust fan is not operational.
  - f) Living area exhaust fan operation unknown but is in poor condition.

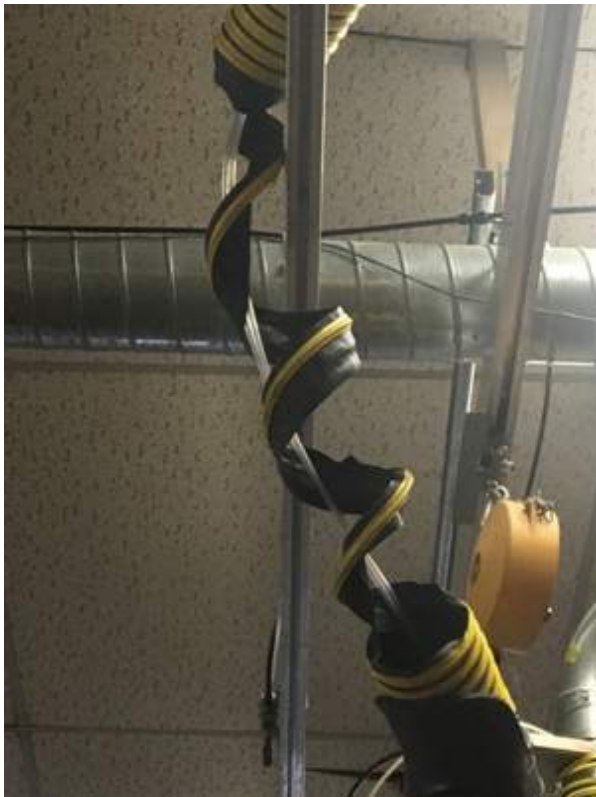
Plymovent System Hose

- 4) Plymovent system is in disrepair and is not operational. System capture hoses are torn and rendering the system unusable. Subsequent to this observation, repairs were made and system is fully operational.

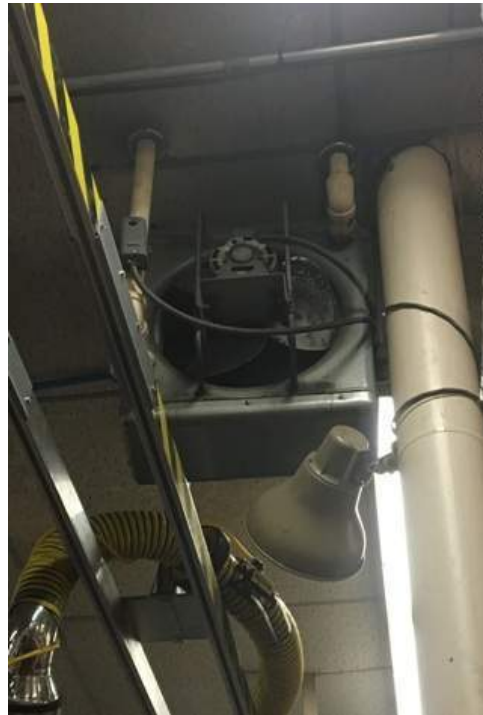
Unit Heater

- 5) Existing Apparatus bay hot water unit heaters are in poor condition. Operational status of the unit heaters is unknown.

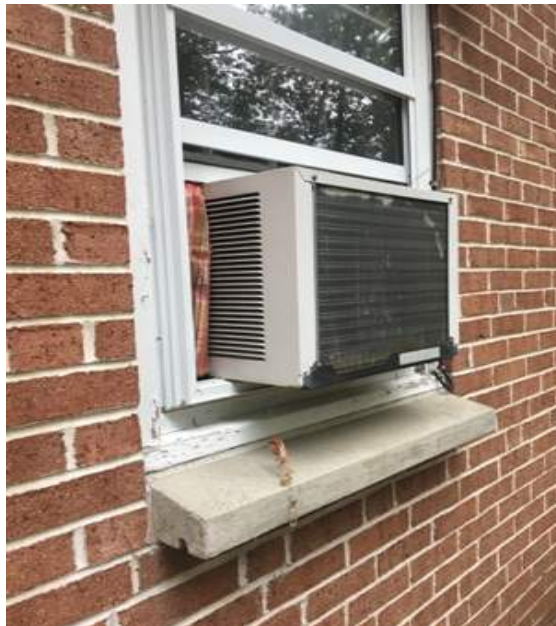
Window Unit

- 6) Air conditioning is provided to the Multi-purpose room and Bunk room with through wall window type units. Units are in poor condition.

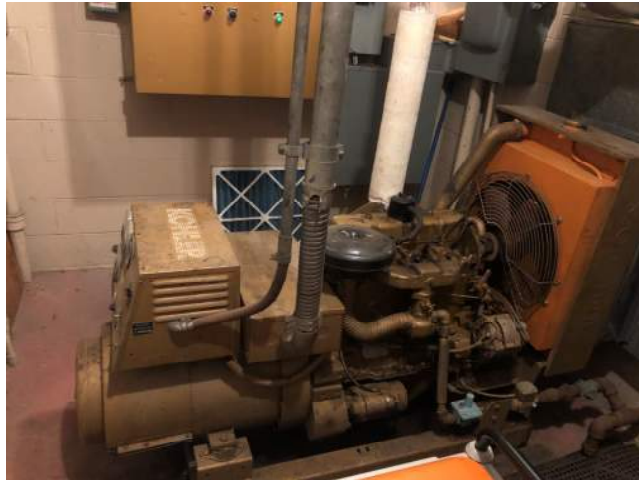
Generator

1. The building is equipped with a Kohler Natural Gas fueled standby generator rated at 25kW/25kVA, 120/240 volt, 1 phase, 3 wire and is equipped with a single 100A output circuit breaker. The generator and the associated automatic transfer switch are located within the mechanical-electrical room and is capable of providing the facility with 100 amperes of standby power. The generator and automatic transfer switch appear to be original building equipment, are in fair condition and have reached the end of their anticipated service life. It was noted that this equipment does not have the code required working clearances.

2. The existing generator's output rating is 104 amperes and does not have the capacity to provide standby power to all building equipment/loads simultaneously.
3. It was noted that a separate enclosed circuit breaker serving the Plymovent System is labeled "wired to street side of generator" and therefore cannot be powered by the generator with its current arrangement.

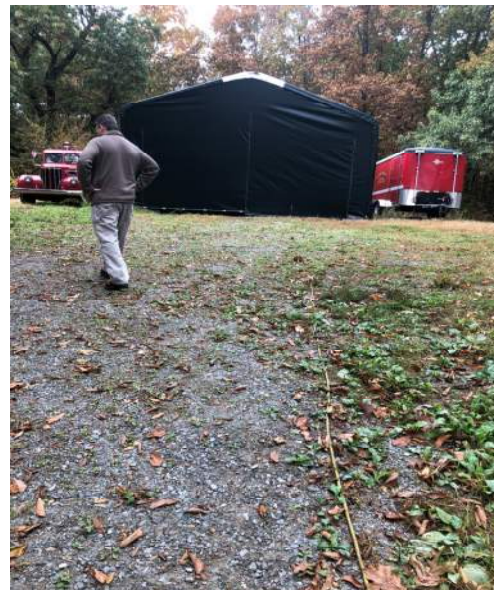
Extension Cord to Boat Storage Structure

1. In general, there are grounding type duplex receptacles installed in all areas with GFCI receptacles located where required by code. The devices appear to be in average condition.
2. Branch circuit wiring observed consists of conductors installed in conduit or type MC cable. An extension cord is being used to serve the fire boat storage structure located behind the Fire Station which is a code violation as extension cords cannot be used as a substitute for fixed wiring.

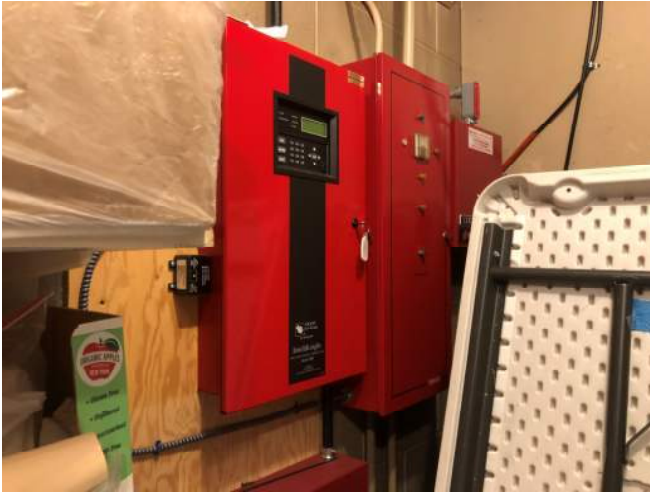
Building Fire Alarm Equipment

1. The existing fire alarm system is an addressable system as manufactured by Silent Knight and is connected to a Sig-Com radio master box for system monitoring. Device coverage includes manual pull stations at each egress door and smoke/heat detector coverage throughout the building. Fire alarm notification devices are provided in main circulation areas, bathrooms, bunk room, and on the building exterior. Separate CO detectors have been installed in the bunk room and adjacent corridor.

2. The notification device installed within the bunk room does not appear to have a low frequency type sounder that is required by present code.
3. In general, all fire alarm system devices and components appear to be in good condition.
