Posted 11.26.2019 at 3:30pm by JAD

**SELECT BOARD**

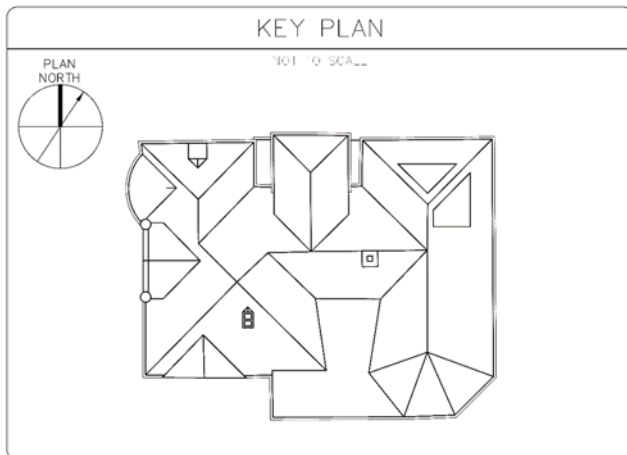
Figure 1: Key Plan of the Old Library

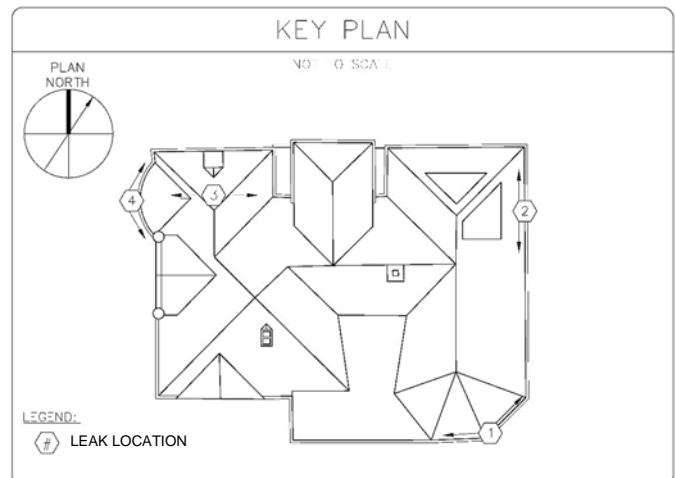
Figure 2: Key Plan of leak locations at the Old Library

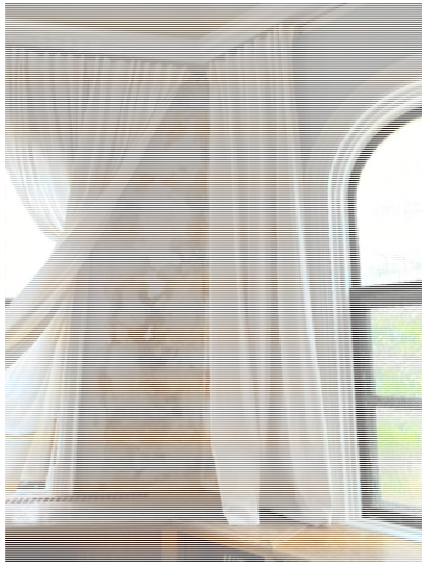
Photo 1: View of heavy water staining on the first floor walls at Leak Location #1.

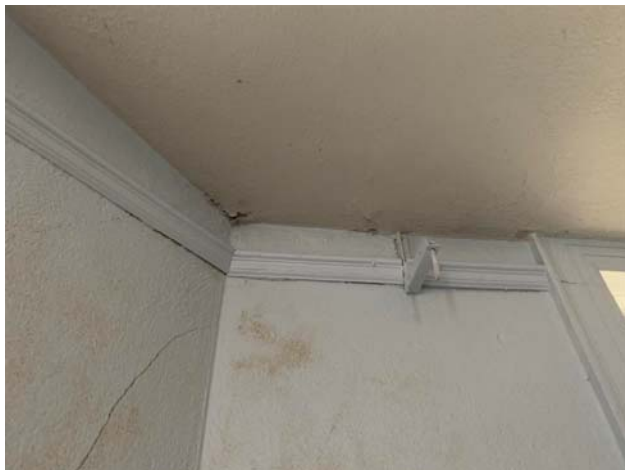
Photo 2: View of peeling paint, cracked plaster, and water staining on the basement floor walls at Leak Location #1.

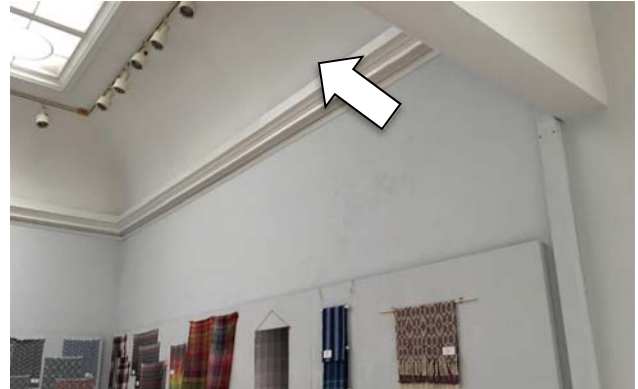
Photo 3: View of Leak Location #2.

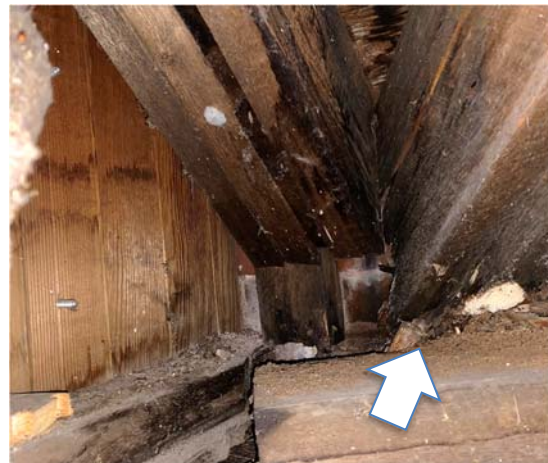
Photo 4: View of rotted wood at the end of the roof framing valley beam Leak Location #4.

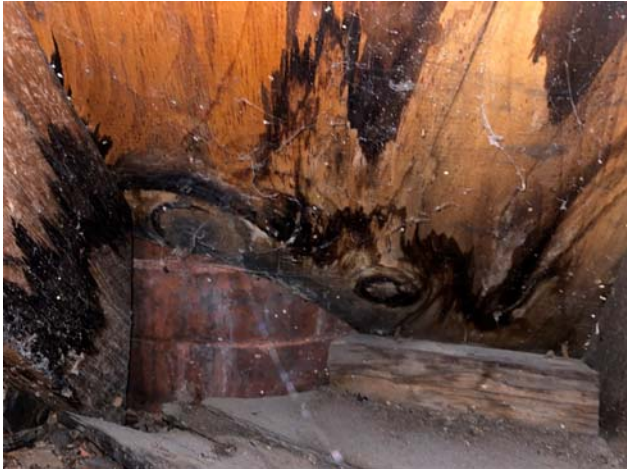
Photo 5: View of water staining on the underside of the roof sheathing at Leak Location #4.

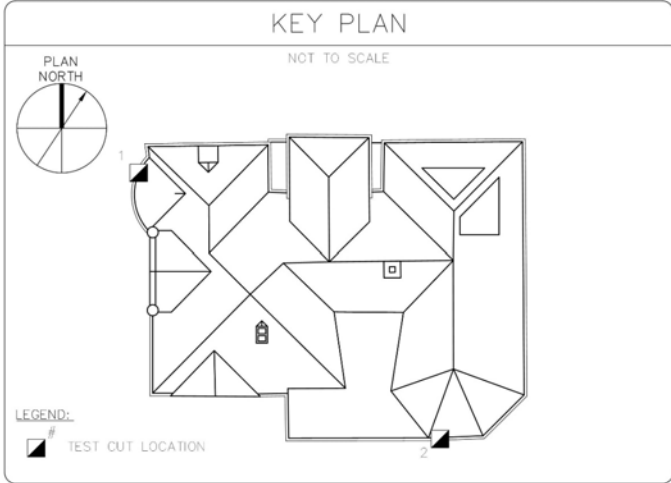
Figure 3: Key Plan of test cut locations at the Old Library.

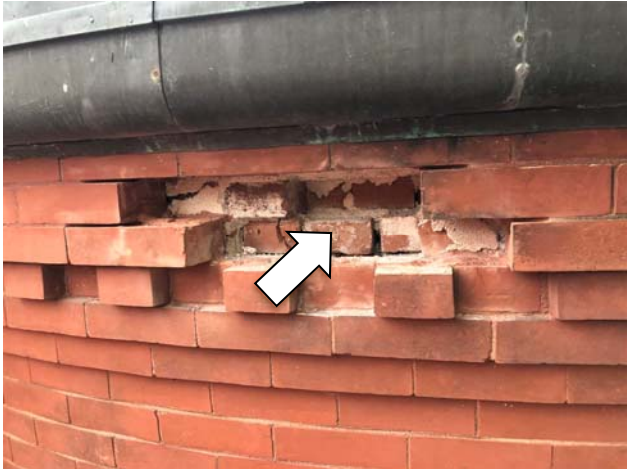
Photo 7: View of test cut 1 at the masonry directly below the gutter. Note the cracked brick and deteriorated mortar in the second wythe of brick.

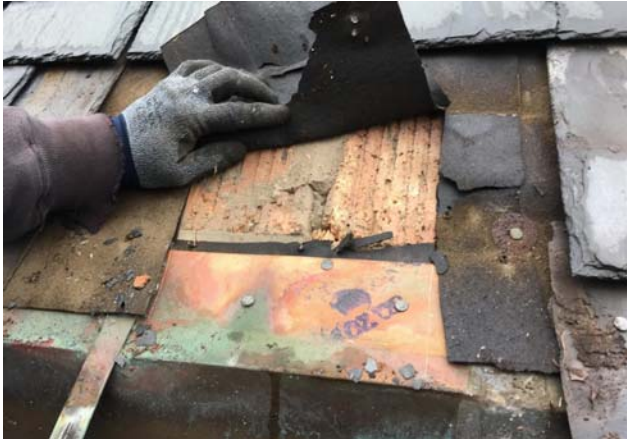
Photo 8: The slate, underlayment, and copper gutter are nailed directly into the terra cotta roof deck.

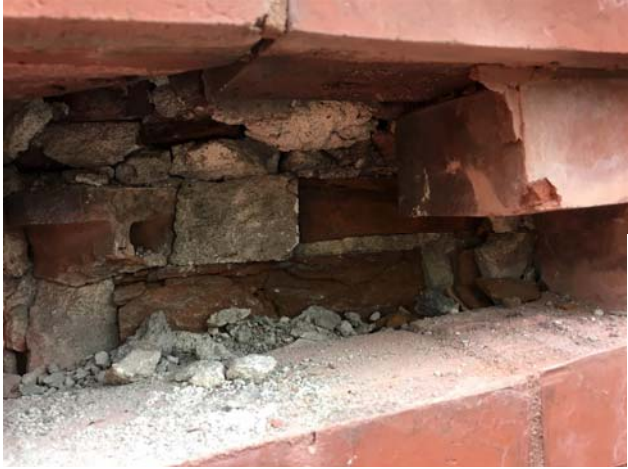
Photo 10: View of cracked brick and deteriorated mortar in the second wythe of masonry.

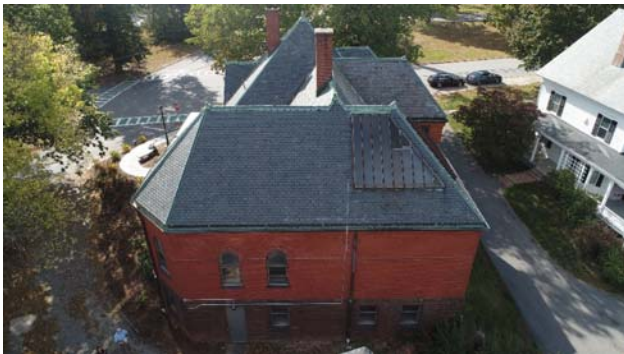
Photo 11: Overview of the slate roof areas at the Old Library.

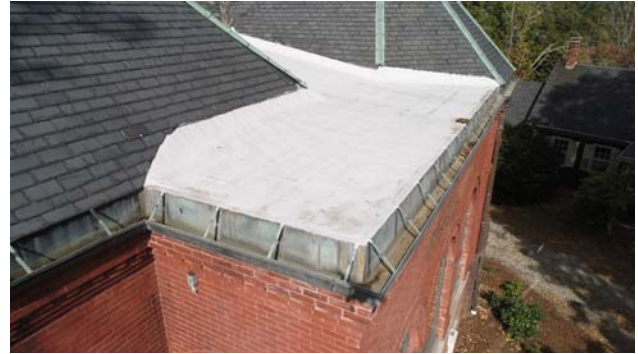
Photo 12: View of the white fluid-applied low-sloped roof area.

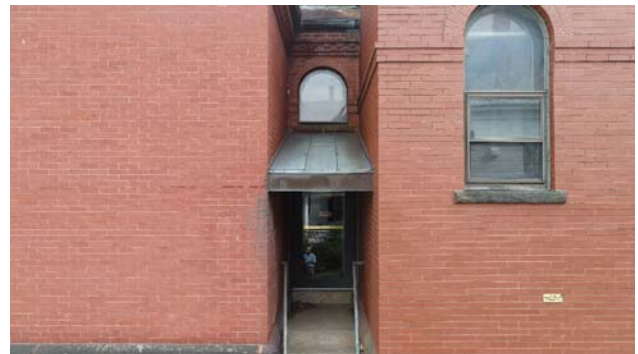
Photo 13: View of the standing seam metal roof area.

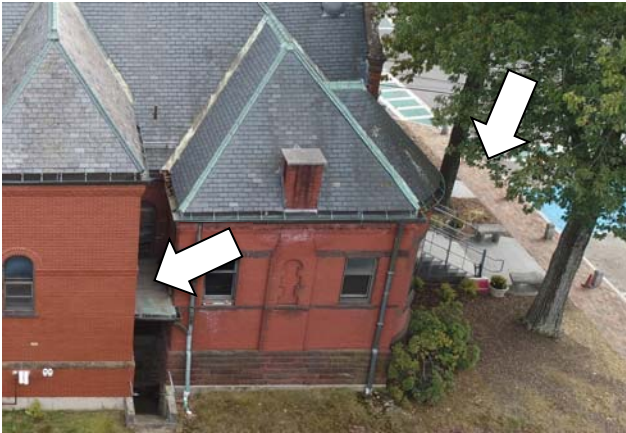
Photo 15: View of the flat lock copper roof area.

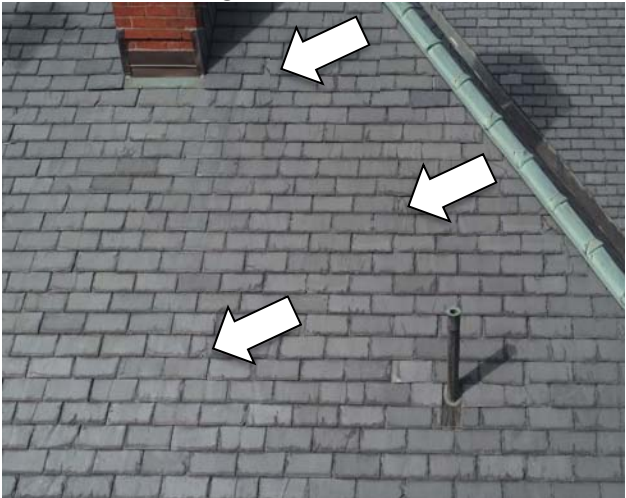
Photo 16: View of typical broken shingles.

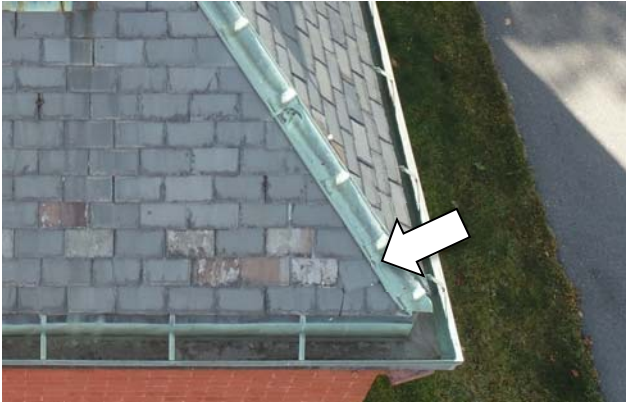
Photo 17: View of a loose slate.

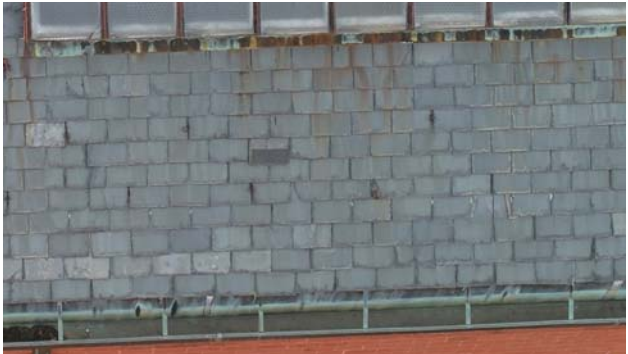
Photo 18: View of a missing shingle.

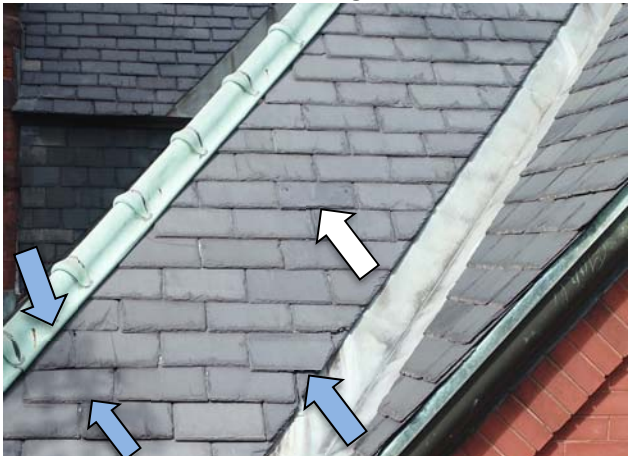
Photo 19: View of exposed slate fastener holes. Note also the loose slates (dark arrows).

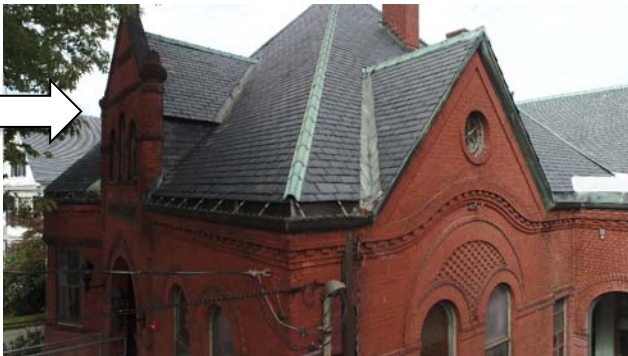
Photo 20: View of the masonry above the front entrance.

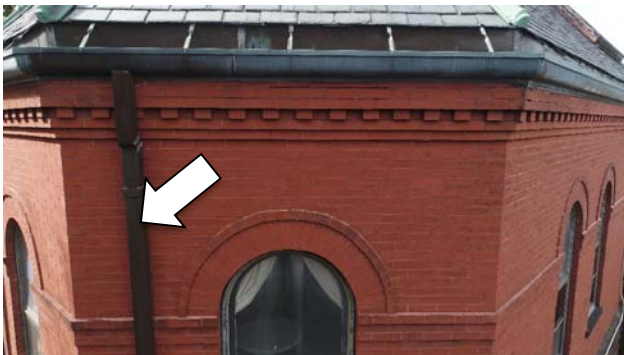
Photo 22: View of a downspout resting against the face of a wall.

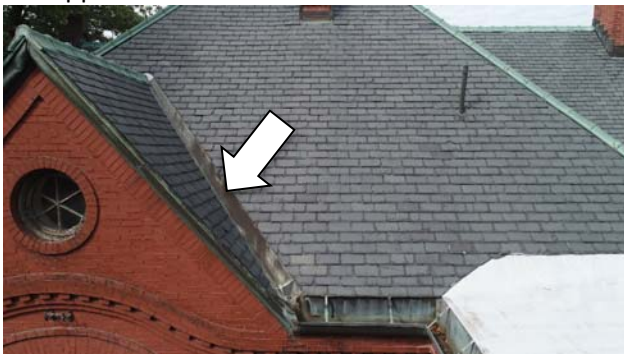
Photo 23: View of deteriorated sheet metal valley flashing.

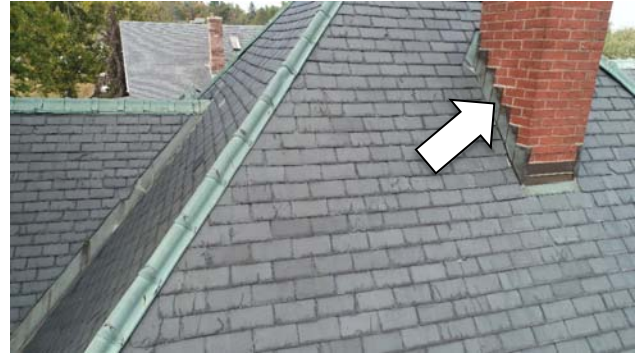
Photo 24: View of deteriorated sheet metal flashing at a chimney.

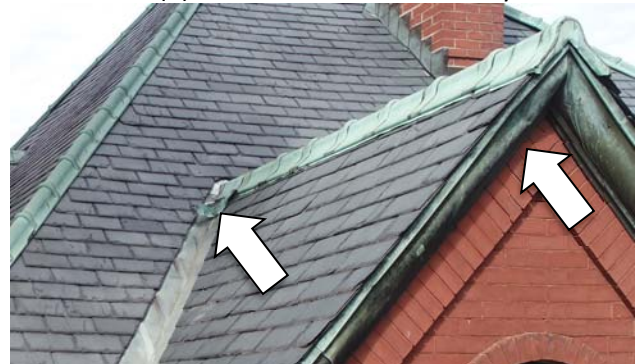
Photo 25: View of deformed and displaced ridge cap and rake trim.

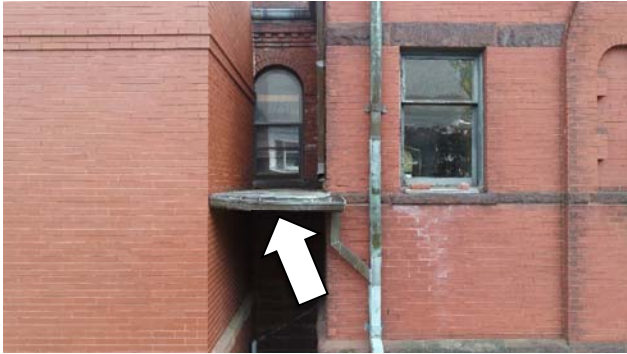
Photo 26: View of a deformed gutter.

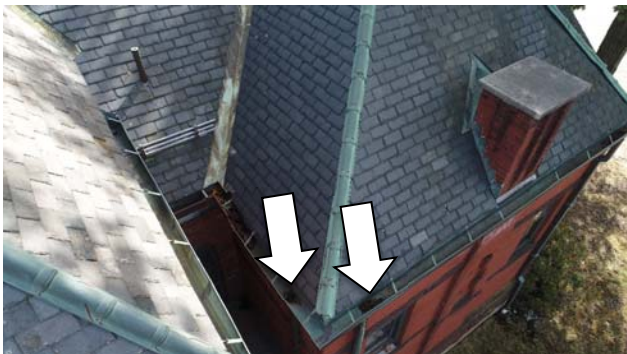
Photo 27: View of two obstructed downspouts.

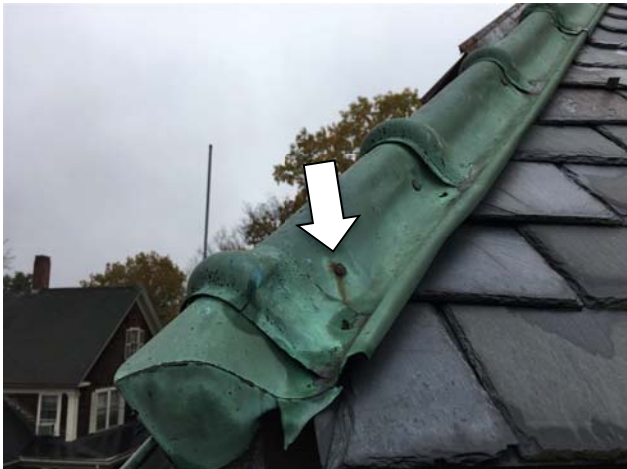
Photo 28: Sheet metal fasteners appear rusted in some locations.

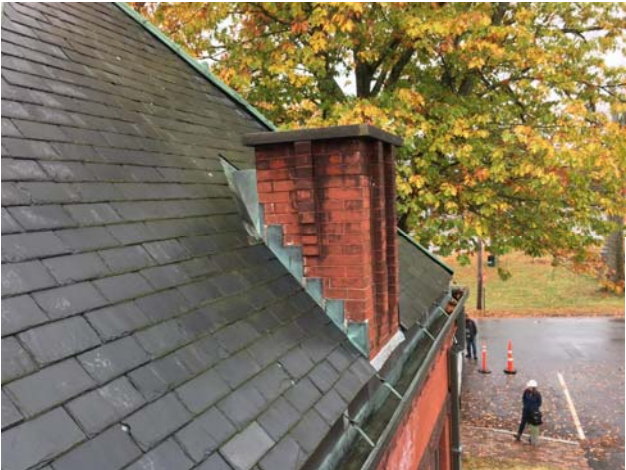
Photo 29: The sealant along the sheet metal flashing is failed, and the brick masonry appears stained at this chimney.

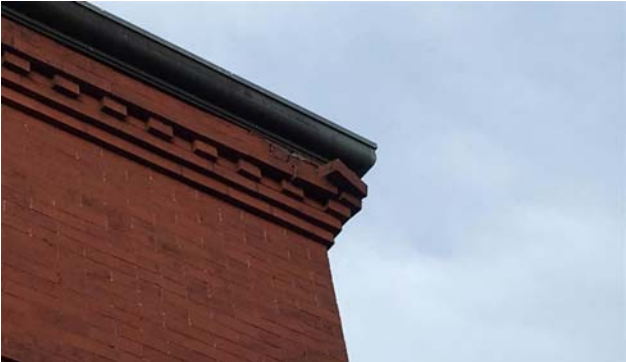
Photo 30: View of the displaced brick in danger of falling.

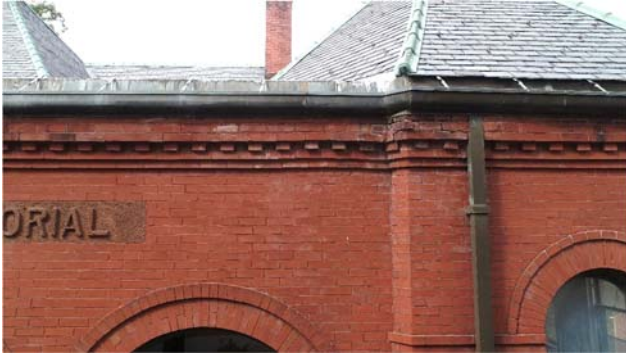
Photo 31: View of the deteriorated mortar and white colored efflorescence staining.

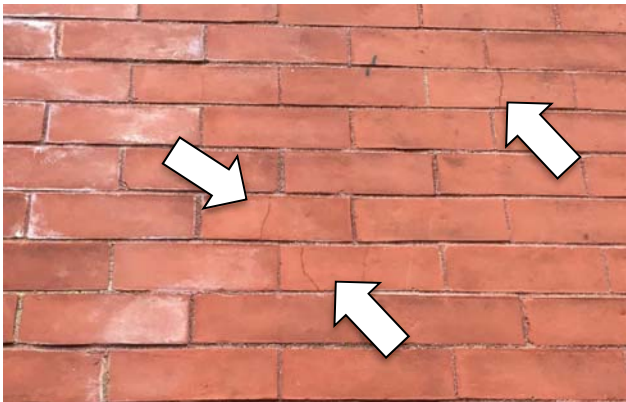
Photo 32: View of cracked brick masonry units.

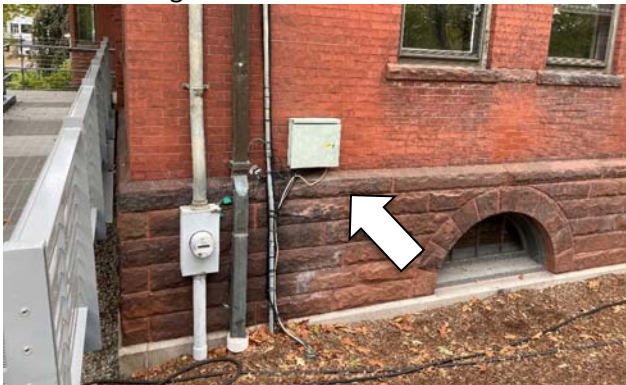
Photo 33: View of downspout connection to a sub-grade drainage leader line.

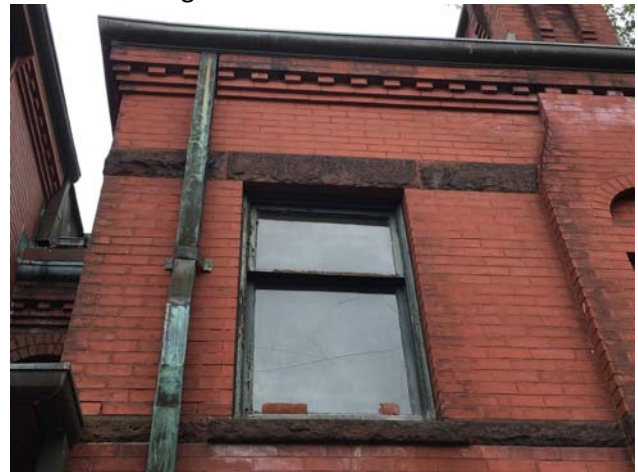
Photo 34: View of cracked glazing and loose brick masonry units on the brownstone sill.

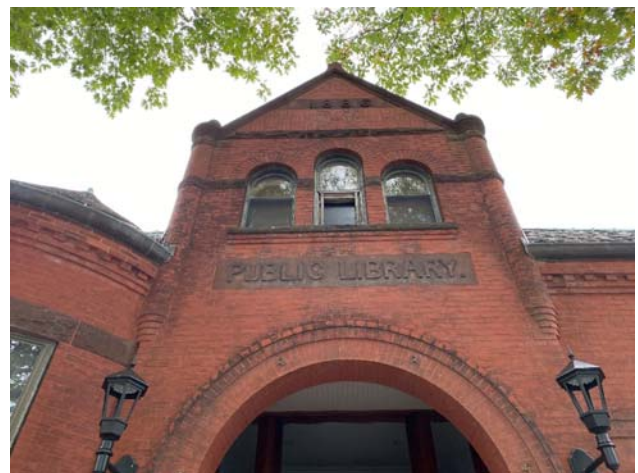
Photo 35: View of missing glazing.

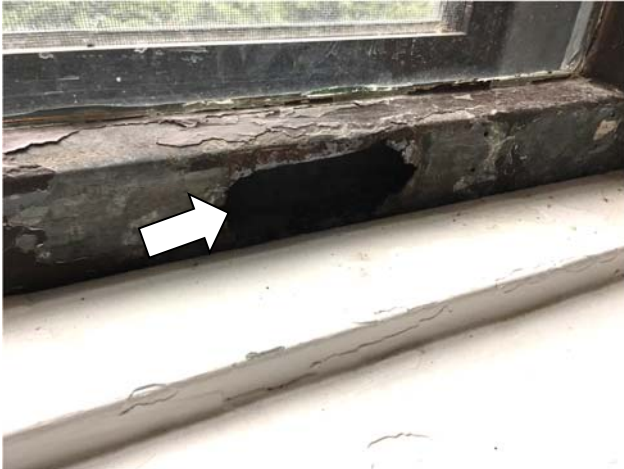
Photo 36: View of window with a rusted hole in the frame.

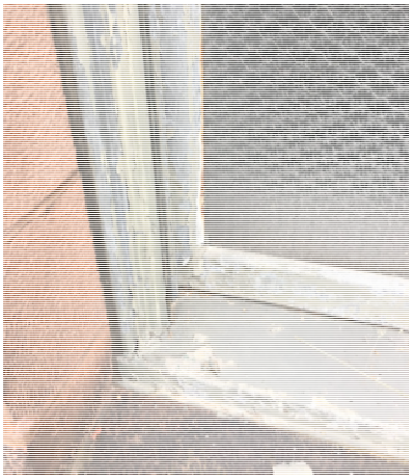
Photo 37: View of a window with peeling paint.

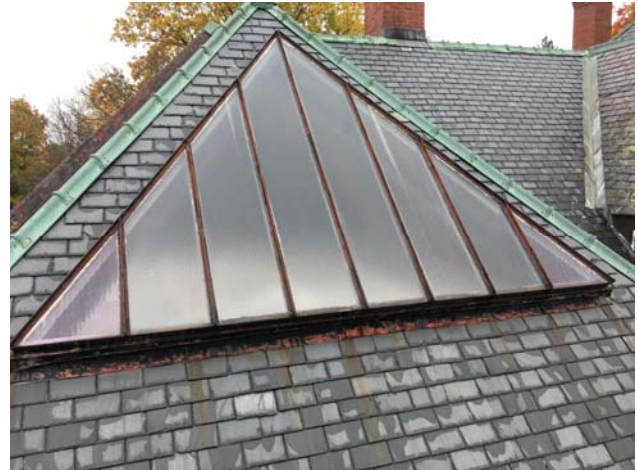
Photo 38: Overview of one of the skylight assemblies.
