## SELECT BOARD

Tuesday, December 7, 2021

**Department of Public Works Facility  
Garage, Facility Analysis and Space  
Needs Assessment  
Harvard, Massachusetts  
November 3, 2021**

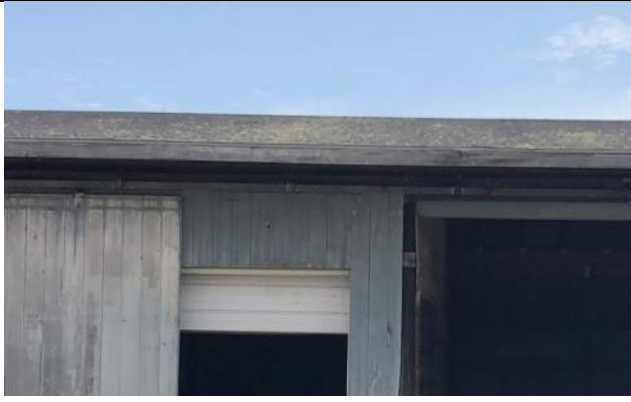
In general, the condition of the roof is poor. This description is largely due to the deficiencies found during CBI's review. CBI observed weathered and deteriorated single tab asphalt shingles. Organic growth has accumulated on the surface of the roof shingles (Refer to Photographs 2).

Weathered and deteriorated single tab asphalt shingles
3.

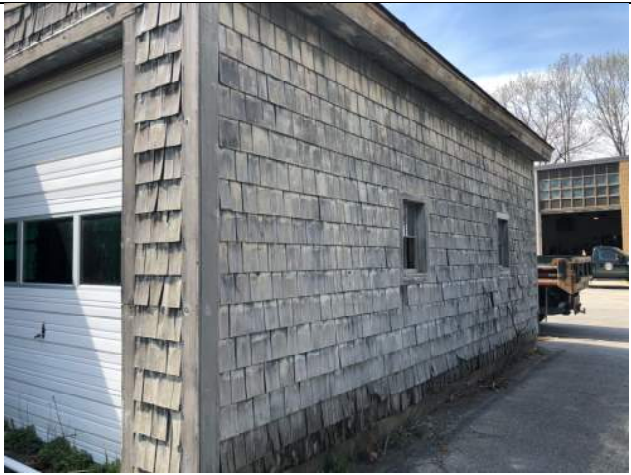
The condition of the exterior wood shingle walls are in poor condition. There are sections where shingles are missing, deteriorated shingles due to water damage and warped/coupling of shingles. (Refer to Photographs 3 and 4). There are gaps between the vertical wall wood siding allowing water infiltration to reach stored materials. (Refer to Photograph 5).

Deteriorated wood shingles. Image 1 of 2.

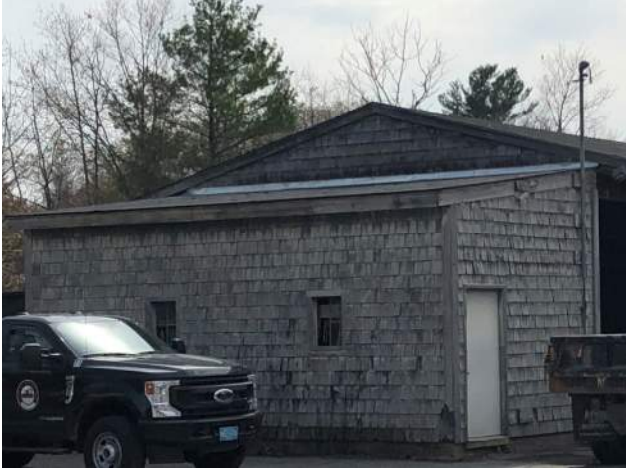
Deteriorated wood shingles. Image 2 of 2.
5.

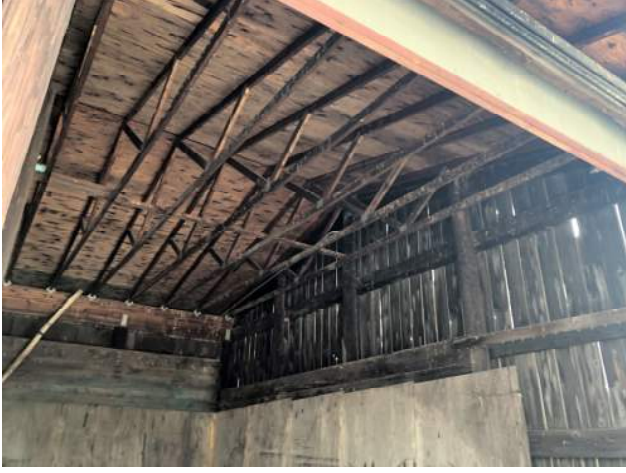
There are gaps between the vertical wall wood siding allowing water infiltration to reach stored materials.
6.

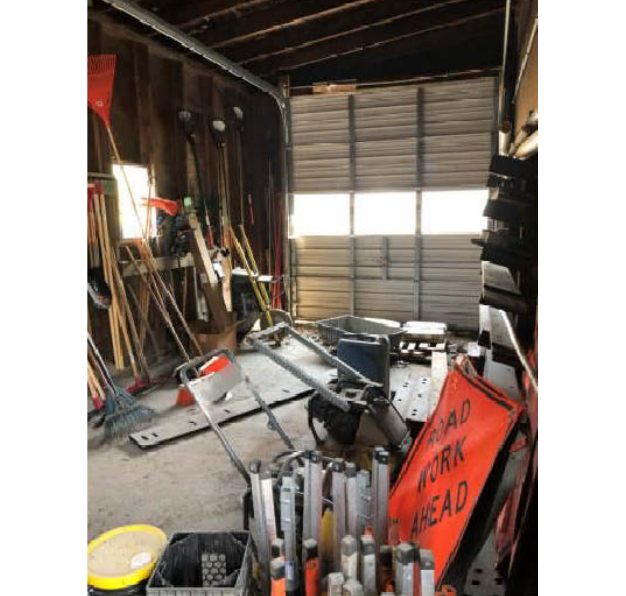
In general, the condition of the windows and doors are poor. The fixed wood windows are missing glazing panels, and also are missing sealant around the framed openings. The sliding bay wood door shows signs of delamination due weather exposure. The two (2) existing manually operated overhead metal doors bay doors are single ply metal and appear low grade to withstand operation of a material storage garage. (Refer to Photographs 6 and 7).

The manually operated overhead metal door bay doors are single ply metal.

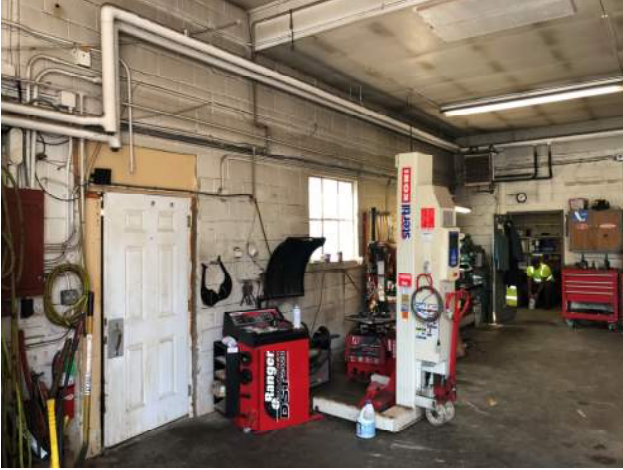
The low ceiling in the mechanic garage restricts servicing larger vehicles on the auto floor lifts.
3.

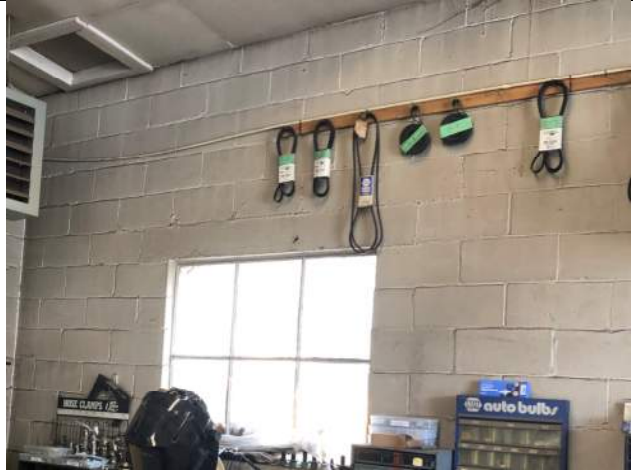
The condition of the single uninsulated wythe concrete masonry block walls appears to be in fair condition. There are areas of individual block interior surfaces not aligned with adjacent blocks thus creating uneven mortar joints which eventually will allow water into the building. (refer to Photograph 4).

<p>There are areas of individual concrete masonry block interior surfaces not aligned with adjacent blocks.</p>
<p>5.</p>

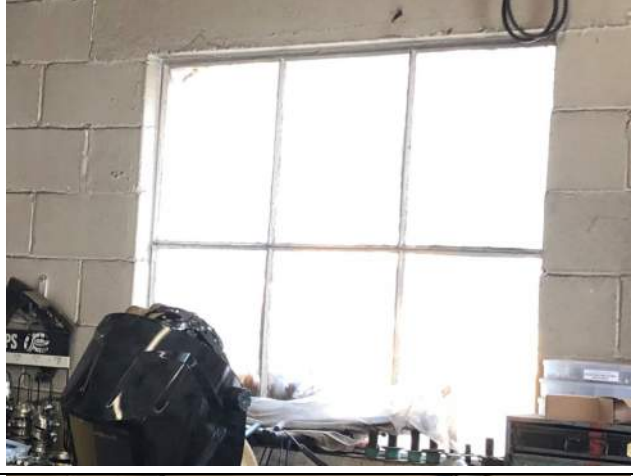
In general, the condition of the windows are poor. The windows are drafty fixed wood frame single plane glazed windows with deteriorated putty around the wood muntins. (refer to Photograph 5). The exterior metal door appears to be in fair condition. The one (1) bay overhead metal door is manually operated and appears to be in good condition (refer to Photograph 6).

<p>View of one of the wood frame single plane glazed windows with deteriorated putty around the wood muntins.</p>
<p>6.</p>

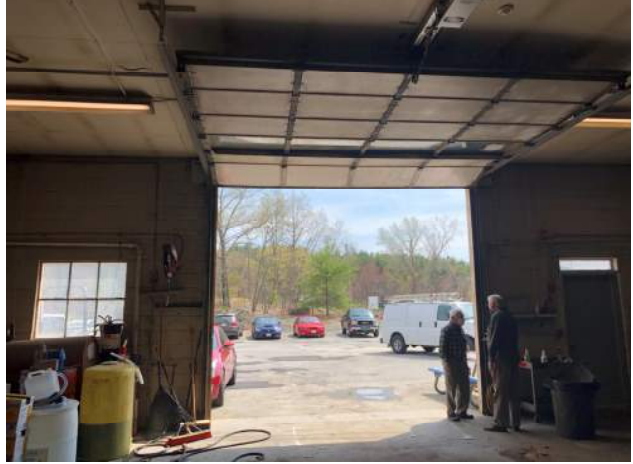
<p>The one (1) bay overhead metal door is manually operated and appears to be in good condition.</p>

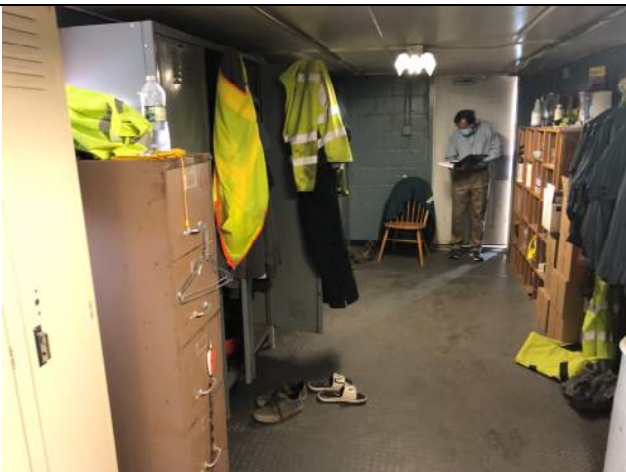
In general, the office storage capacity is inadequate with the office storage overflow located in the corridor. The use of the corridor for locker room changing area and for storage creates an egress safety hazardous condition. There is also the use of lack of privacy for the location of the lockers in the corridor.

<p>The use of the corridor for locker room changing area and for storage creates an egress safety hazardous condition. There is also the lack of privacy for staff uniform changing.</p>

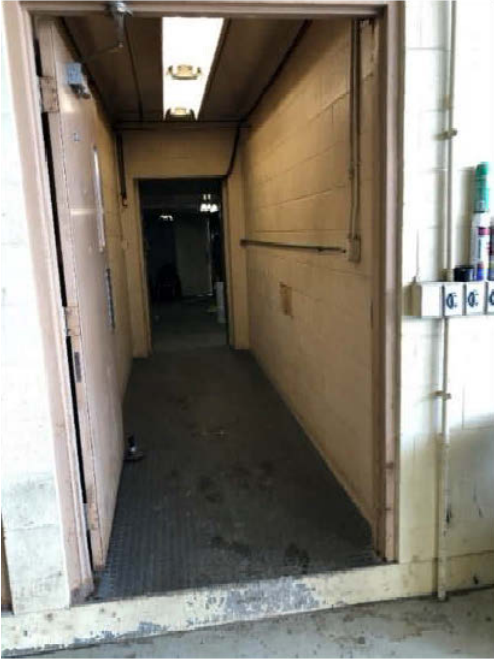
<p>The floor elevation in the corridor leading from the “connector” building to the large vehicle storage garage contains a step and does not meet accessibility requirements.</p>
<p>5.</p>

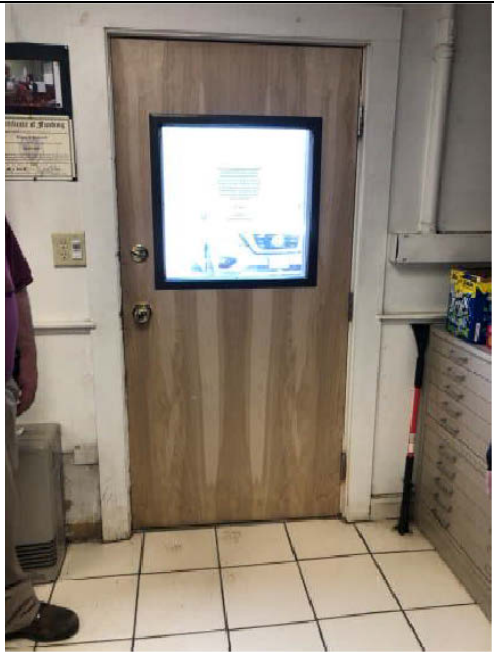
In general, the condition of the window is poor. The sliding wood window is drafty with a single glazed plane. The exterior office entrance wood door is a residential wood grade door not suitable for weather exposure. (refer to Photograph 6).

<p>View of the office exterior main entrance residential wood grade door.</p>

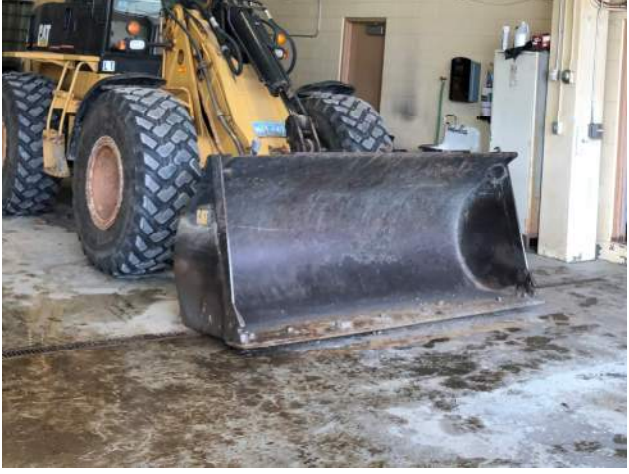
<p>Deteriorated sections of the traffic epoxy floor finish and pitted concrete floor in the garage caused by water and de-icing salts.</p>
4.

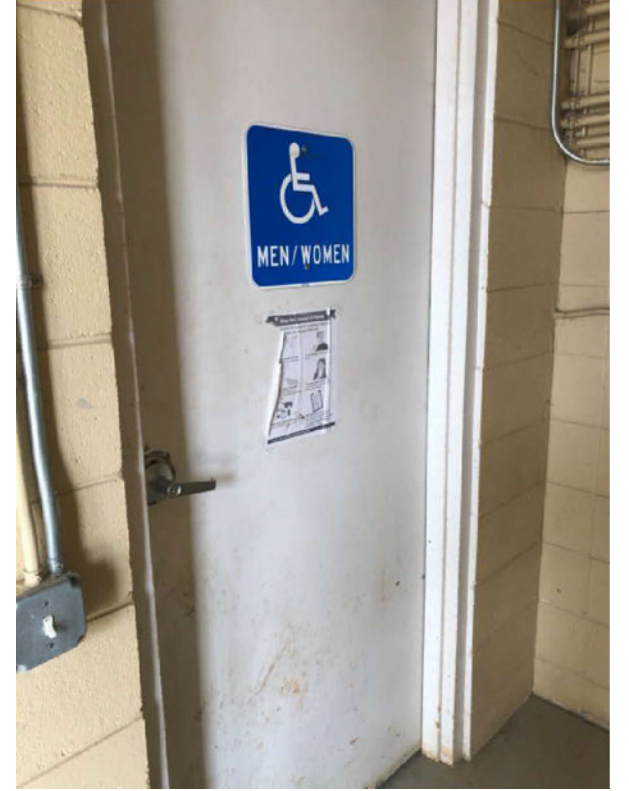
<p>The unisex toilet interior metal door and frame and exhibit signs of rust.</p>

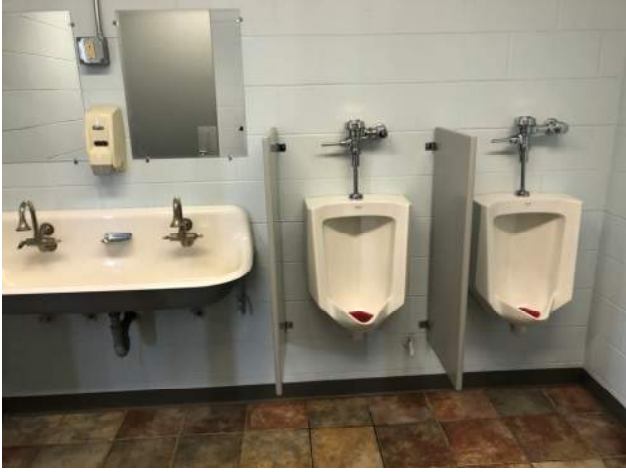
<p>The male multi-user toilet room plumbing fixtures appear to be fair but are outdated. The fixtures and heights are not handicap accessible.</p>
<p>6.</p>

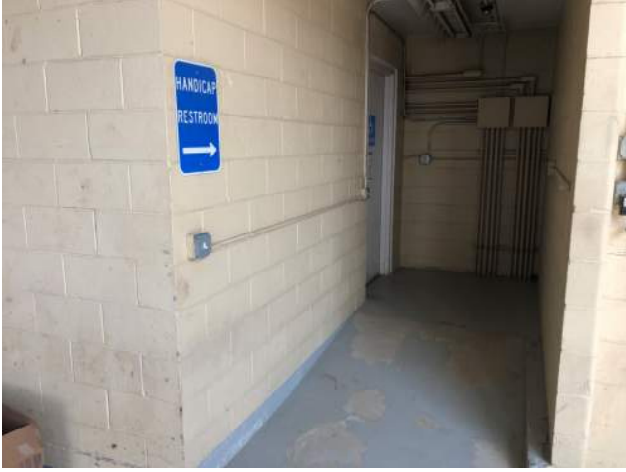
<p>The existing ramp leading to the unisex bathroom exceeds the slope requirements of 1/12 pitch. It also lack handrails on both sides.</p>
<p>7.</p>

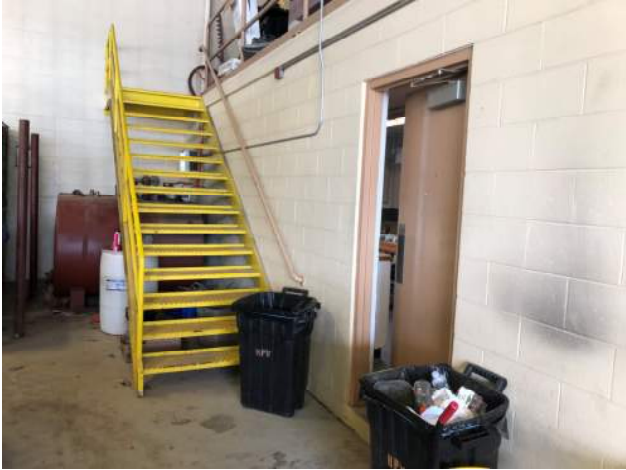
room to the garage floor does not meet accessibility requirements, (refer to Photograph 7). The unisex toilet room does not meet ADA accessibility requirements including maneuver clearances within the toilet partition and the shower stall approach and there is no shower seating as required by the accessibility code. (refer to Photograph 8 & 9).

<p>The 7-1/2" raised floor elevation from the break room to the garage floor does not meet accessibility requirements and it also creates a tripping hazard.</p>

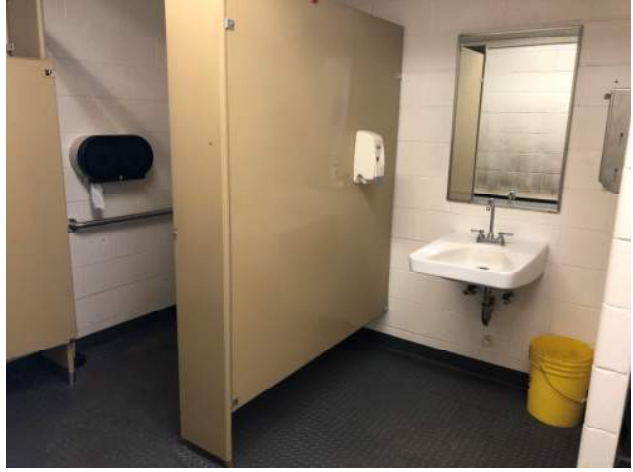
<p>The unisex toilet room does not meet ADA accessibility requirements for the maneuver clearances within the toilet partition</p>
9.

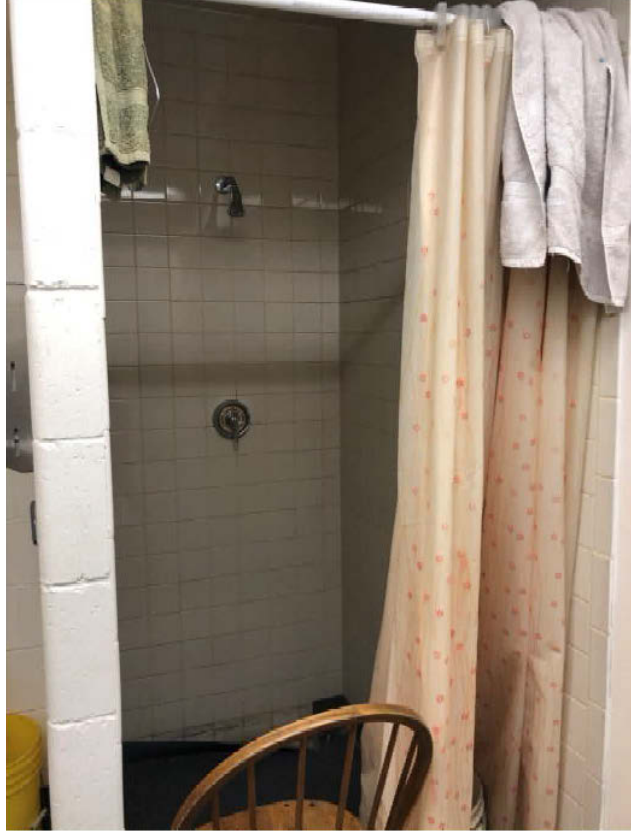
<p>The unisex toilet room does not meet ADA accessibility for the shower stall approach and lack of seating</p>

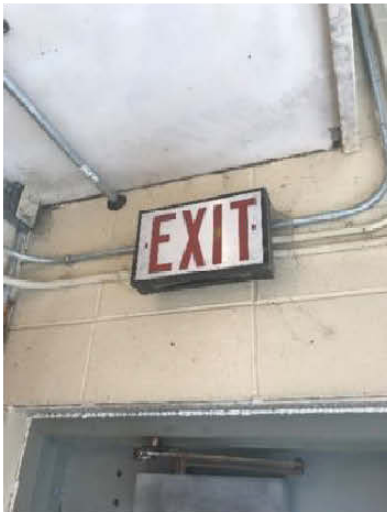
**Non-Illuminated Exit Sign - Corridor**

- Exit signs are illuminated (with the exception of one) but coverage is not adequate. The exit signs have approached their expected useful life.
- There is an existing exterior weatherproof enclosed propane generator, located in the exterior fenced-in area adjacent to the Mechanic's Service Garage. The generator was manufactured by Kohler. The rating of the generator is 100KW, 120/240V, 1-phase. The generator backs up the entire facility except the air compressors. The employees manually shut off the breakers for the compressors. It appears to be in good working condition, is maintained annually, exercised weekly, was installed in 2000. Continuing the maintenance and exercising, the generator has an additional 12 to 15 years of expected life. The generator turns on automatically when there is a utility outage, via the existing 400 Amp Kohler Automatic Transfer Switch. The ATS also appears to be in good condition with an additional 12 to 15 years remaining.

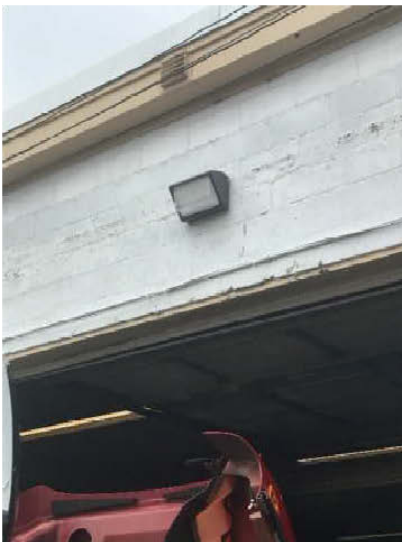
**Exterior Wall Pack - Six Bay Vehicle Storage Garage**

- The building has exterior lighting consisting of wall packs. These fixtures are inefficient and have reached their expected lifespan.
- The existing pole barn storage has minimal electrical components; all electrical components have surpassed their expected lifespan and should be replaced.
