SELECT BOARD AGENDA Tuesday, May 23, 2023 7:00pm

Feasibility and Space Needs Study

HARVARD FIRE HEADQUARTERS

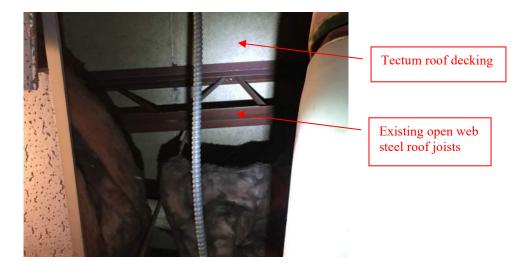
Sloped roof joists and Tectum roof decking Photo 6

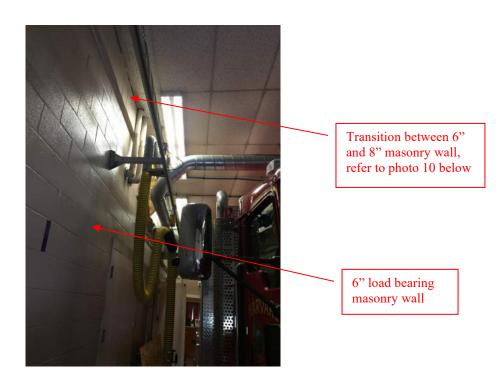
Load bearing masonry wall Photo 7

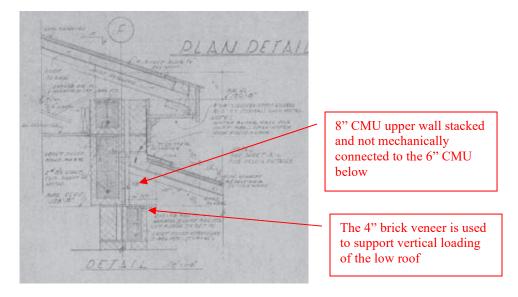
Existing 8" masonry stacked on top of 6" Photo 10

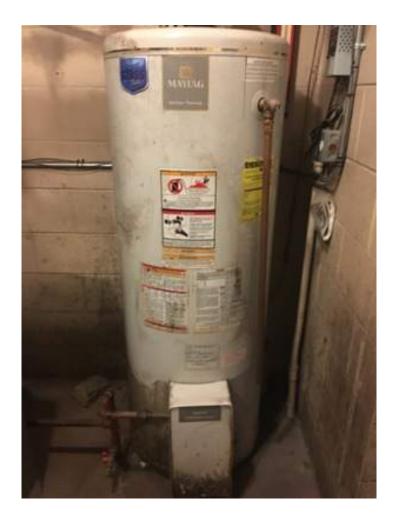
Hot Water Tank

- 1. Plumbing:
 - a. The existing building plumbing systems consist of the following:
 - 1) Water Service The existing water service enters the building in the Work Shop. A water meter could not be located. Currently there is an existing gate valve for the main shut-off.
 - 2) Sanitary System The sanitary piping is cast iron piping which runs underground.
 - 3) Domestic Hot Water The domestic water heater is located in the mechanical room. The water heater is a Maytag 50 gallon, 40,000 btu gas fired water heater. The water heater was manufactured in May of 2005, and is in fair/poor condition. Hot and cold water piping in the boiler room is not insulated.

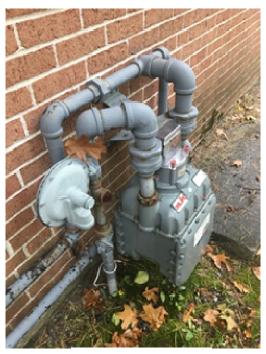
Gas Service/Meter

4) Fuel Source – The natural gas service/meter assembly is located on the exterior of the building. A 2" low pressure gas line enters the building at the mechanical room. The gas line serves the heating boilers and water heater located in the mechanical Room. No deficiencies were observed on the gas piping.

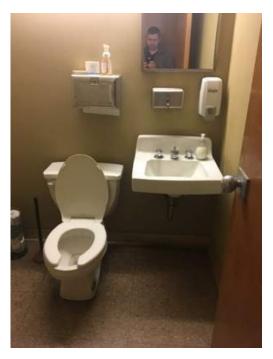
Plumbing Fixtures

5) Fixtures – The plumbing fixtures are not ADA compliant. Toilets are tank type floor mounted. The locker rooms contain one (1) shower in each room (male and female). The plumbing fixtures should all be replaced with low flow, ADA compliant fixtures, per current Code.

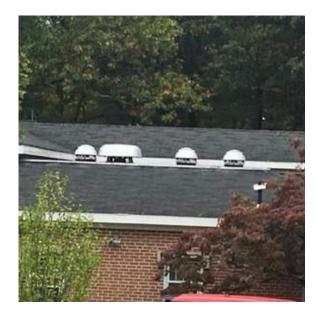
Roof Fans

- 3) Roof exhaust fans are in varies states of operation and disrepair.
 - a) Bathroom exhaust fans appear to be working but are in poor condition.
 - b) Kitchen exhaust fan appears to be operating but at very low airflow. Fan is in poor condition.
 - c) Multi-purpose room exhaust fan is operating but in poor condition.
 - d) Work room exhaust fan is not operational.
 - e) Apparatus bay CO/NO2 emergency exhaust fan is not operational.
 - f) Living area exhaust fan operation unknown but is in poor condition.

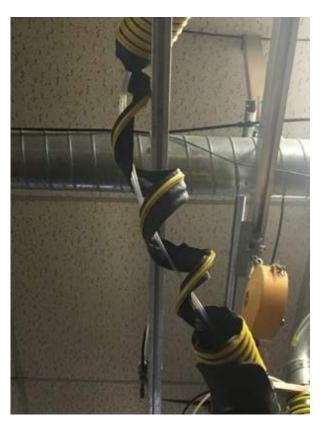
Plymovent System Hose

4) Plymovent system is in disrepair and is not operational. System capture hoses are torn and rendering the system unusable. Subsequent to this observation, repairs were made and system is fully operational.

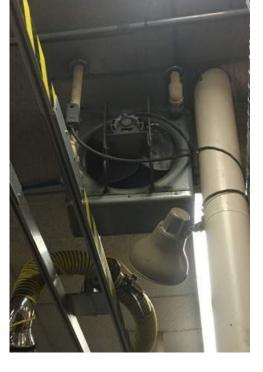
Unit Heater

5) Existing Apparatus bay hot water unit heaters are in poor condition. Operational status of the unit heaters is unknown.

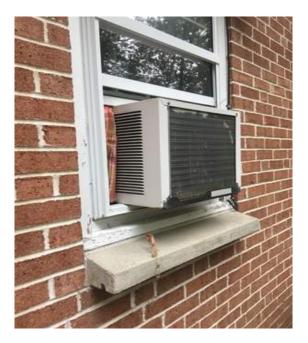
Window Unit

6) Air conditioning is provided to the Multi-purpose room and Bunk room with through wall window type units. Units are in poor condition.

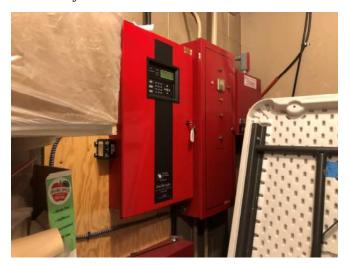
Building Fire Alarm Equipment

The existing fire alarm system is an addressable system as manufactured by Silent Knight and is connected to a Sig-Com radio master box for system monitoring. Device coverage includes manual pull stations at each egress door and smoke/heat detector coverage throughout the building. Fire alarm notification devices are provided in main circulation areas, bathrooms, bunk room, and on the building exterior. Separate CO detectors have been installed in the bunk room and adjacent corridor.

- 2. The notification device installed within the bunk room does not appear to have a low frequency type sounder that is required by present code.
- 3. In general, all fire alarm system devices and components appear to be in good condition.
