Exterior Conditions Assessment
Harvard Town Hall
Harvard, Massachusetts

Prepared for
The Town of Harvard
May 2011

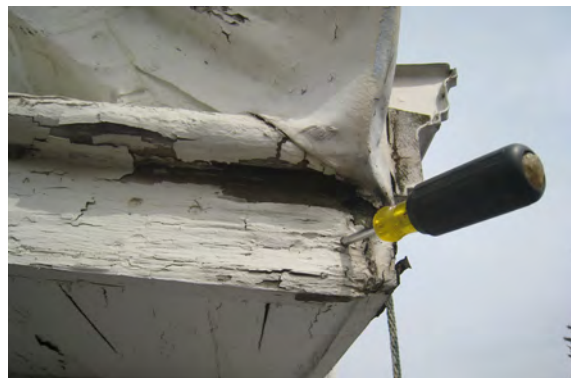
Deteriorated fascia board

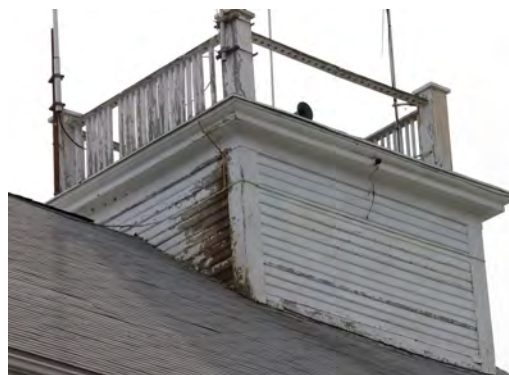
Tower - Balustrade missing many balusters

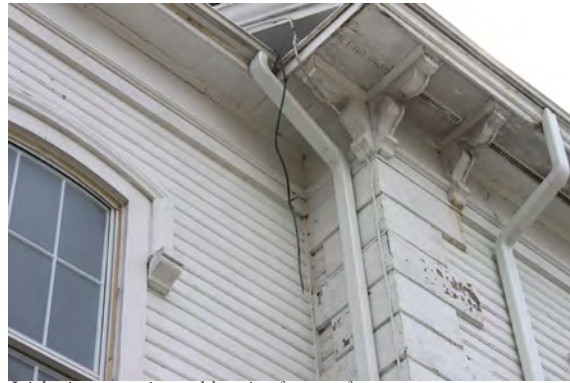
The lightning protection system is in disarray. The cables are sagging along the ridge and at the rear of the building a terminal rod is hanging off of the roof.

Lightning protection rod hanging from roof

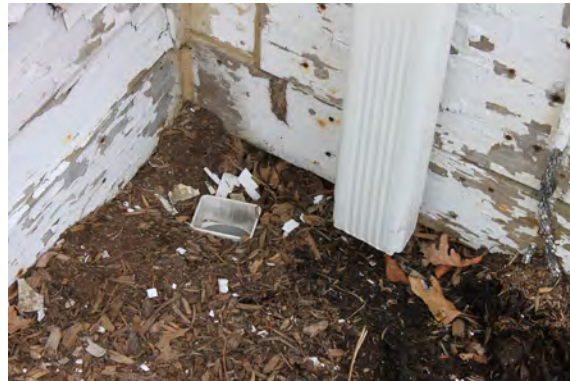
swale and empties onto the ground. On the west side of the building at the front the downspout empties at grade adjacent to a storm drain. At the rear of the building one of the downspouts empties into an aluminum inlet into the ground; a second downspout misses a second inlet by approximately a foot.

Downspout misses inlet in ground

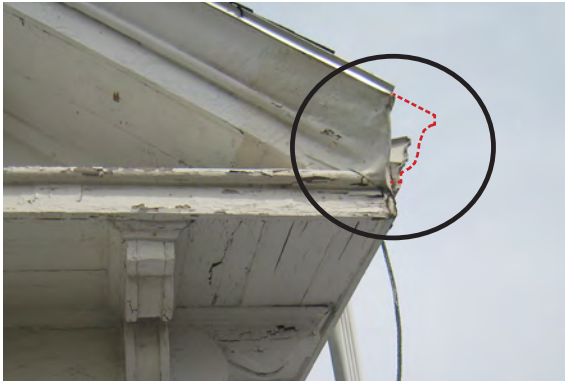
The current gutters are an unfortunate intervention to the building. The installation of gutters prompted the removal of a large section of cornice molding that the gutters’ “k” profile is not large enough to replace. This leaves an area of unprotected wood sheathing between the gutter and the roofing. The gutters themselves are also undersized for the amount of roof area they are meant to drain. The downspouts have an eclectic mix of termination details. On the east side of the building the front downspout empties into a cast iron boot into some form of underground system. At the rear of the building two downspouts drain at grade, one into an asphalt swale leading towards the road and a second that narrowly misses the

Missing cornice molding removed for gutter installation (indicated in red)

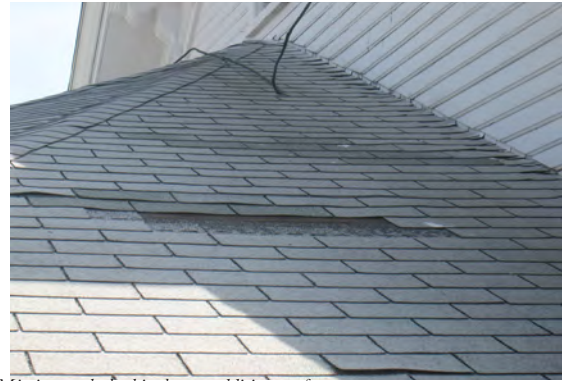
Missing asphalt shingles on addition roof

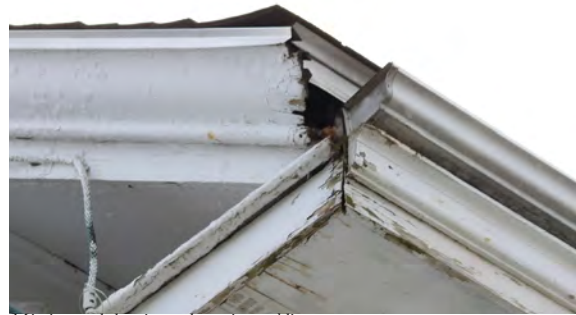
Missing and deteriorated cornice molding.

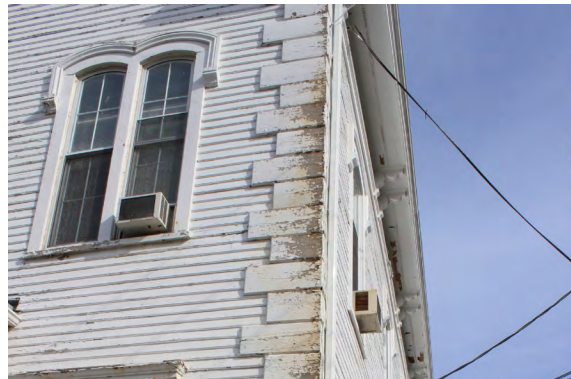
The quoins at the four main corners of the building are deteriorating. Of the four quoin locations, the southeast corner shows the most damage. Many of the quoins have been repaired with wood consolidant and sealant at their mitered corners, which have opened up over time. These repairs have begun to fail, allowing water to infiltrate into the sheathing behind and rot the quoins.

Quoins on South East corner

- Remove and reinstall wood quoins at southeast corner. Work will include sheathing repairs and replacement of approximately 25% of the quoins.
- Provide selective repairs to remaining quoins.

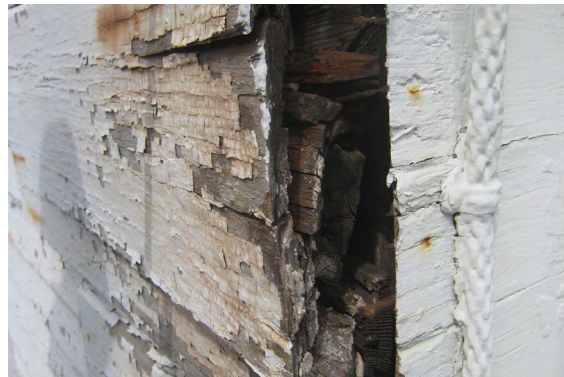
Deteriorated and open quoin

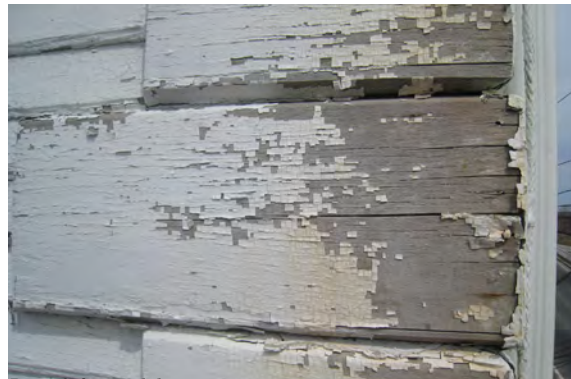
Paint failure and damage on quoins.

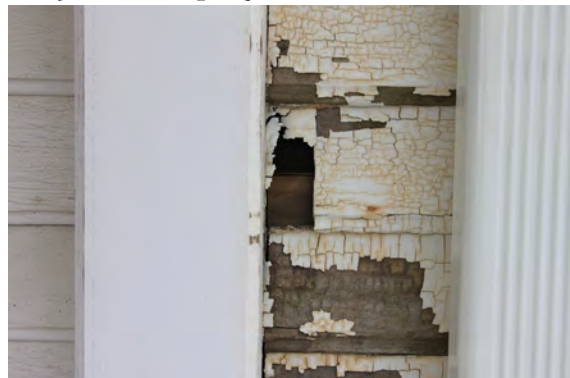
Missing siding board and scaling paint

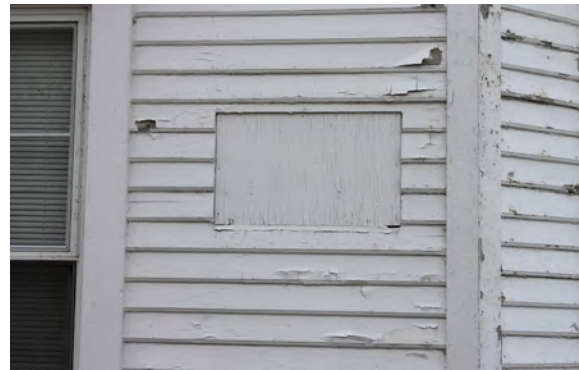
Plywood insert in vacant air conditioner opening

- Repair siding at air conditioner opening and miscellaneous areas of deterioration (approximately 100 square feet). Future siding infill and repairs should be done with wood clapboard to match the original using a durable wood such as Spanish cedar. Infill should be toothed into the existing clapboards to disguise the intervention.

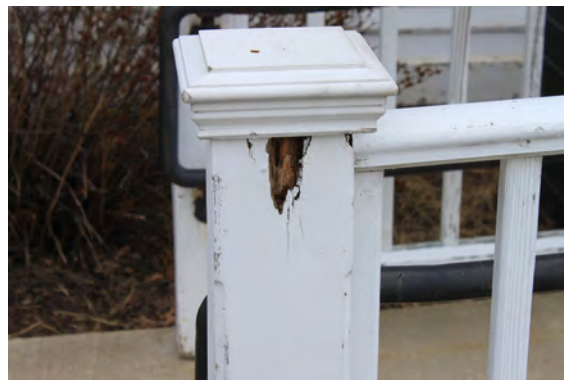
The wood railings of the two west entrances and the porch over the accessible entrance are rapidly deteriorating. These features were constructed of a low quality wood, probably fast growth softwood that does not hold up against the harsh weather of the North East. In fact, we saw more deterioration of these newer elements than of the 140 year- old wood features used in a similar manner. The bases of all the posts show specific areas of wear. This is an extremely vulnerable detail where the end grain of the wood sits upon a concrete base and absorbs water through the unfinished open end. There is also significant deterioration where the hand rails meet the posts.

Deteriorated wood trim board at railing post.

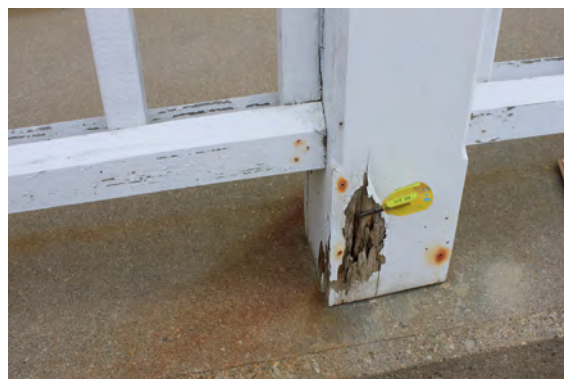
Deteriorated post base

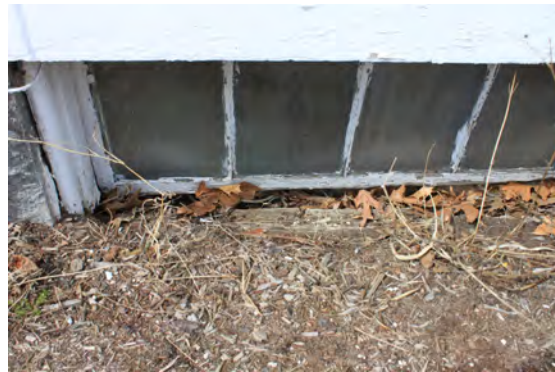
Grade at window sash level - window propped open.

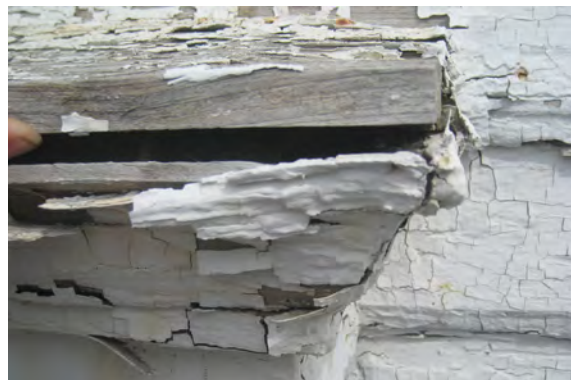
Open joint in window hood

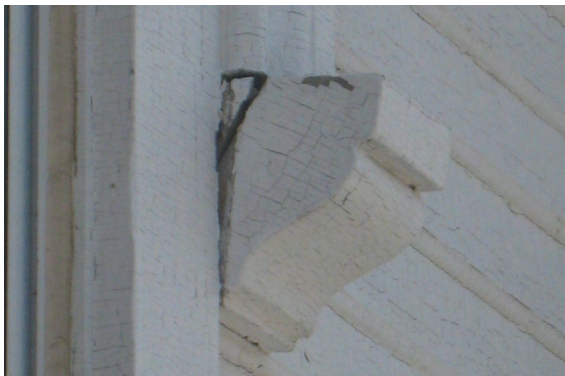
Cracked lamb's ear bracket

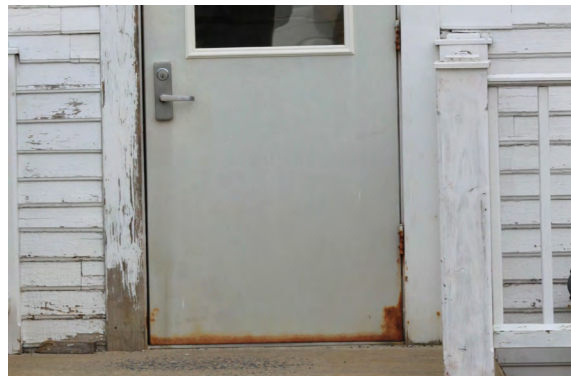
Metal door is rusted and historically inappropriate

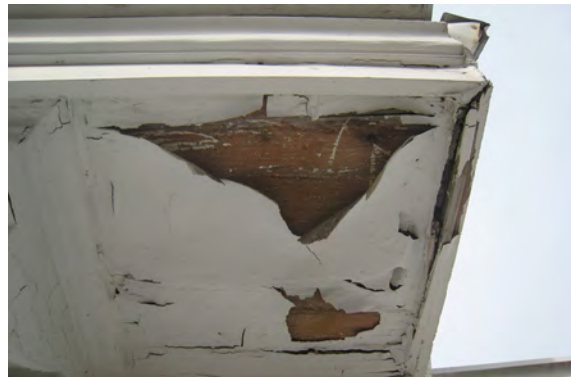
Peeling paint on soffit

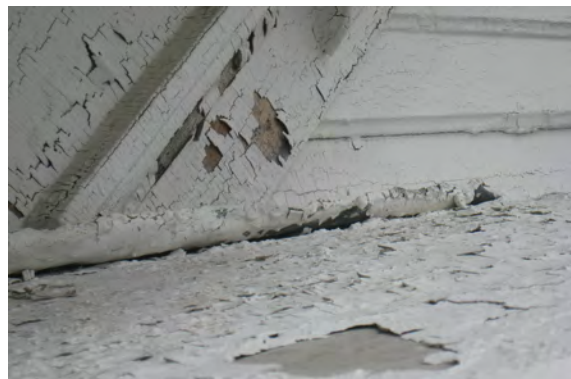
Scaled and flaking paint on cornice

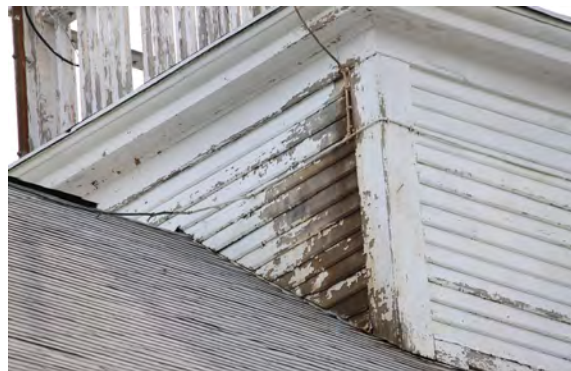
Missing paint tower

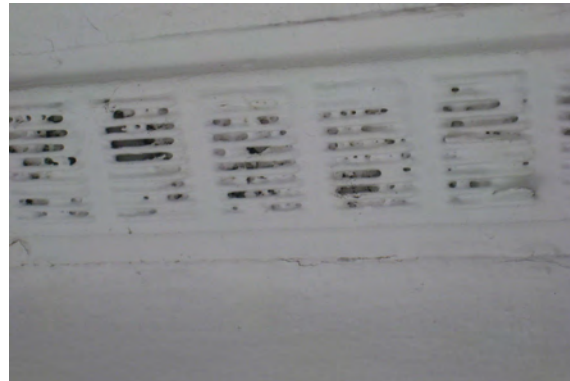
Soffit vents painted shut

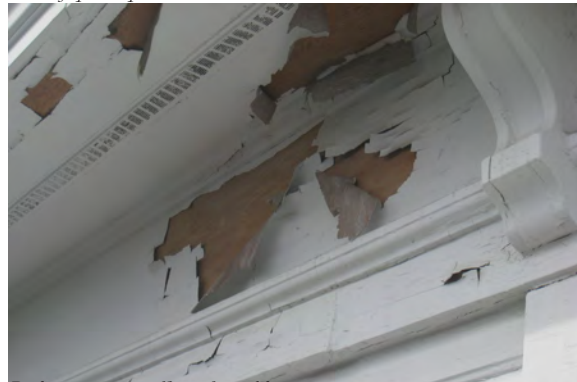
Peeling paint at soffit and entablature

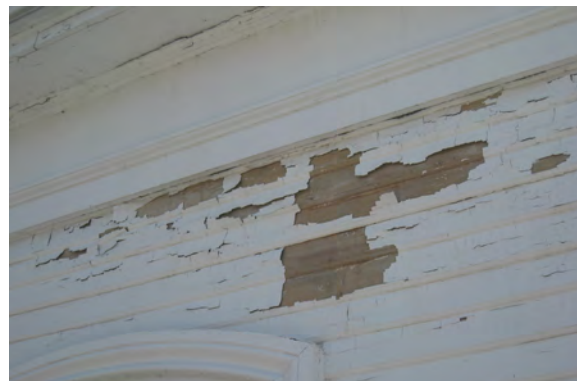
The likely culprit behind the paint failure is moisture. As damp air migrates through the interior wall it is trapped by the paint layer, which is relatively impermeable. The trapped moisture eventually causes failure of the adhesion of the paint to the wood. Modern latex based paints are less vapor permeable than oil based paints. Latex paints provide protection from external moisture but do not allow internal moisture to escape. Compared to historic oil based paints, latex paints also provide a weaker bond to the wood substrate, which may explain why the most recently painted side of the building is in the worst condition.

Paint failure on wood siding

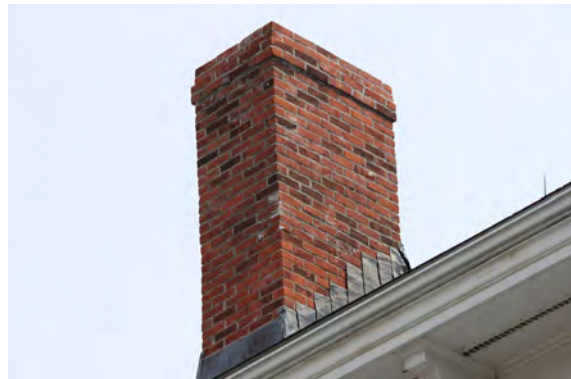
West chimney, capped with mortar

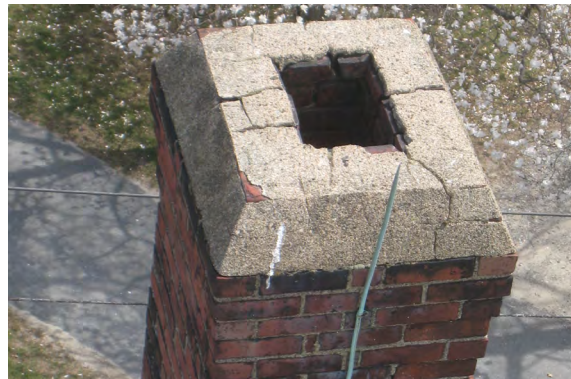
South east chimney with cracked mortar wash

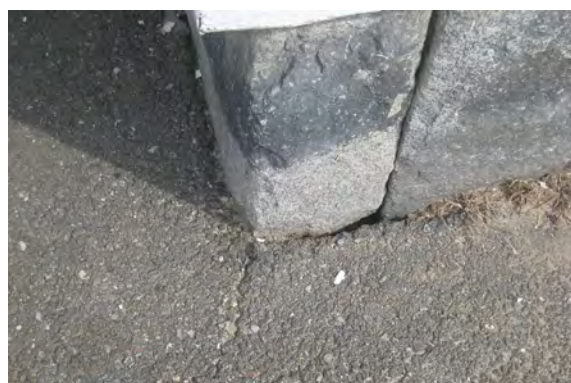
Open mortar joint in granite foundation

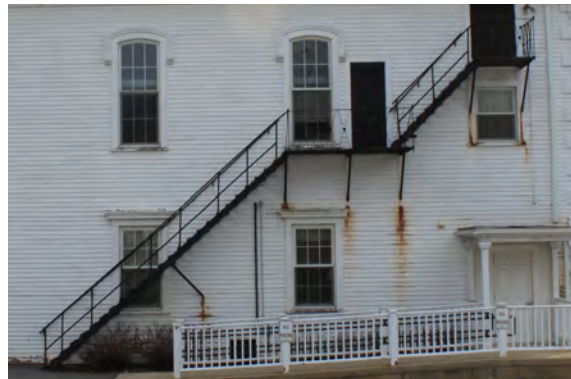
The painted steel fire escape on the west elevation is in very poor condition and poses a life safety hazard owing to one of the treads which is visibly detached from the steel stringer. The tread has completely rusted through, which suggests that many more are about to fail in a similar manner. The stair is attached to the building with steel brackets and bolts which have rusted and are staining the clapboards beneath. These bolts are also a potential water infiltration point into the wall system. In general, the entire fire escape with associated exit doors is an eyesore on the building. The doors were crudely installed into the wall and are not sympathetic to the architecture of the building.

View of fire escape, staining from brackets, and added doorways

- Remove or repair metal fire escape. Patch all associated holes if removed; if repaired have an engineer certify for structural soundness.
- Determine present use of areaway on east elevation. If actively used, redesign in a safe manner with new railings or bulkhead doors. If no longer used demolish and infill hole.

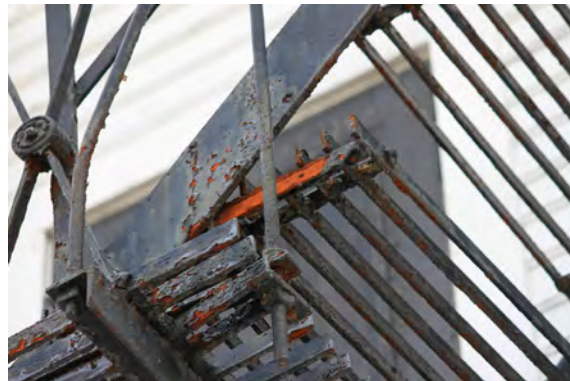
Tread separated from stair stringer

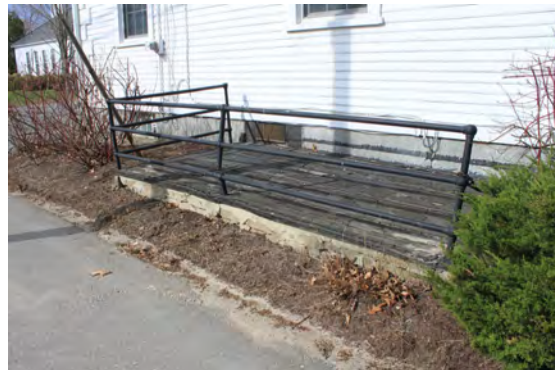
On the east elevation is a concrete areaway covered by a felt and tar roof over plywood. It was unclear what framing supports the roofing, but the whole is surrounded by a low steel railing. The roofing materials are badly deteriorated and likely to be leaking. One of the railing posts has rusted through and broken off, and is suspended in mid air by the horizontal rails. The concrete foundation is cracked and shows spalling. The areaway is currently sealed shut with roofing and sheathing. It does not appear to be used owing to the advanced deterioration of its components and should be removed if no use is planned.

Covered areaway on east elevation

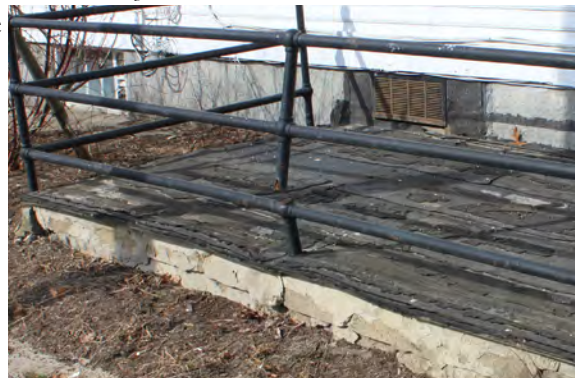
Broken railing, deteriorated concrete and roofing material
