MUNICIPAL BUILDING AND FACILITY ASSESSMENT

DRAFT August 7, 2007

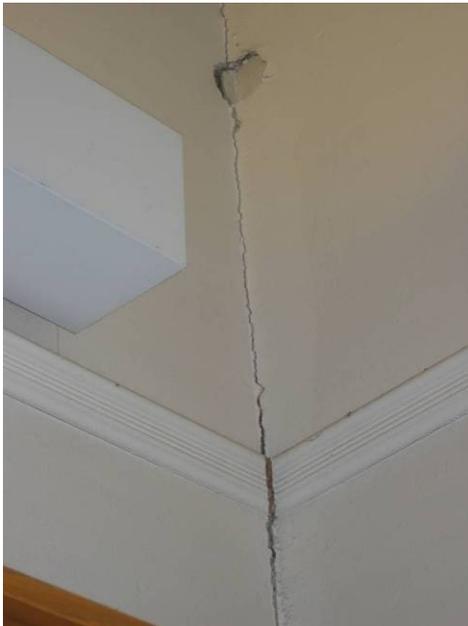
As noted previously, the only evidence of water damage was in the basement area near the exit stair, while the remainder of the visible foundation presented no apparent issues and was free of cracking. A significant crack in the interior plaster finish in the area of the vaulted ceiling was located on the first floor reading room in the front right (south) corner of the building. GPR surmised that this may be the

result of the temperature differential between the exterior masonry and the supporting structure of the vaulted plaster finish.

Crack in interior plaster finish

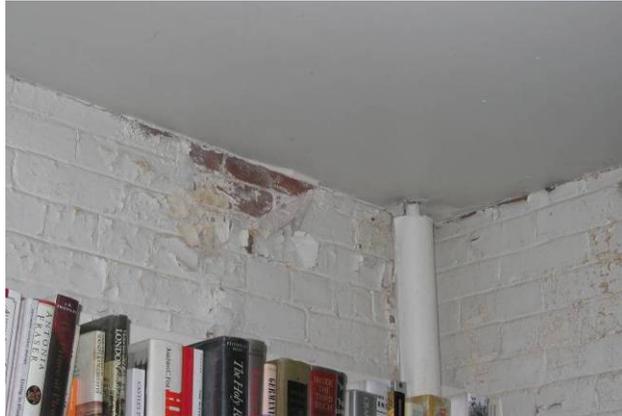
Typical Water damage to paint on basement bricks

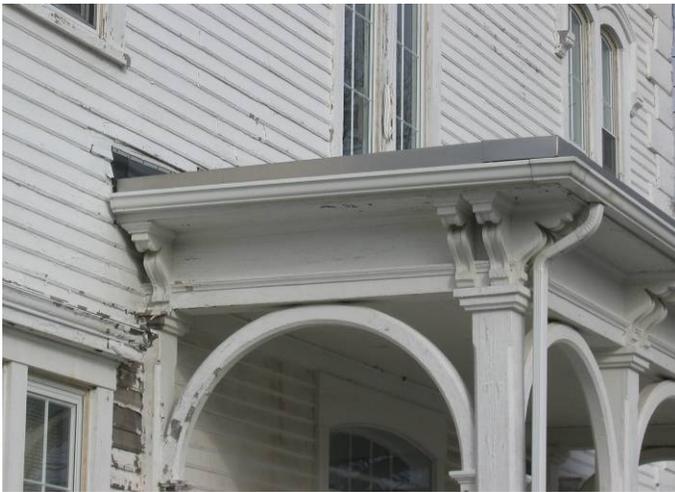
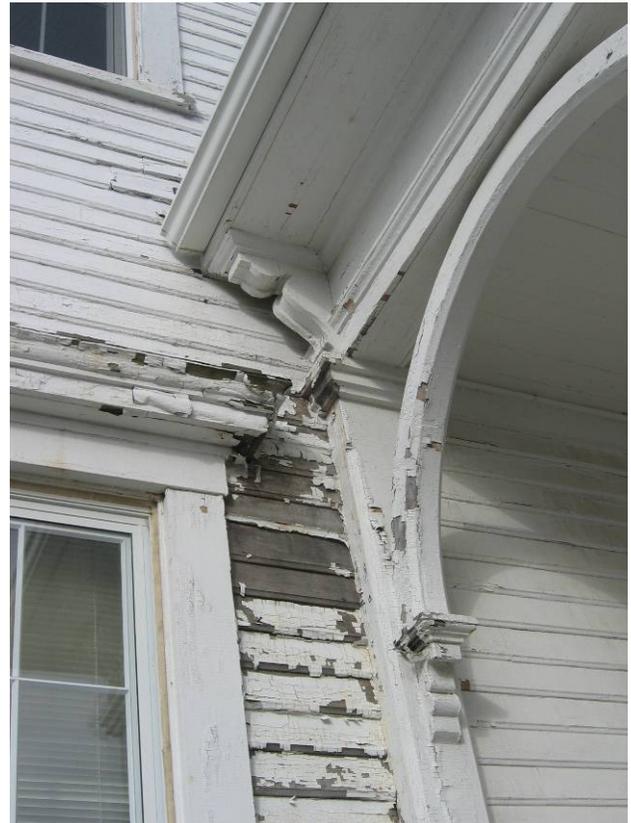
The exterior is of wood construction and currently carries a monochromatic color scheme of white on the siding and trim. Peeling paint is evident in numerous locations due to continued exposure to water/snow/ice and improper flashing as roof intersections – primarily at the front porch area, where an incomplete repair on the roof was performed a number of years ago. Several foundation window wells and portions of the sill are at risk to decay due to the build up of organic materials and mulch around the perimeter of the building. Blown cellulose insulation was observed in the attic areas and under the stage area, but no insulation was observed in the basement areas – with daylight visible from exterior while traversing the crawl spaces. Exterior wall cavities were not inspected and were not accessible. The painted iron exterior fire escape has been condemned (See Section 4.0) due to broken stair treads and questionable structural integrity. Windows have recently been replaced throughout the building with double

Roof repair and siding damage at front porch area

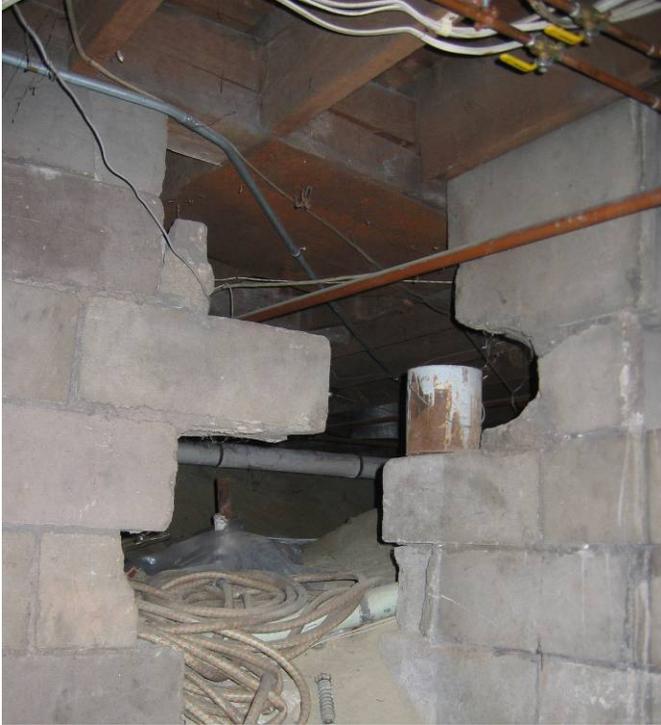
This photo was taken of the corner of the concrete block bearing wall that was removed in the southwestern corner of basement, leaving the primary support member from the upper floors unsupported. A large crack in carrier beam is visible at the top of the photo between joists where the wooden beam has failed. This has caused notable deflection in the upper floors in that area and continued cracking in main stair walls.

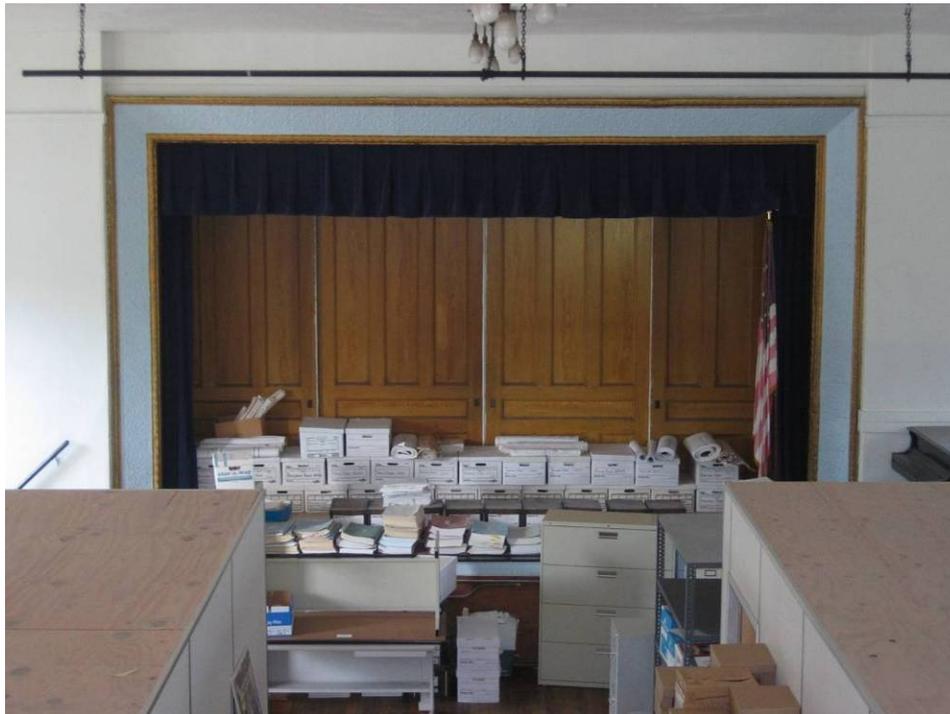
The Stage area serves as an unsecured area for storage for documents and old furniture while the piano stands idle.

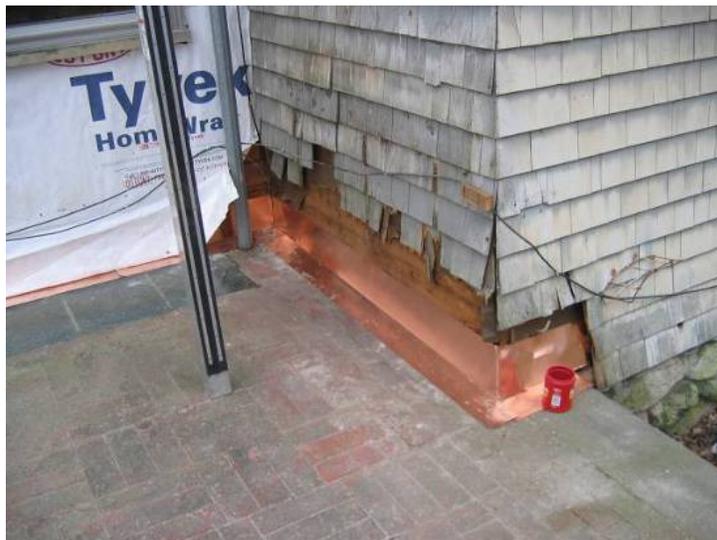
Although the exterior envelope has been secured, the recent repair to the sill area at the rear patio area on the north side of the house warrants “further review of the repair detail and flashing” as the patio condition that caused the damage has not been remedied. (See photo at right and GPR report in Section 2.5)

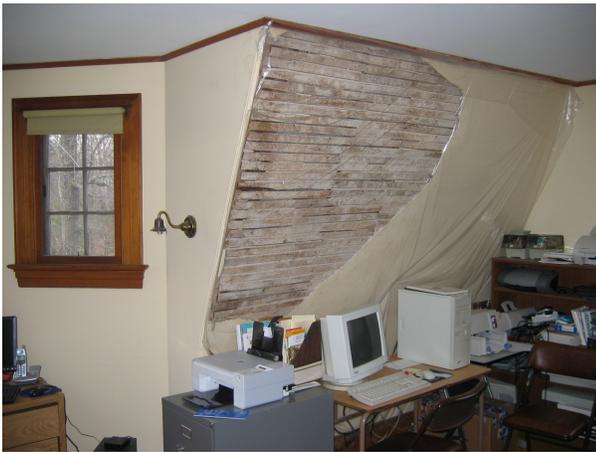
Until the recent repairs were performed on the exterior, extensive water damage had occurred in the exterior walls of the second and third floors. Plastic sheeting has been used to keep plaster from falling onto residents using the computers in the second floor computer lab. While the condition of most of the rooms on the second floor are acceptable, the third floor has suffered from neglect and only recently cleared of their collection of discarded documents and outdated equipment from the police department. The kitchen, although outfitted with a new electric stove is inadequate for the COA and unsafe for handicapped persons (*see HP assessment in Section 3.0*). For a sample of the conditions see the following photos.

Water damage in computer lab on second floor

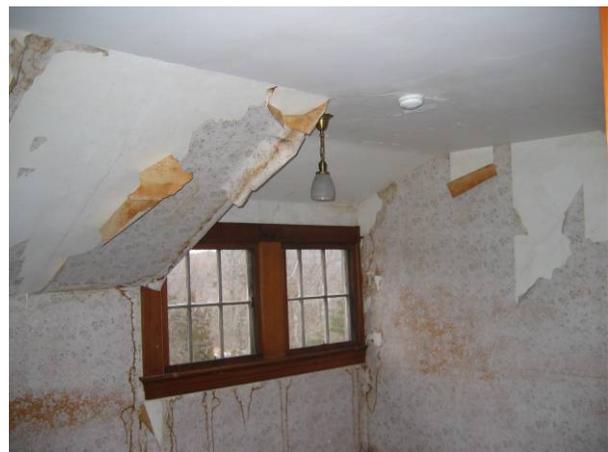
Water damage to room on third floor
