### Bare Hill Pond Watershed Management Committee Town of Harvard Harvard, MA 01451

Re: 2011 Report and Fall 2011 Drawdown Plans

This report provides a summary of the watershed, in-lake and plant survey data collected in 2010.

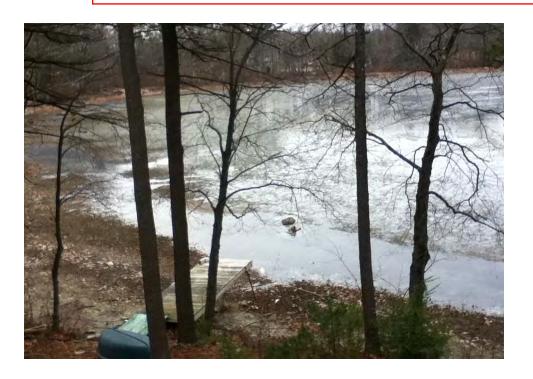
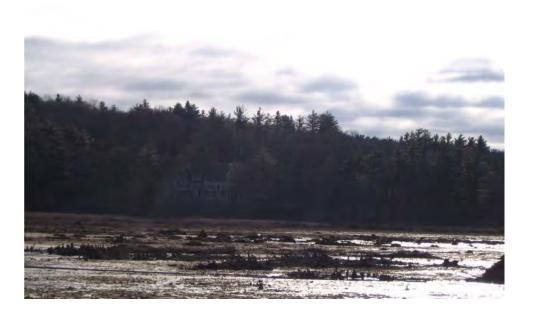
# Photo showing the effect of melting after a freeze lifting the invasives
