Town of Harvard
Bare Hill Pond Watershed Management Committee
Harvard Massachusetts

Bare Hill Pond In-Lake Water Quality and Plant Surveys - 2017

Prepared by:
Aquatic Restoration Consulting, LLC
18 Sunset Drive
Ashburnham, MA 01430

August 2017

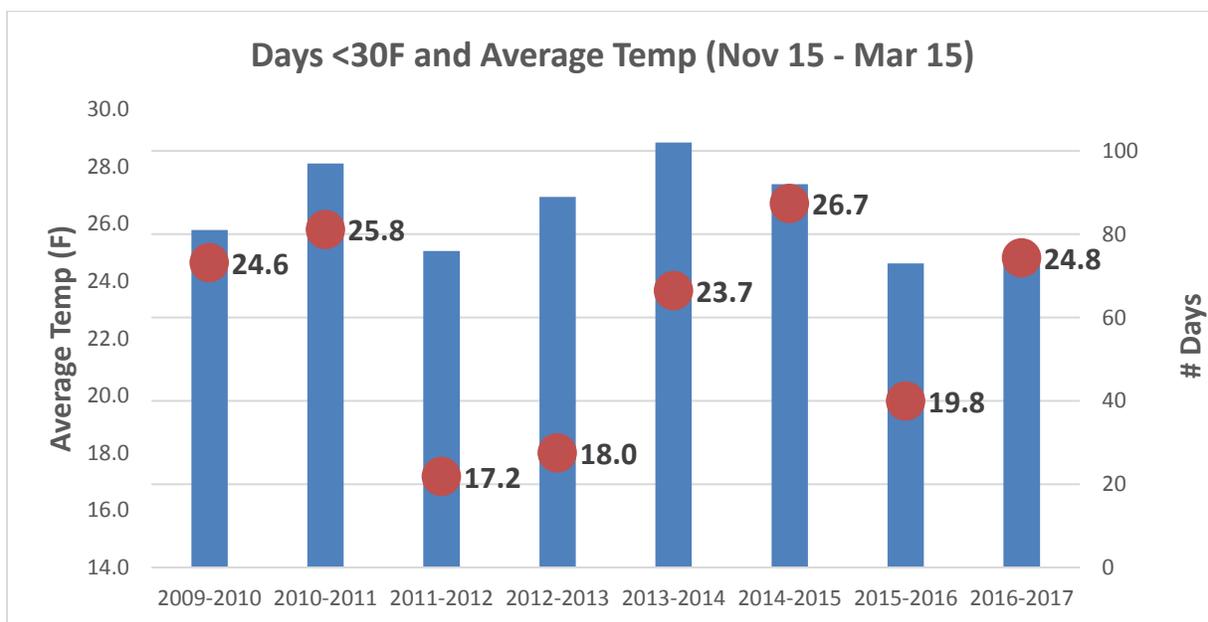
Figure 1. Air Temperature and Number of Days below 30°F during the Winter Season.

Ideal conditions for a winter water level drawdown to control rooted plants is a consistent cold winter (consecutive days below freezing) with little rain or snow. Snow insulates the ground preventing the hard freeze necessary to kill plant roots. Looking at the historic weather conditions recorded at Fitchburg Airport since 2009 during the Nov 15 through Mar 15 winter season, the winters of 2011-2012 and 2012-2013 had the lowest average temperatures (17.2 and 18.0°F, respectively; Figure 1). The number of days below 30°F were 76 (2011-2012) and 89 (2012-2013). The winter of 2013-2014 had the highest number of days below 30°F (102 days, highest number in December; Figure 2), but the average temperature was also higher (23.7°F).

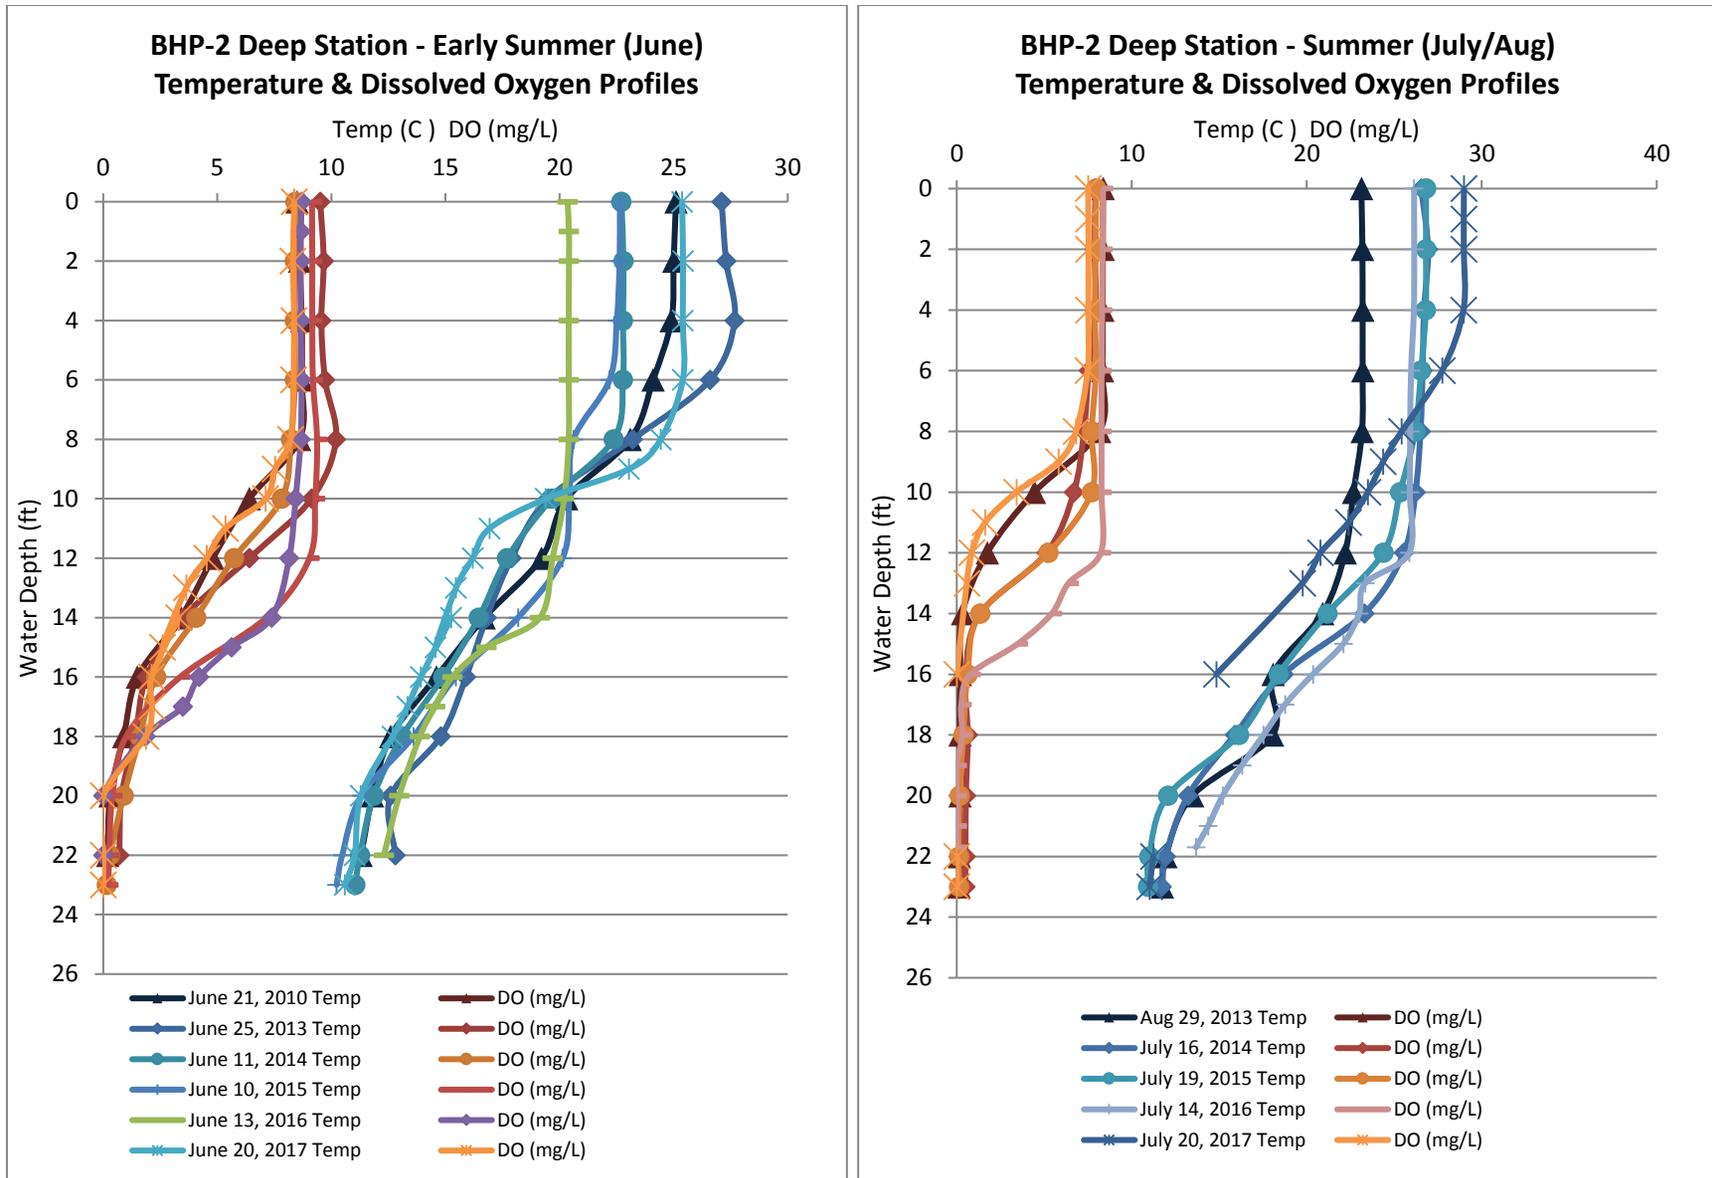
Figure 3. Temperature & Dissolved Oxygen Profiles at BHP-2 for 2010-2017

The temperature and DO profiles suggest that the lake began to thermally stratify in May and was strongly stratified by June, with thermal stratification lessening in July. However, we experienced equipment problems so this data set is incomplete. Concentrations of DO in May were consistent throughout the water column until a depth of nineteen feet where concentrations dropped below the threshold desirable level for fish [5 - 6 milligrams-per-liter (mg/L)]. Concentrations in June were less than desirable below at 11 feet and even shallower in July, with concentrations <5 mg/L recorded at 10 feet. Oxygen depletion was second worse to only 2010 in June. DO concentrations were the worst in July since 2013 (there were no July data in 2010). Figure 3 shows the decline of oxygen and comparison to prior years.

Oxygen depletion starts above the thermocline. Much of the cold water fish refuge area is undesirable given the lack of oxygen. These data suggest that the lake has a substantial oxygen demand and is susceptible to iron-bound phosphorus release from the sediment. Phosphorus can accumulate in the hypolimnion under these conditions. Once the hypolimnetic phosphorus is mixed in the photic zone, algal blooms are more likely to occur.

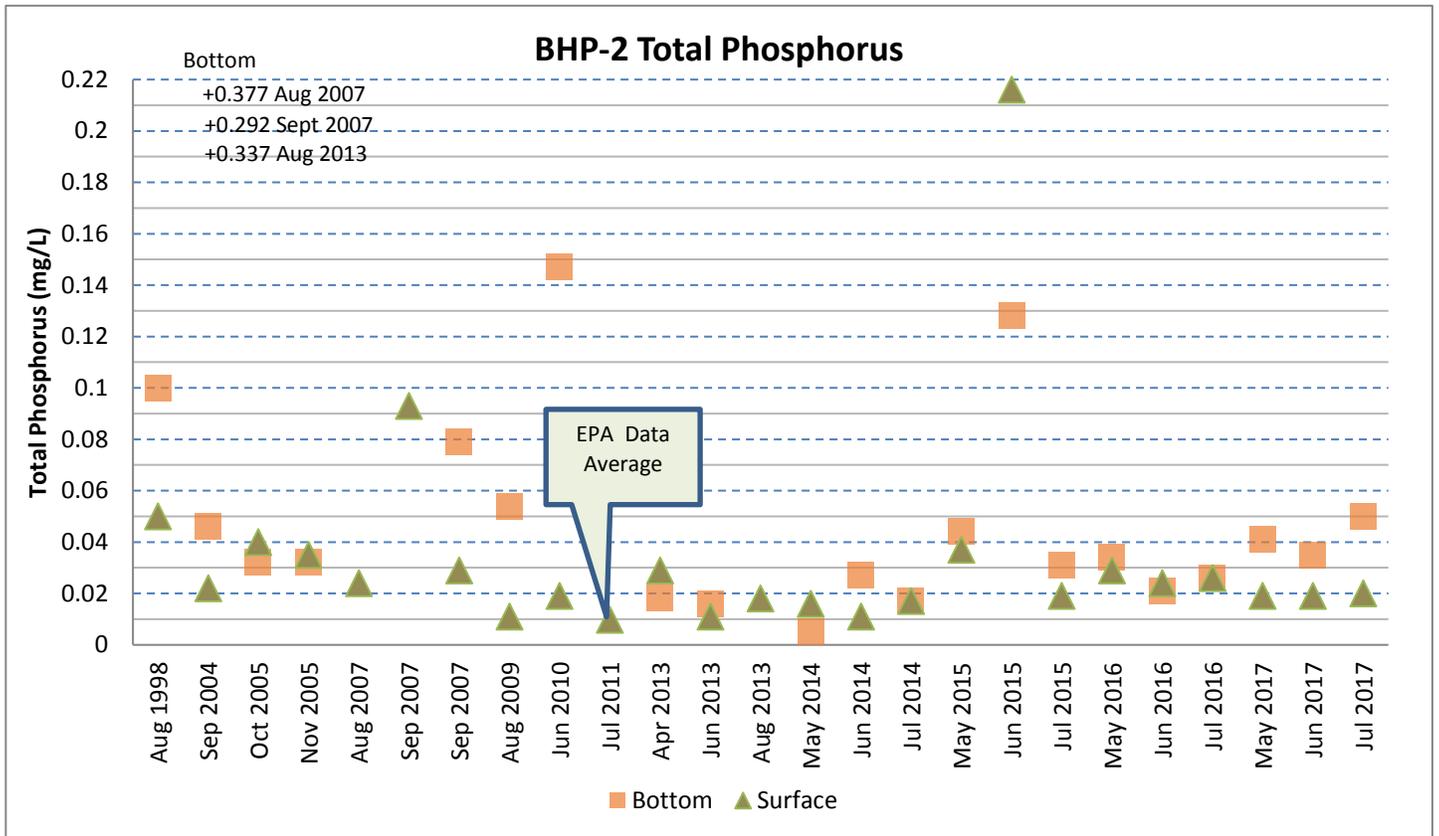
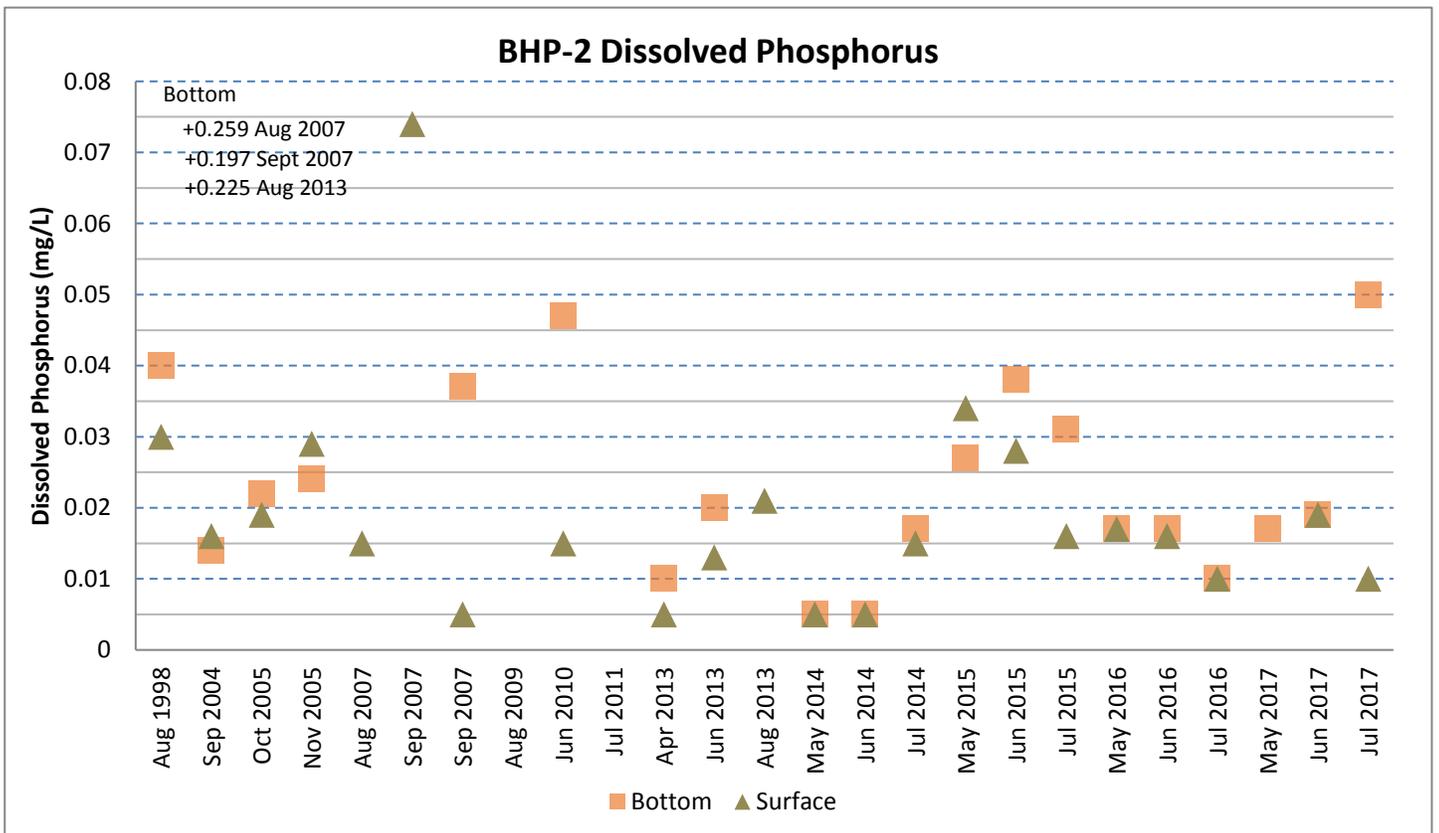
Figure 4. BHP-2 Total and Dissolved Phosphorus Concentrations.

Table 3 provides the results of phosphorus, total suspended solids and water clarity (measured by Secchi disk transparency) during 2017. 2017 phosphorus concentration comparison with prior years is illustrated graphically in Figure 4. The surface total phosphorus (TP) concentrations in 2017 were relatively consistent throughout the summer, but bottom concentrations increased over time. This is typical of a highly stratified lake with low DO in the hypolimnion and ample stores of phosphorus in sediments. Surface phosphorus concentrations were lower in 2017 than in 2016 (average 0.019 vs 0.026 mg/L). It should be noted that the laboratory reported high phosphorus concentrations for the surface sample at BHP-2S in May. ARC requested the lab reanalyze for total phosphorus; dissolved phosphorus was beyond the hold time and could not be accurately reassessed. The initial run reported a TP value of 0.082 mg/L and the revised value was 0.016 mg/L. The lesser value was more consistent with the results in June and July. Dissolved phosphorus values were generally low with the exception of the bottom sample in July.

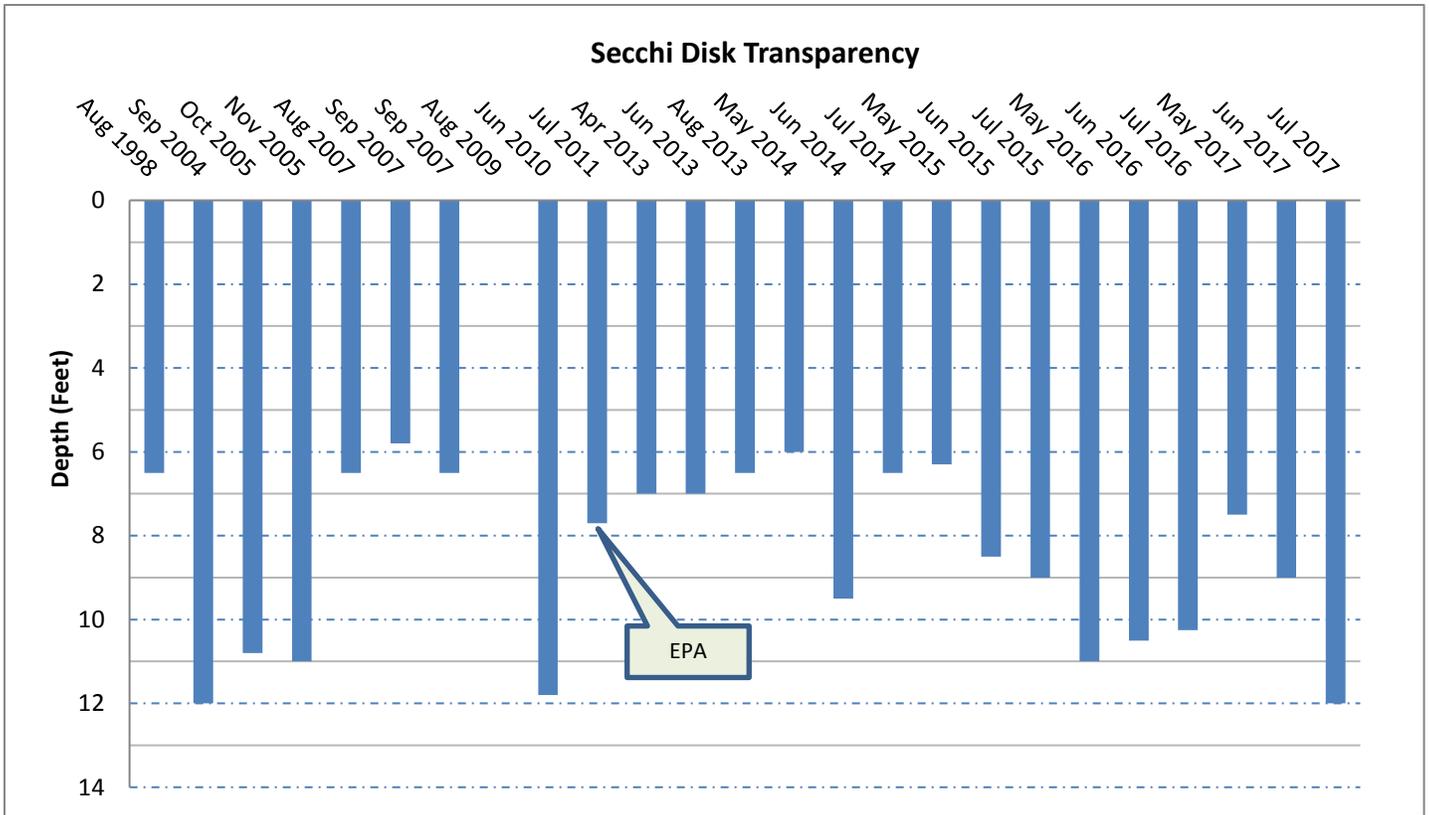
Figure 5. Bare Hill Pond (BHP-2) Secchi Disk Transparency.

Secchi disk transparency in 2017 ranged from 7.5 to 12.0 feet. Clarity was lowest in May. Surface water in May contained colloidal material that appeared green and may have been algae, but the sample was not analyzed under a microscope to confirm. Clarity increased with time. This is an opposite trend that occurred in 2016 where clarity decreased over the summer. 2017 was a wet year and perhaps the increased flushing improved conditions. Clarity was the greatest reported since 2004 (Figure 5).

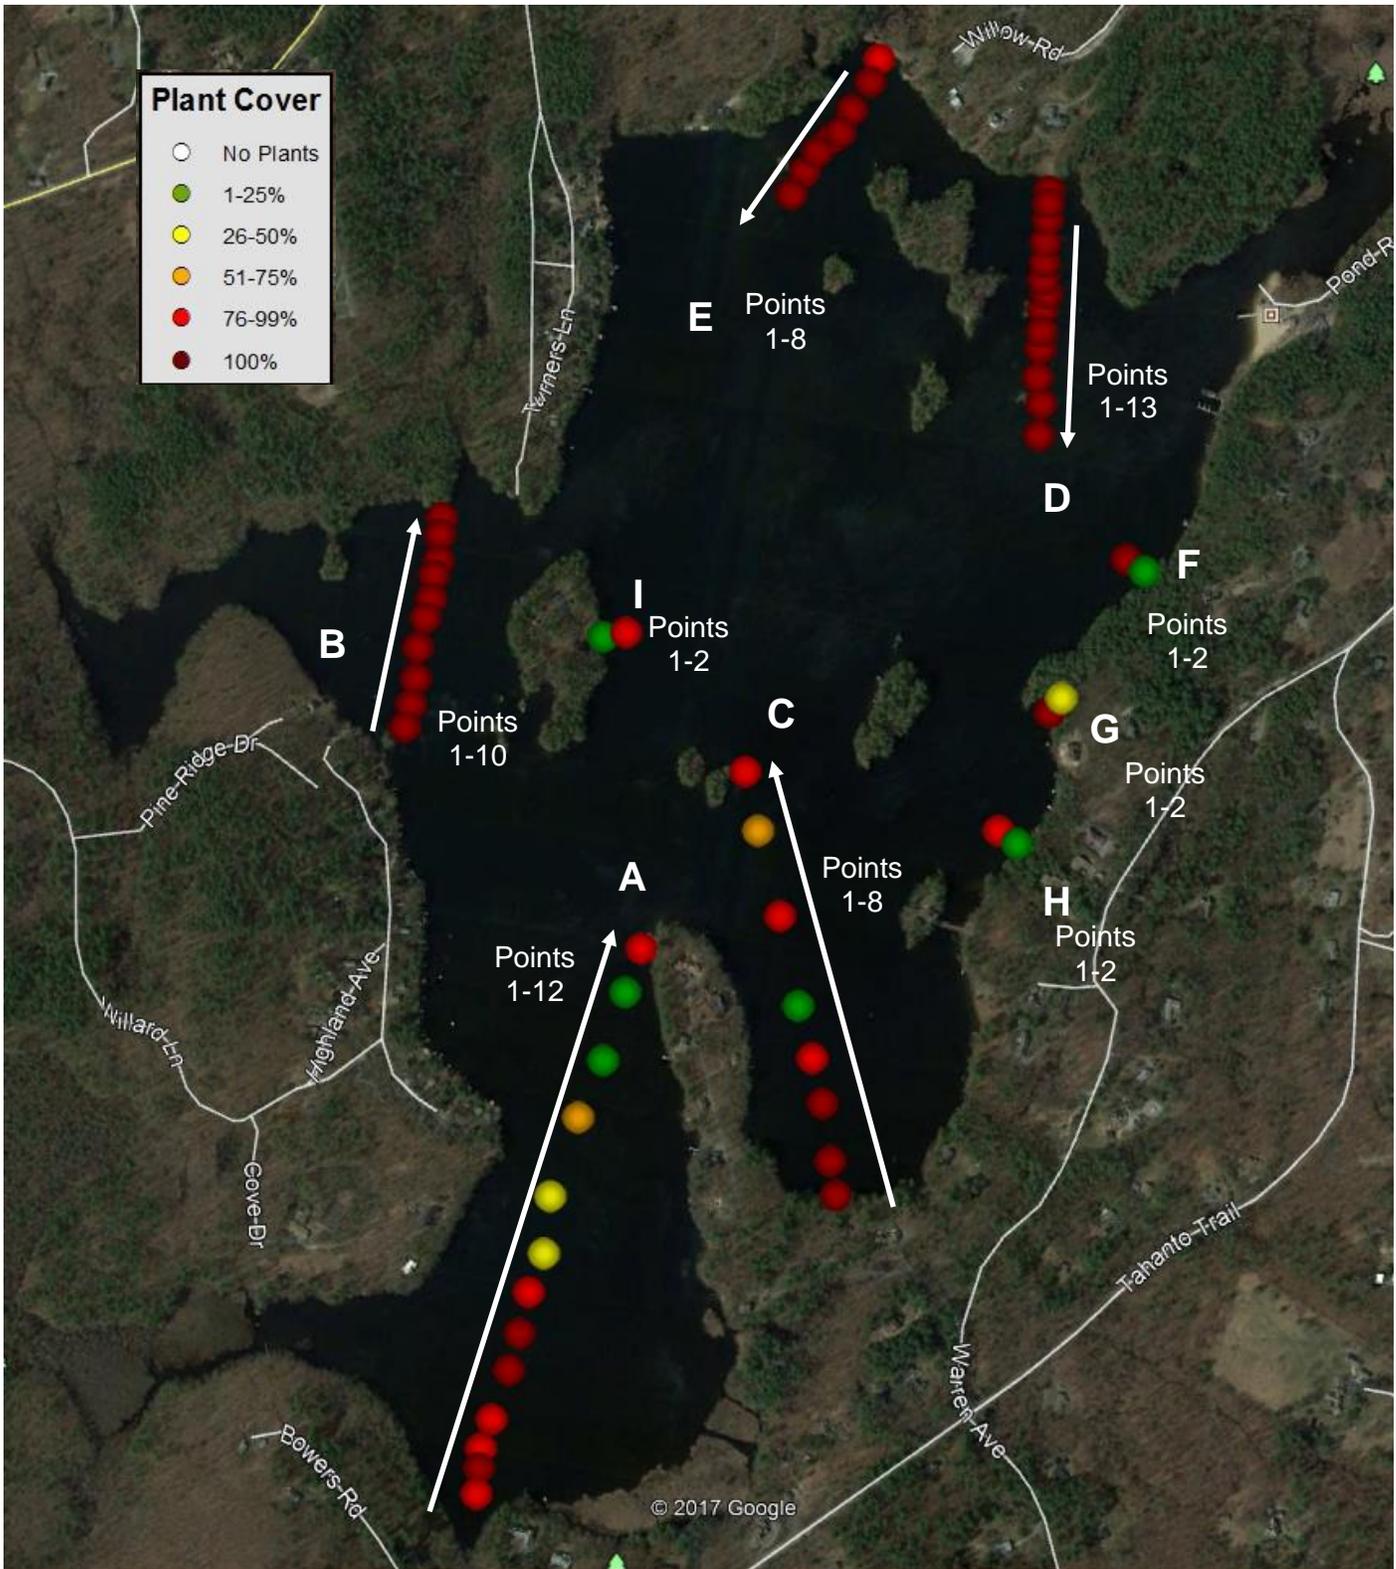
Figure 6. Bare Hill Pond 2017 Plant Cover

The plant survey focused on macroscopic fully submerged (e.g., milfoil), floating-leaved (e.g., pond lily), and/or free floating plants (e.g., duckweed). At each transect point, we recorded the percent cover of all plants, the percent biovolume (as measured by the amount of the water column filled with plants) using a semi-quantitative (0-5) ranking system. A rank of 0 represented 0% cover/biovolume. A rank of 1 corresponded to 1 - 25% cover/biovolume; 2 = 26 - 50%; 3 = 51 - 75%; 4 = 76 - 99; and 5 = 100%. Species observed in each transect were identified and assigned a percent of composition of all species present. Water depth was also recorded at each transect point. These data are presented in Table 4 and Figures 6 and 7.

Generally a shift by two or more ranks (e.g. change from rank 1 to 3) is required before statistical significance is reportable. Plant cover data recorded in Transect B & D showed the largest change of all observation locations in 2017. Cover increased at three locations, two of which are within the drawdown zone. Within Transect B (point 4), the composition of plants were the same in 2016, watershield (*Brasenia schreberi*) and tapegrass (*Vallisneria Americana*), both native plants. One or both increased the two dimensional coverage. With Transect D, point 12 there was a shift from grassy arrowhead or duck potato (*Sagittaria graminea*) to Robbins pondweed (*Potamogeton robbinsii*), again both native species. Robbins pondweed grows in much denser clusters than duck potato. Point 3 in Transect D suggested more growth of watershield in 2017 than in 2016.

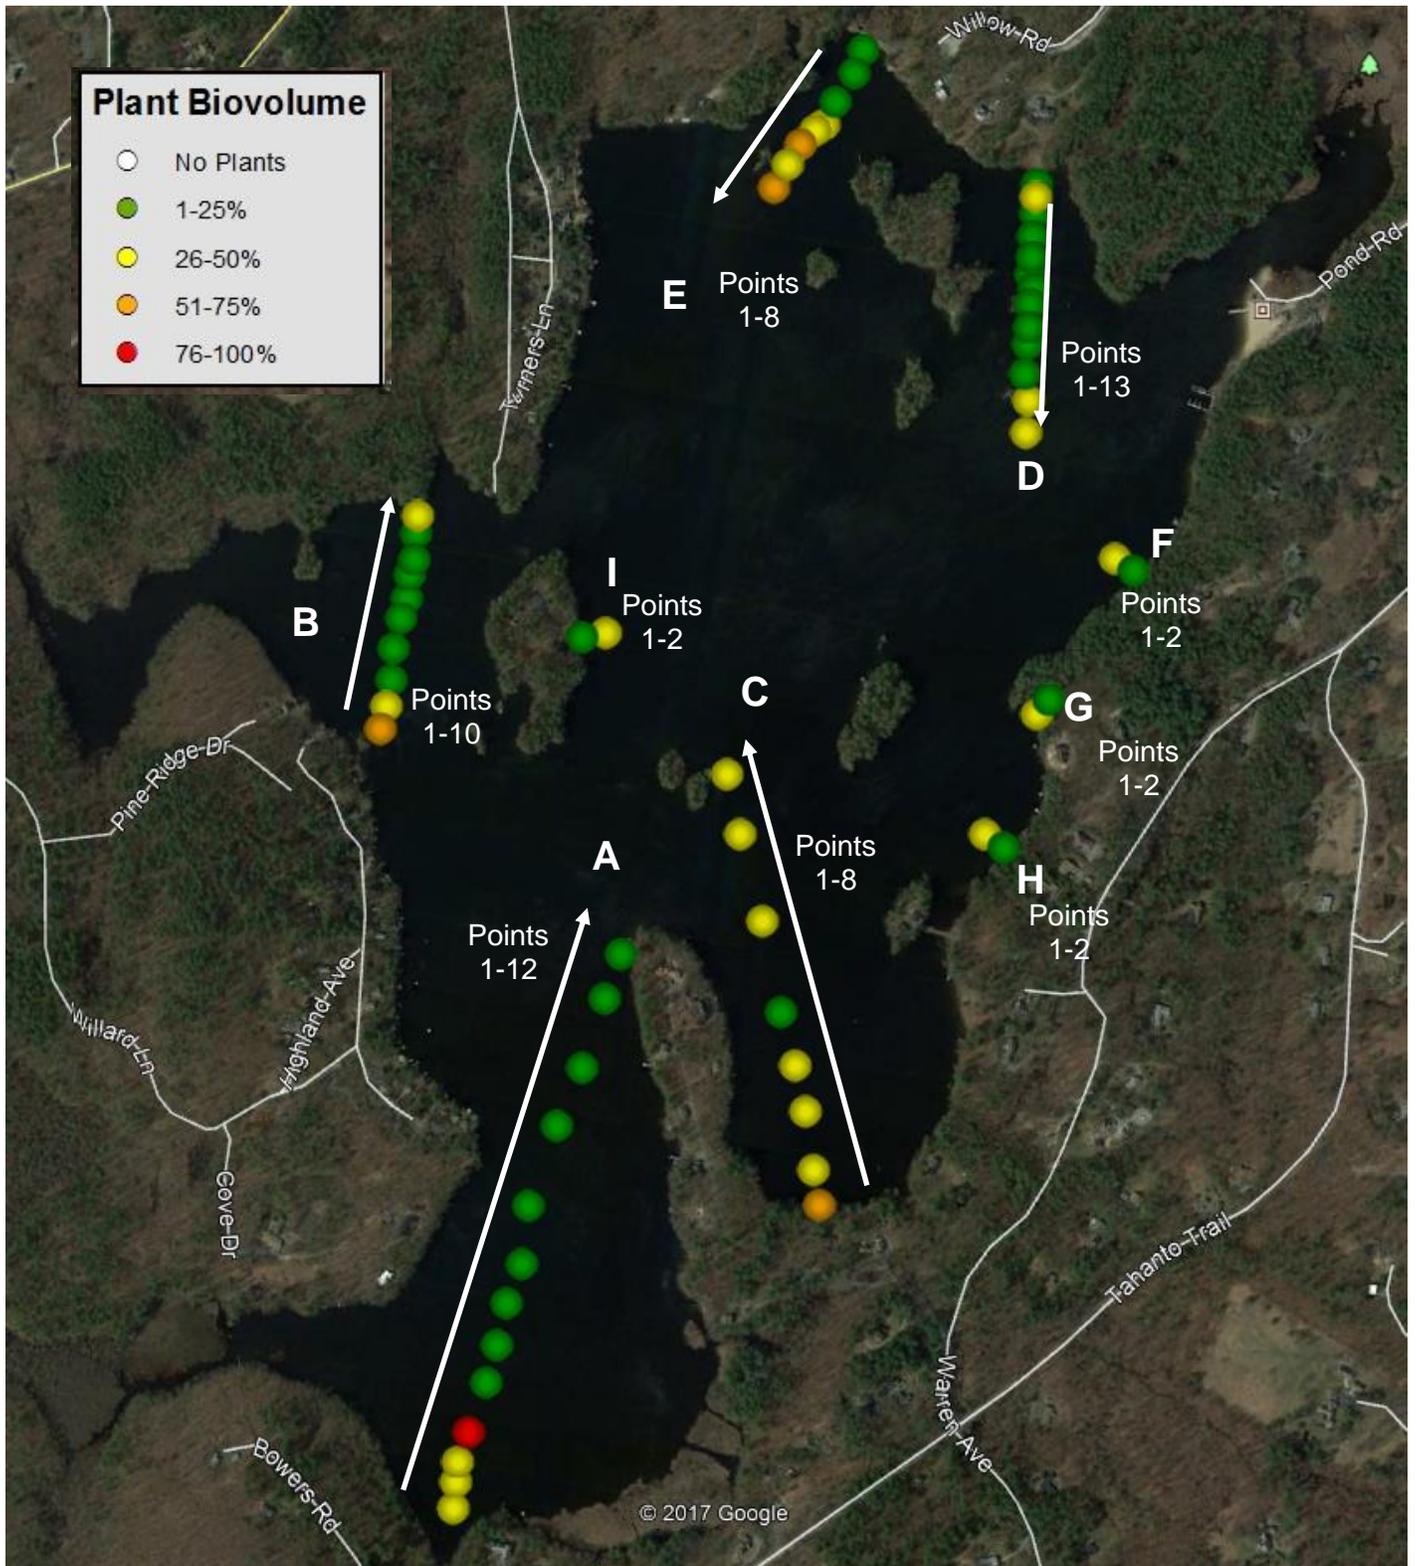
Figure 7. Bare Hill Pond 2017 Plant Biovolume

There were only minor changes in the overall biovolume from 2016 to 2017. All category changes were less than two. And those that differed had a lower biovolume rank in 2017 (i.e., less plant biomass) with the exception of one point Transect E point 8. The invasive species fanwort (*Cabomba caroliniana*) dominated this point in both 2016 and 2017. Variable-leaf milfoil (*Myriophyllum heterophyllum*) was also observed at this location both years. This point is outside the drawdown zone. These data suggest that there is no appreciable difference between the years in plant cover and density. However, outside the points, there were multiple locations where milfoil and fanwort reached the surface. Watershield coverage also appeared greater in 2017, but only one point suggested this increase.

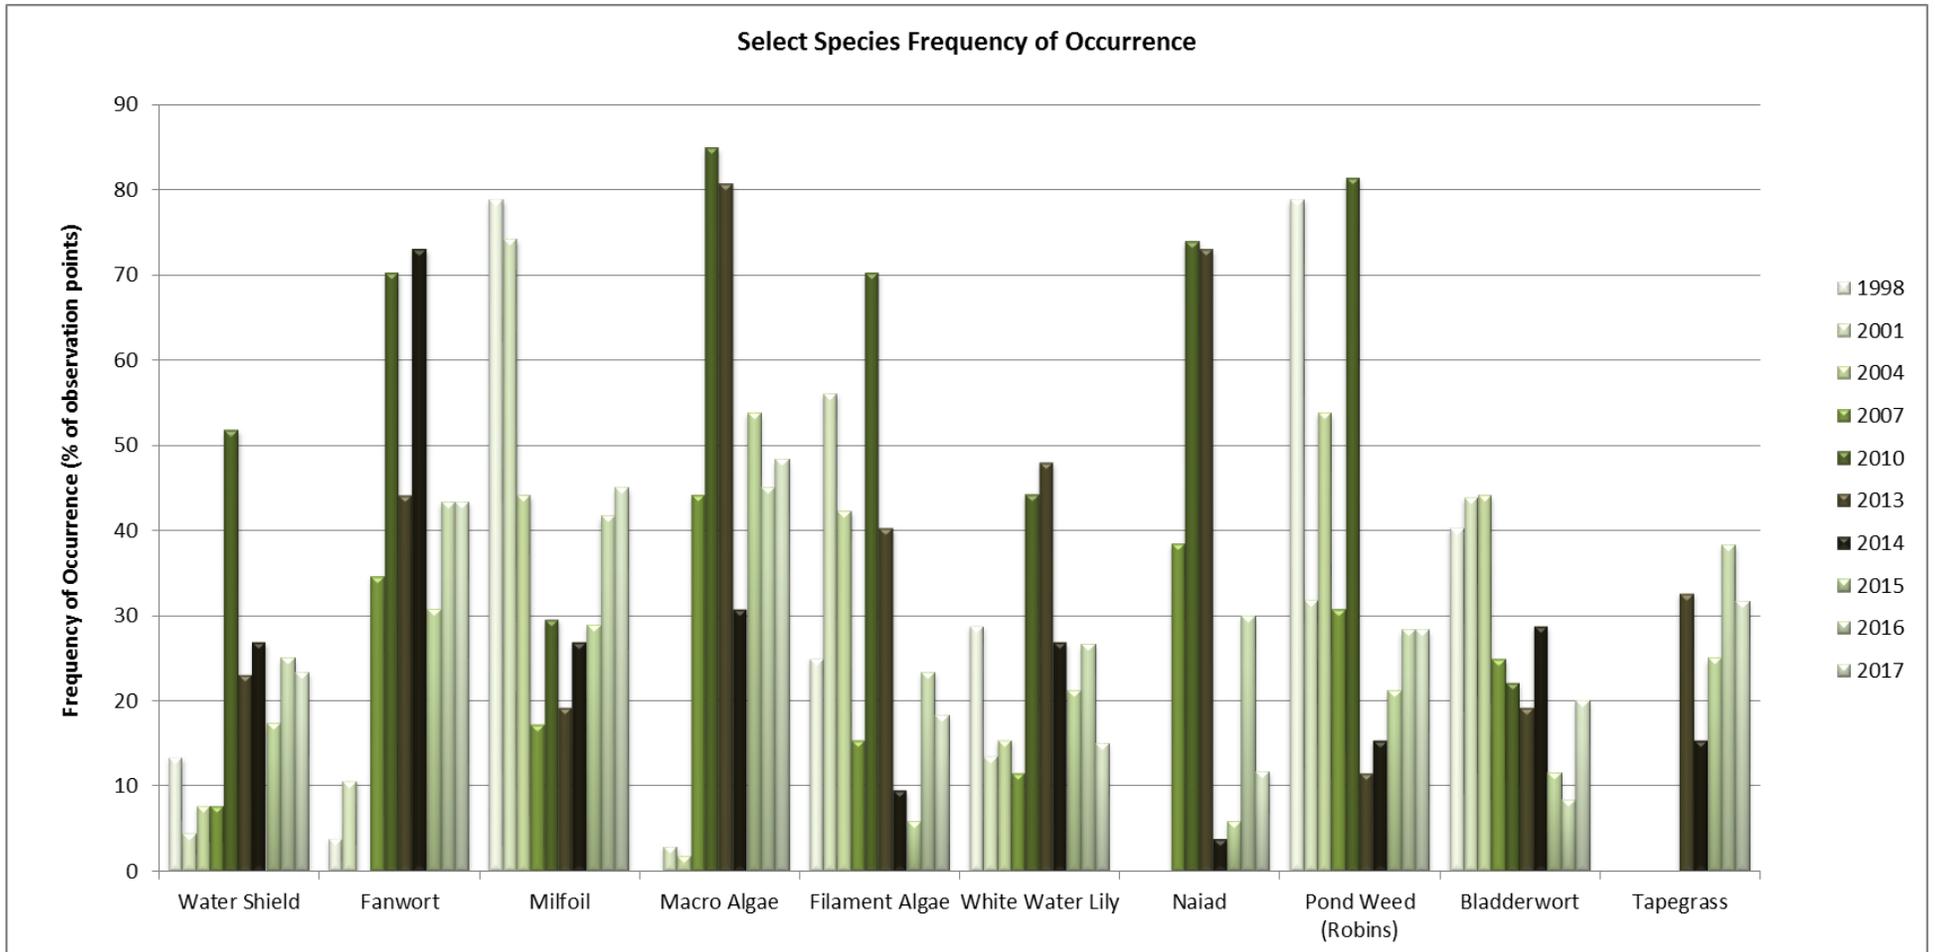
Figure 8. Bare Hill Pond Select Plant Species Frequency of Occurrence

The general appearance of the pond showed similar plant growth conditions to 2016, with perhaps more watershield. While it wasn't encountered more frequently, its coverage was greater as indicated by point D-3. These conditions are supported by the cover and biovolume ranks shown in Table 5 and the plant species frequency data shown in Figure 8. While 2017 was similar to 2016, 2016 had more frequent observations of certain plants than in 2015 suggesting an increase in plant growth: watershield, fanwort, milfoil (*Myriophyllum heterophyllum*) and pondweeds (*Potamogeton* spp.). Figure 8 illustrates the most frequently encountered species data since 2010. Macro algae were abundant again in 2017 (observed at just under 50% of the points). This non-vascular plant is low growing and forms a carpet on the bottom. Plant dominance has shifted from fanwort and milfoil to macro algae and naiads (*Najas* spp.) in past drawdown years, but recent data do not indicate any major shifts.

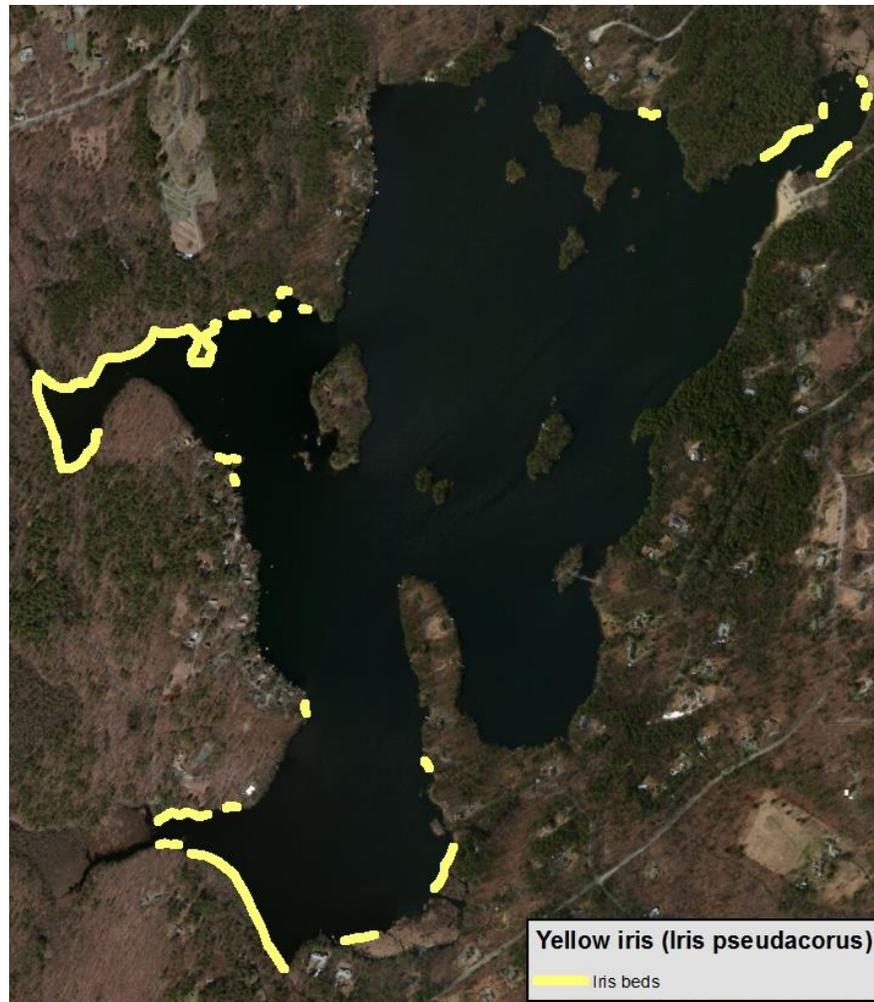
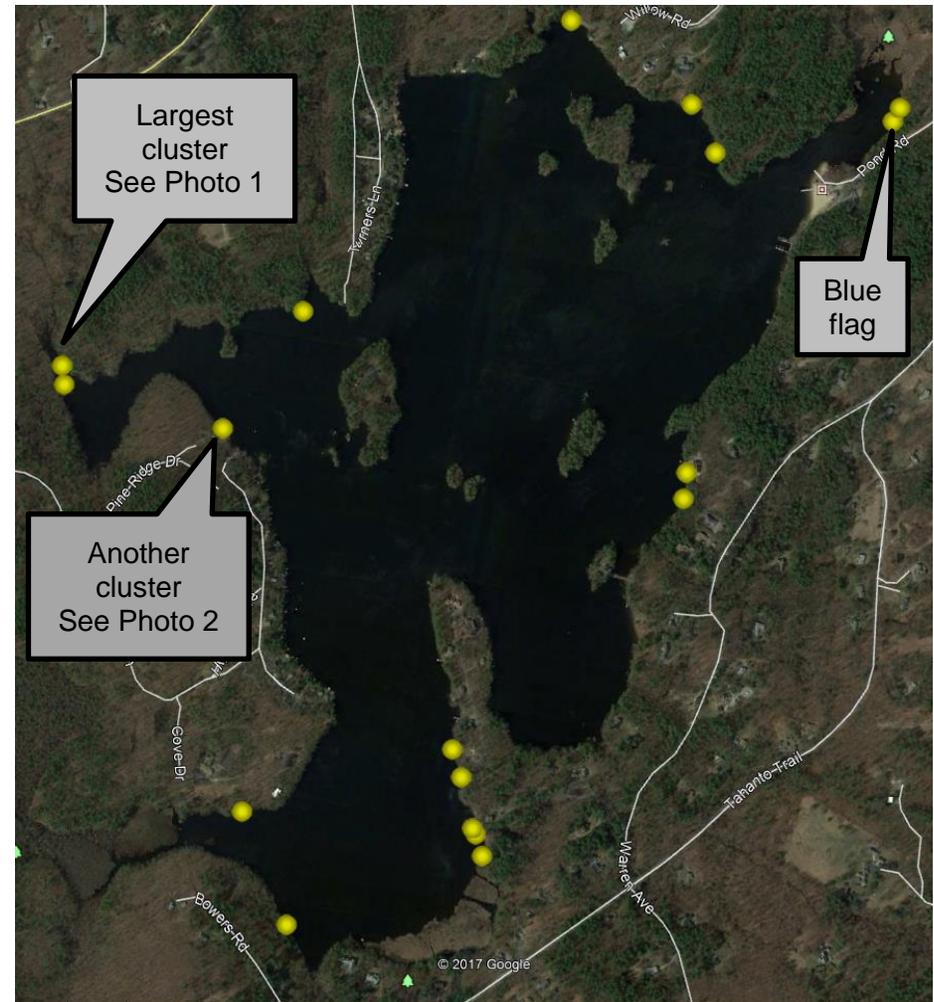
Figure 9. Iris Surveys 2013 (left) and 2017 (right),

In 2013 ARC marked the lateral extent of yellow iris (*Iris pseudacorus*) along Bare Hill Pond's shoreline. At the time, residents and the Conservation Commission were concerned that the drawdown was encouraging the growth and expansion of this non-native invasive species. Yellow iris is an invasive species that can outcompete native shoreline plants, reducing diversity and habitat value.

ARC repeated the presence/absence mapping of iris in June 2017. The latitude and longitude was recorded using a handheld GPS unit when observed. This method was different than the mapping employed in 2013. In 2017 points were recorded to represent one to a cluster of plants, in 2013 iris presence was much greater and therefore the lateral distribution of the plant was reported. Not all plants were in bloom at the time of these surveys. We observed the native species (blue flag iris) in the north eastern portion of the pond in 2017. It is possible that some of these points may represent native iris. A map of the two surveys is provided in Figure 10. Iris was much less abundant in 2017. Most of the iris observed were in waters less than 1' deep or on the bank.

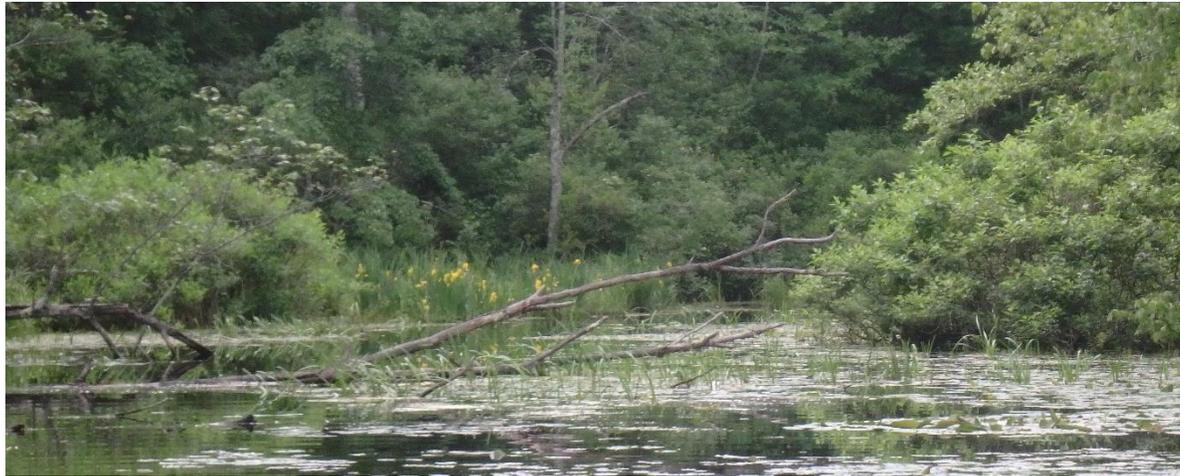
Photo 1 – yellow iris at northern tip of western cove

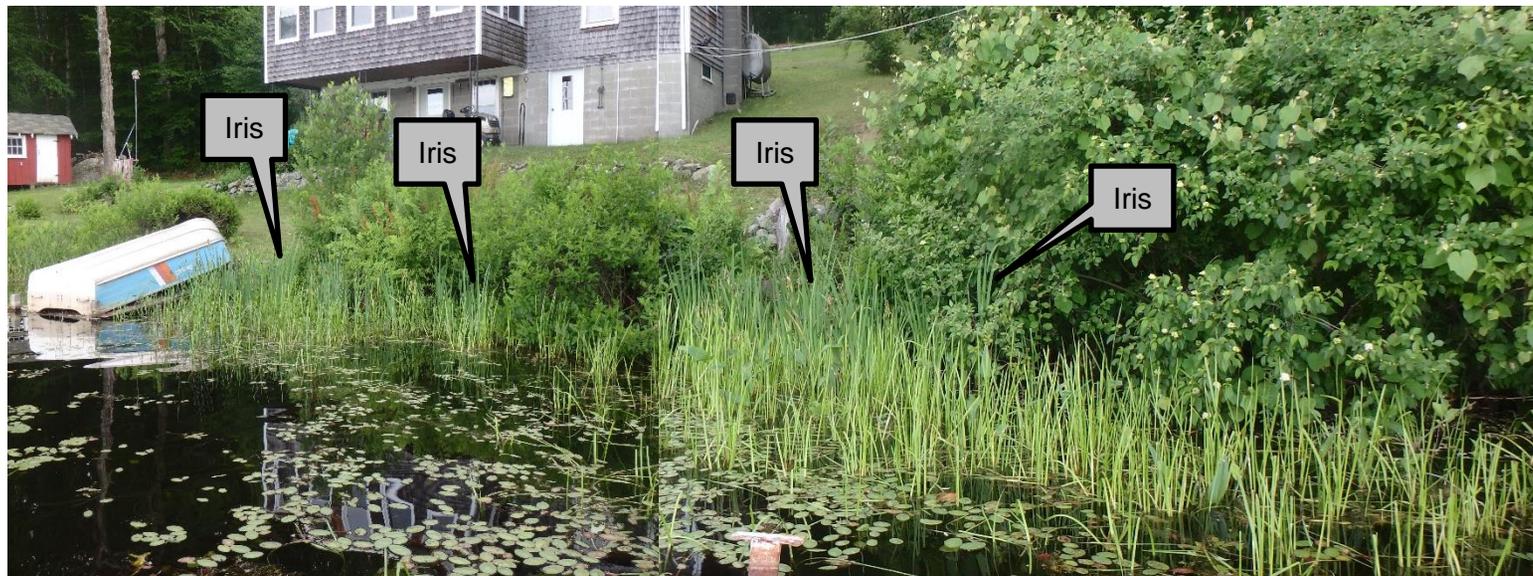
Photo 2 – Large cluster in front of home on west shore. Iris is the darker, taller form. Shorter brighter green plant in foreground is bur-reed (*Sparganium*)
