Bare Hill Pond Watershed Management Committee Town of Harvard Harvard, MA 01451

Re: 2022-23 Drawdown Report and Fall 2023 Drawdown Plans

Pond Draw Down and Refill Data Fall 2022 – Spring 2023 Exhibit A

100' Shoreline Photos Nov 2022 Exhibit B

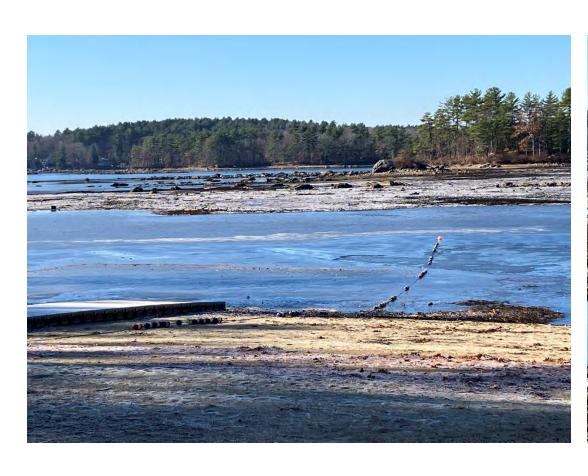
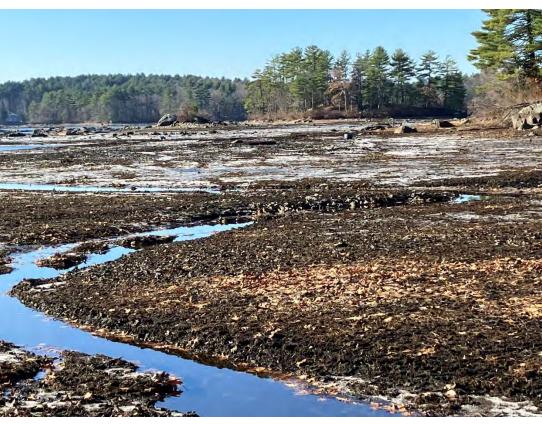
Town Beach Town Beach

The 100 feet shoreline photos of the draw down in early December are attached as Exhibit B.

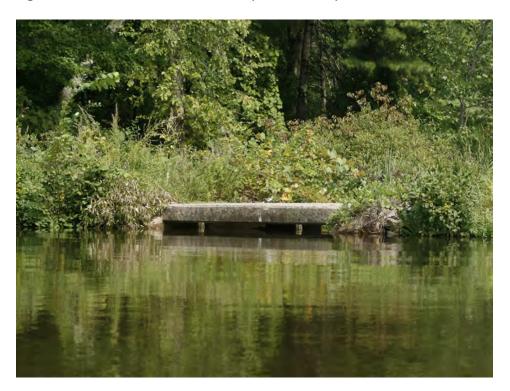
The morning following Hurricane Ida rains and previous rains throughout the summer, evidenced by the high-water mark at the damn on the day of this survey.

As indicated on the map below my route in 2021 was ~60% of the shoreline I covered in 2017 and 2018. The 2021 survey was also earlier in the day, cloudy and the day following a large amount of rain (Hurricane Ida). The water level in the pond was very high for August/September as evidenced by the photo of the damn on the day of the survey. This high level appears to have decreased the amount of sunbathing habitat along the shore and on shallow stone outcrops offshore. Finally, the vegetative growth in the pond was very thick in some areas. This factor made it difficult to approach certain habitats for inspection due to significant drag on the bottom of the kayak, which makes noise and scares subject turtles to slip into the water before they can be confidently sighted. Given these factors I do not believe there is a significant difference in the Bare Hill Pond turtle population between 2017 and 2021, the three years I have conducted this survey. More quantitative techniques that would allow formal year-to-year comparisons including marking campling, motion videography, or others, could be
