FIELD REPORT

Nitsch Project #:	12808	Date:	April 23, 2020
Client:	Pine Hill Village, LLC	Time:	4:00 PM EST
Project:	Pine Hill Development	Location:	Harvard, Massachusetts
Weather:	Sunny, 50°F		
Present:	Gavin Graham – Nitsch Engineering

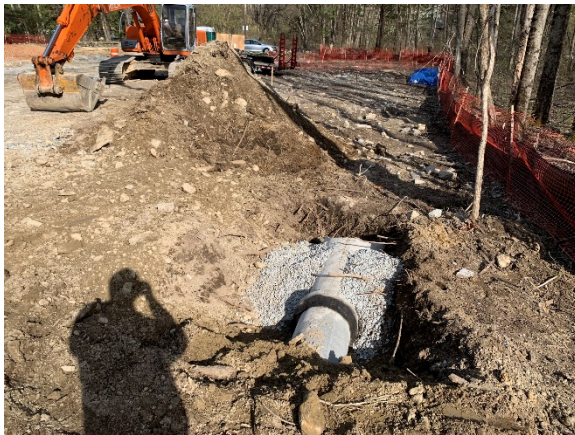
Picture 1

1. At approximately station 2+00 (low point) the 12" RCP pipe connected to flared ends was observed in the ground. The riprap was not observed in place and it is unclear how water will flow from the low point to the designed bioretention cell. Nitsch Engineering recommends the contractor confirm pipe invert and compare it to bioretention grades such that water flows as intended. See Pictures 1 and 2 below:

1. At bioretention cell near entrance on Stow Road, contractor to confirm pipe invert and compare it to bioretention grades such that water flows as intended.

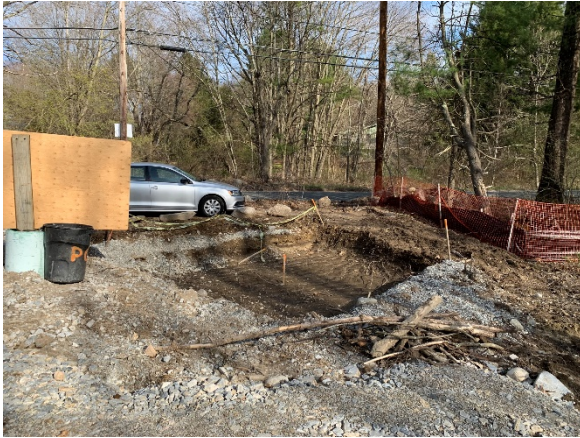
Picture 3

Pictures 3 and 4 show where the bioretention cell is, however, there is not a path of travel for stormwater exiting the pipe to flow into the cell.

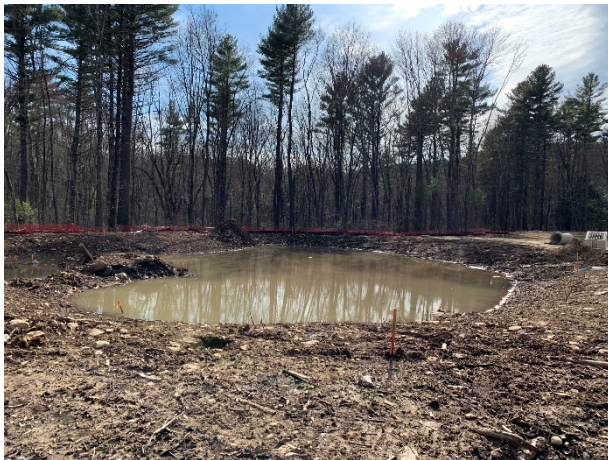
Picture 5

2. The large boulder encountered in the constructed wetland appears to have been broken down per conversation on March 9, 2020. Standing water was observed at time of site visit (Pictures 5 and 6). The last recorded rainfall event in the area was two (2) days prior (0.4").

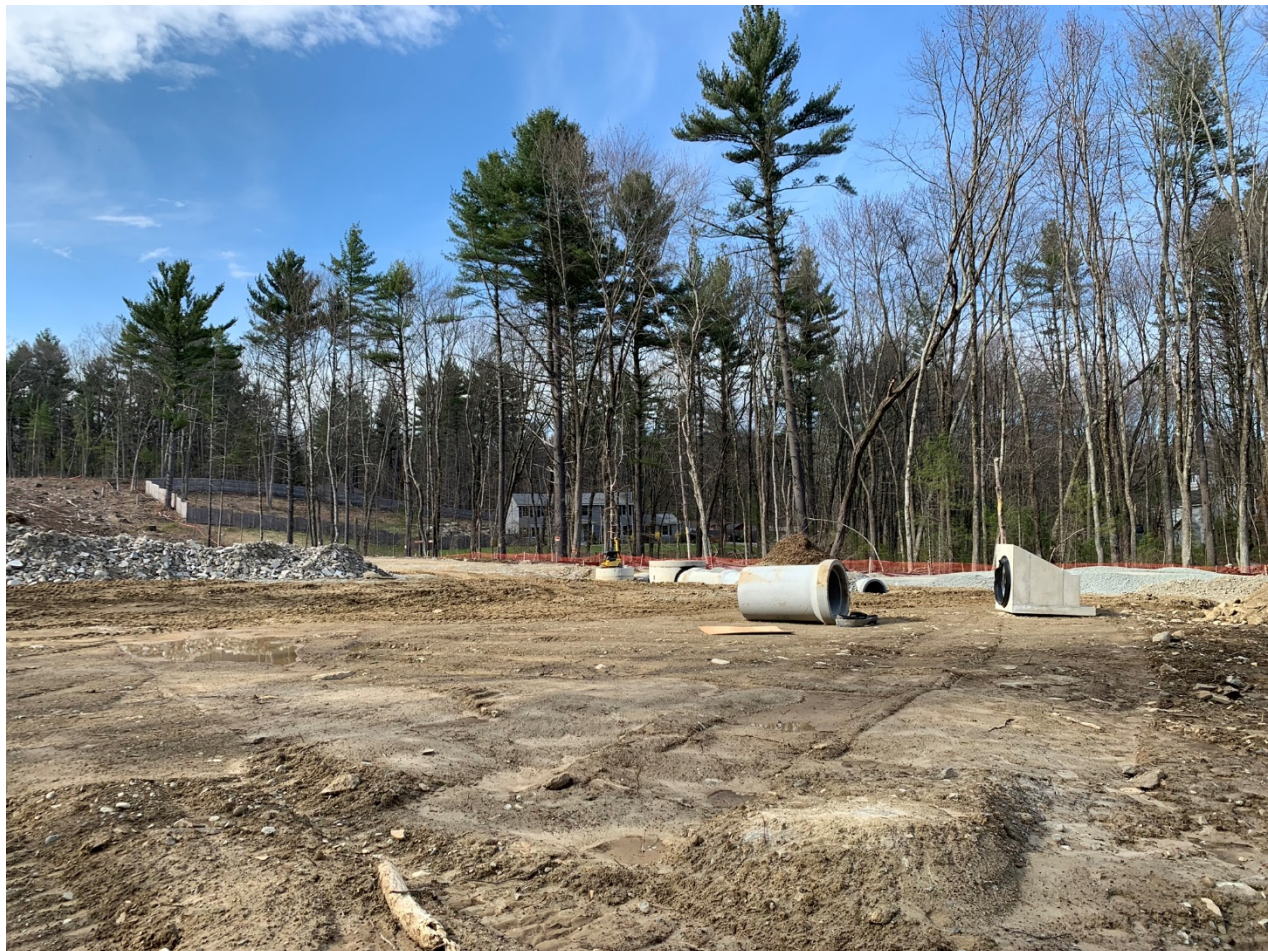
3. Pine Bank area is at a rough sub-grade. See Picture 7 below:

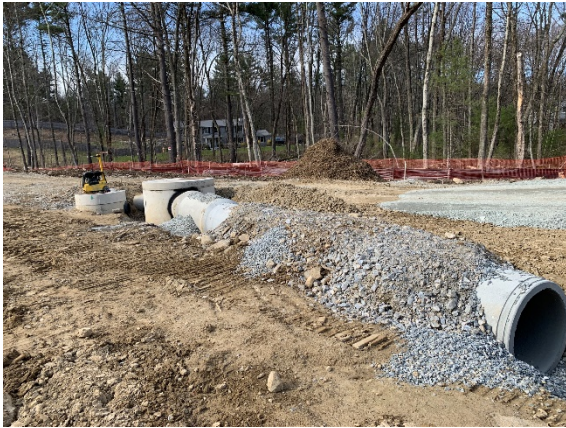
Picture 8

4. Drainage pipe leading to the bioretention area along the roadway has been installed. See Pictures 8, 9, and 10 below:
