**DATE:** November 10, 2022

**FROM:** Land Use Administrator/Conservation Agent

**RE:** Pine Hill Village Status Report Update

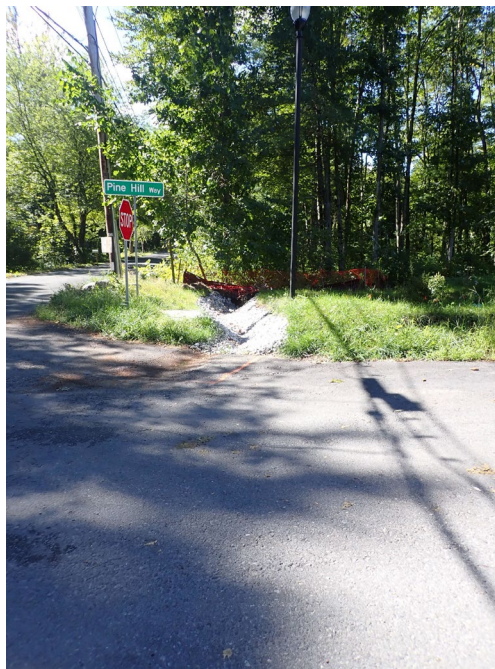
**Conservation Update:** The repair has not been completed. Haybales used to reduce silt from entering the drainage channel cause water to back-up within the swale leading to the channel.

**Conservation Update 11/10/2022:** Work completed as requested

**Conservation Request:** Repair the drainage swale at the entrance off of Stow Road as shown in the detail provided by Markey & Rubin, Inc., dated December 1, 2021.

**Updated Answer 10/20/2022:** The swale has been updated (regraded and stone lined) as per plan from Ian Rubin.

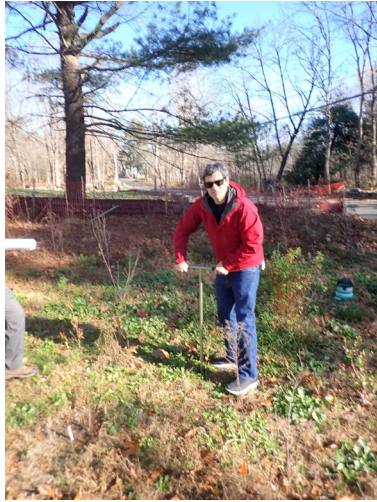
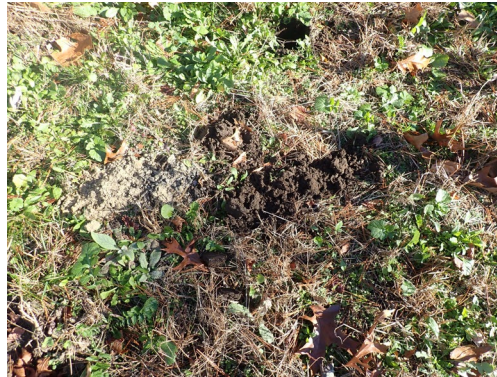
**Conservation Update:** The material used to construct the rain gardens includes more than a bioretention seed mix. The Commission is seeking core samples be taken and witnessed by the Commission or the Nitsch Engineering to verify installation was done according to the approved plan.

**Conservation Update 11/10/2022:** Verification of materials used to construct the rain gardens was completed by Steve Ventresca, of Nitsch Engineering

**Conservation Request:** Verify material to construct Rain Gardens #22 and 23

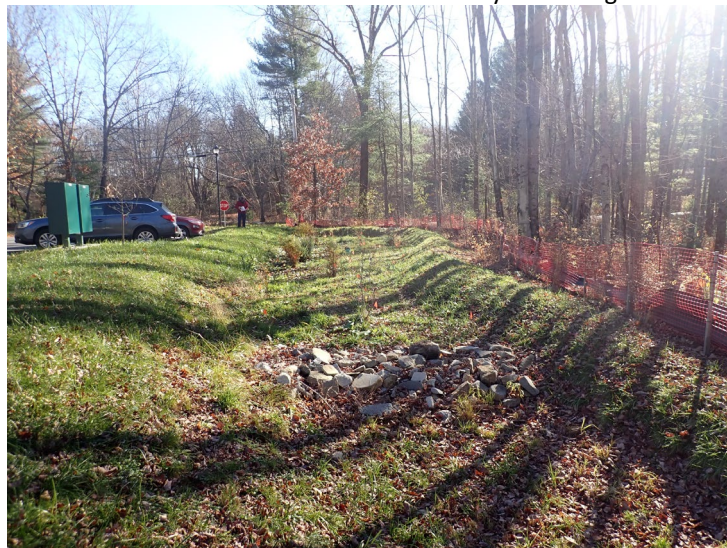
**Conservation Request:** Bioretention cell only has one riser pipe; detail shows two; verify one pipe is sufficient.

**Conservation Update 11/10/2022:** The stormwater model used to design the bioretention cell should be run again with only one riser pipe in order to provide clear evidence that one riser pipe is sufficient. This information shall be provided to Nitsch Engineering for review. In addition, the elevation of the forebay shall be compared to that of the rain garden as they appear to be of different elevations. The Notice of Intent Landscape Fencing and Planting Plan shows an elevation of 257 for the bottom of the forebay and rain garden and a rim of 257.8

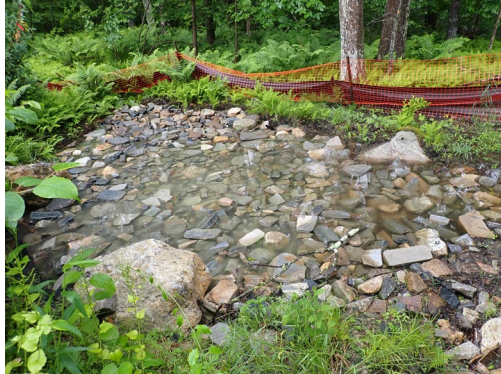
**Conservation Update 11/10/2022:** The letter from Ian Rubin did not clarify the issue, which is the Conservation Agent, along with Nitsch Engineering, believes the energy dissipator is not deep enough to function as designed.

**Conservation Request:** The installation of the energy dissipation at the outlet at the constructed wetland should be verified with approved detail

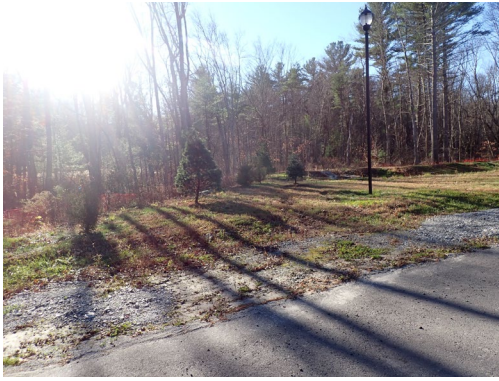
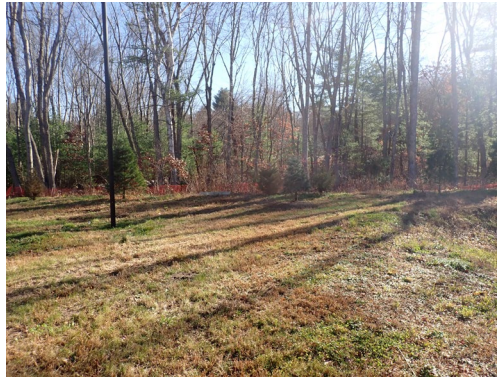
**Conservation Update:** Plantings have been replaced, however the area is well over grown and should be maintained to help reduce the spread on invasive plants.

**Conservation Update 11/10/2022:** Recommend this area be periodically mowed along with lawn areas around the units as part of the routine maintenance of the site and reduce the growth and spread of invasive plants.

**Conservation Request:** Plantings around the constructed wetland are not consistent with the approved plan and some of the trees are dead; replacement plantings shall be in a random pattern.

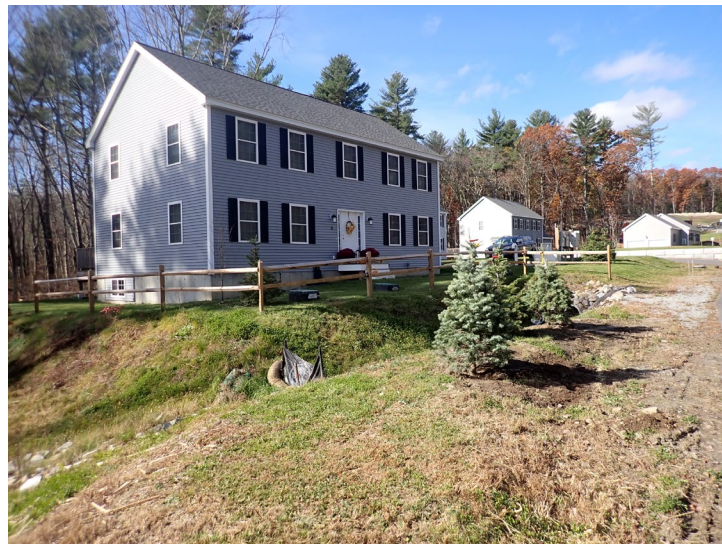
**Conservation Update:** Plantings are still not in accordance with the approved plan.

**Conservation Update 11/10/2022:** Work completed as requested

**Conservation Request:** Additional planting required in front of Units 1A and B as shown on the approved plan.

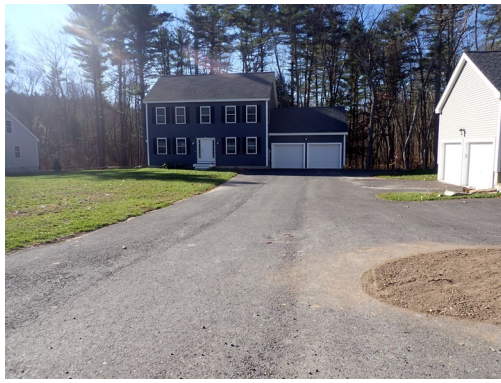
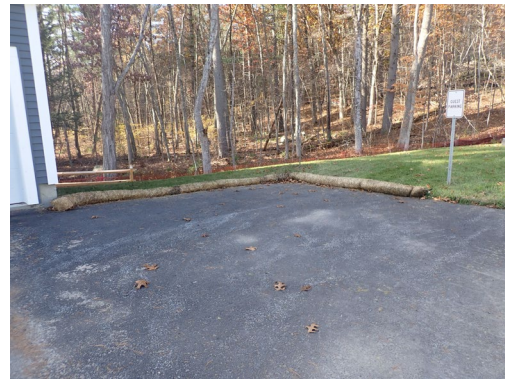
**Conservation Update:** Although a berm was installed at the entrance to the driveway silt continues to collect on the driveway between units 5 and 7 as water pools in that area during heavy rain events. The silt sock installed on the edge of the driveway near unit 5 has been removed without approval from the Commission. Silt laden waste is passing over grassy area before accumulating at the edge of the existing erosion control barrier.

**Conservation Update 11/10/2022:** Improvements made up hill of this site have eliminated silt accumulating in the driveway. The pooling of water will continue until the final coat is installed on the driveway. The silt sock has been replaced as requested.

**Updated Answer 10/20/2022:** A new hay wattle has been installed. Will install check dams on the shoulders of the roadway between stations 7+00 to +950. See Ian's plan page when the final coat of pavement gets put on.

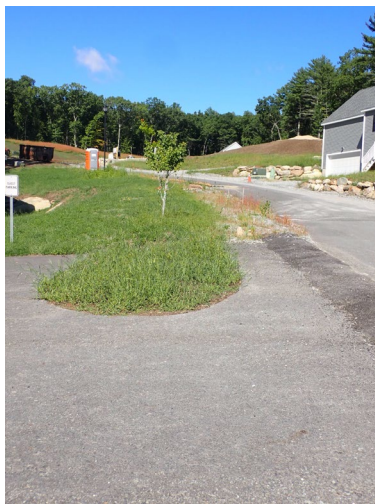
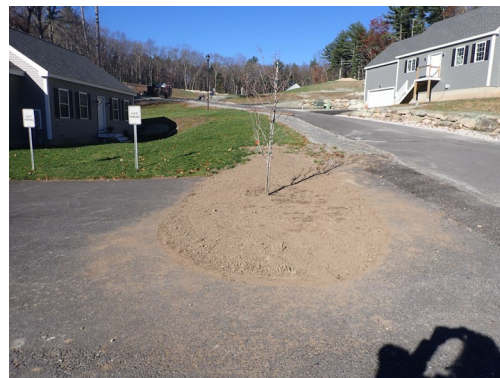
**Conservation Update:** Although the excess pavement was removed in early 2022 no other activity has occurred to rectify the issue.

**Conservation Update 11/10/2022:** In September when the Conservation Agent was on site the area had been stabilized with grass, however during review of the site on November 10, 2022 the Agent observed the newly planted tree, but there was no longer any grass. Re-hydroseed area for compliance.

**Conservation Request:** An additional parking space has been installed at units 5 and 7 this pavement shall be removed and replaced with loam and seed as well as the planting as shown on the approved plan.

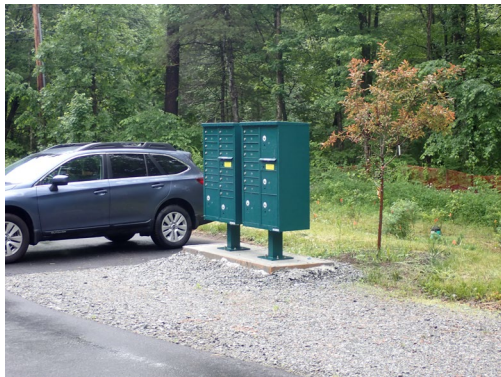
**Conservation Update:** A mail kiosk has been added to the west side of the visitor park at the entrance to the development, but was not on the approved plan. This addition was not approved by the Commission, nor the Zoning Board of Appeals.

**Conservation Update 11/10/2022:** The Conservation Commission will be issuing a fine in the amount of \$300.00 for this violation of the approved plans under the Order of Conditions.

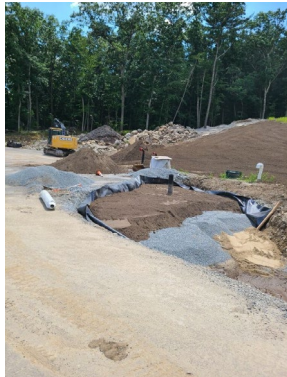
**Conservation Update:** According to the weekly reports from the Developer, rain gardens 16 and 21 were to be worked on the weeks of June 20 and 27, 2022, however no inspection of the installation of these gardens was arranged as previously requested.

**Updated Answer 10/20/2022:** We were under the impression that the notification of the weekly updates would serve as the notification and then the inspection would follow. Please see attached pictures of rain garden 16.

**Conservation Update 11/10/2022:** The remaining rain gardens requires a member of the Commission, its Agent and/or an employee of Nitsch Engineering to be on site during installation. Mr. Cricones is to make direct contact with the Conservation Agent in order to arrange these inspections. ***The submittal of the weekly reports will not be considered notification.***

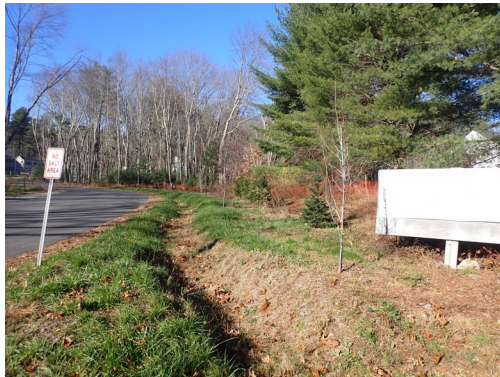
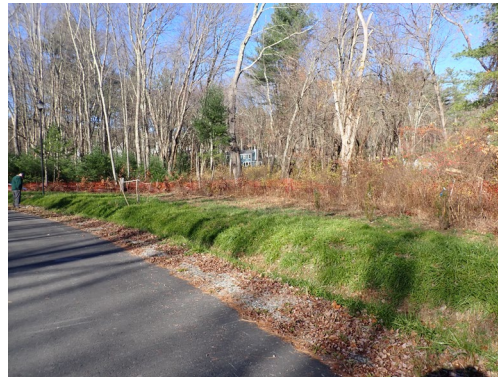
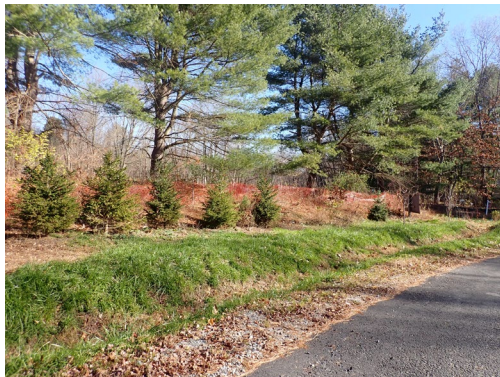
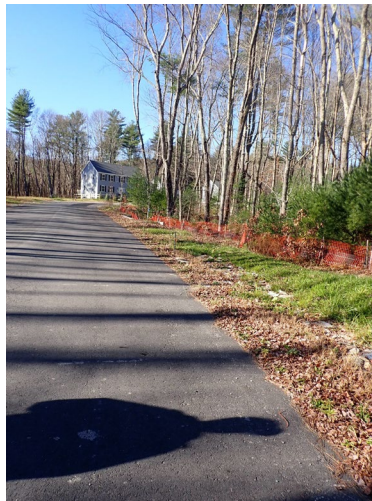
In general, the common areas on the site are not being maintained cause unwanted over growth around the

**Conservation Update 11/10/2022:** Management Plan by Ruby Environmental was approved by the Commission. Photos above show areas that previously included invasive plant species. As stated above the Commission recommends these areas be maintained with mowing at the same time the lawn areas of the units are mowed in order to reduce the growth and spread of invasive plants. A progress report from Ruby Environmental shall be provided for the Commission's review.

**Conservation Update 11/10/2022:** The Commission recommends these areas be maintained with mowing at the same time the lawn areas of the units are mowed as part of the routine maintenance of the site, as well as to reduce the growth and spread of invasive plants.

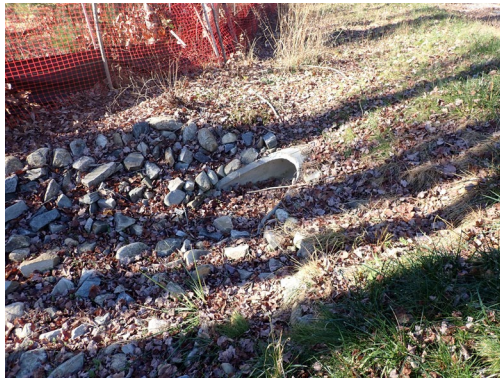
The lower Bio-Retention Cell is receiving silt during rain events. Areas in which stormwater is flowing shall be

**Conservation Update 11/10/2022:** Outfall remains free of silt; continue to monitor for compliance.

stabilized to reduce silt from entering this cell.

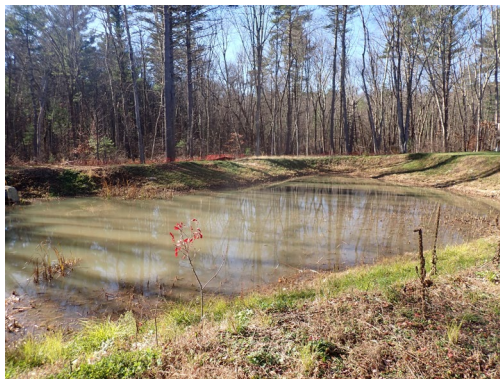
The constructed wetland is acting a sediment basin during construction, however silt in this basin has reached levels that should be addressed to avoid adverse impacts to the wetland resource areas.

**Conservation Update 11/10/2022:** A dewatering plan has been approved by the Commission and may proceed.

**Answer:** A dewatering plan of this area has been approved by the Conservation Commission to allow for the removal of silt within this basin.

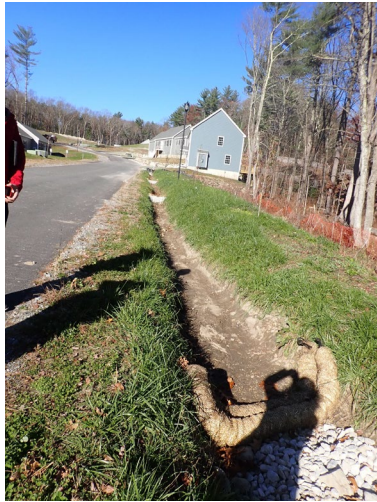
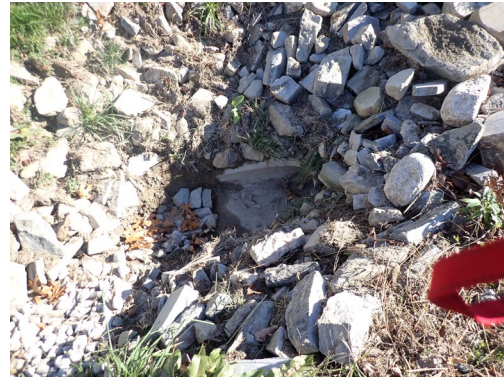
Parabolic Channel 7 (PS7) was designed to be a series of step pools along the main road of the development. As constructed this channel is one long channel that has been stabilized sporadically similar to PS8. Proper installation and maintenance of this and all of the Parabolic Channels shall be adhered to.

**Conservation Update 11/10/2022:** Outfall remains free of silt; continue to monitor for compliance. The swale itself had originally been proposed as step pool. Although the check dams installed along the swale will slow the flow of water during heavy rain events the Agent would recommend the step pools be installed to better control water within the swale. If it is the desire of Mr. Cricones to keep the swale as constructed the stormwater model shall be run again to prove it will function to control stormwater.

**Answer:** The swale has been cleaned and the check dams have been installed in a series of step pools.

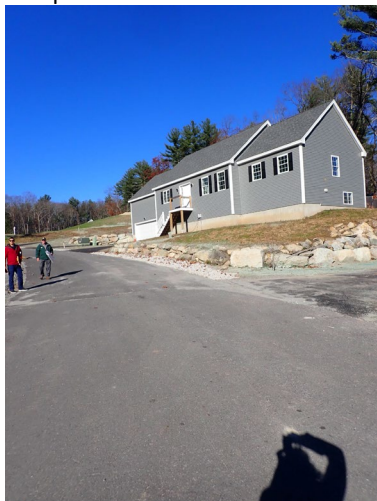
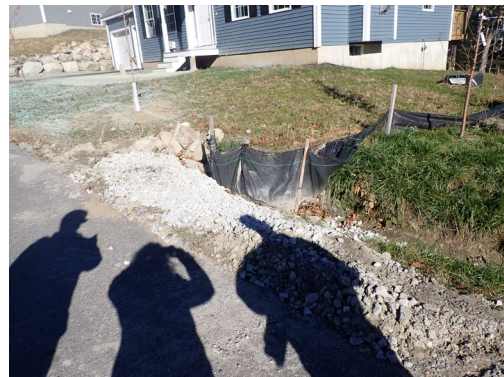
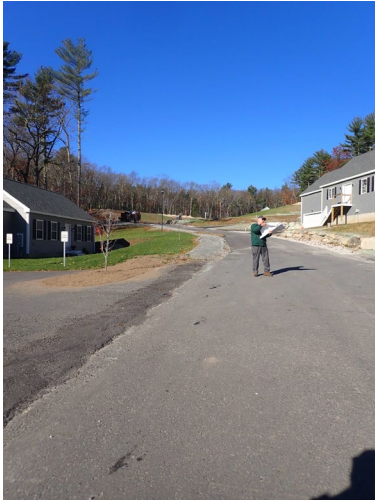
A major cause of siltation with the Parabolic Channels and Constructed wetland is the uncontrolled runoff from the upper portion of the site. A plan to properly control stormwater runoff shall be submitted to the Commission for their review.

**Conservation Update 11/10/2022:** These areas have stabilized as detailed above. Monitor for continued compliance.

**Answer:** We have added more check dams every couple hundred feet up the roadway on the side along with adding 3" crushed gravel on the right side of the road going up the hill. The fact that the driveways have been paved and the whole site has been hydro seeded has also greatly reduced this issue. Any material that ends up in the parabolic swale 1 has been and will continued to be cleaned out if anything goes in there. We have also added more check dams in front of it and within it
