FIELD REPORT

Nitsch Project #:	12808	Date:	March 9, 2020
Client:	Pine Hill Village, LLC	Time:	9:30 AM
Project:	Pine Hill Development	Location:	Harvard, Massachusetts
Weather:	65°F, Sunny		
Present:	Liz Allard – Conservation Agent, Town of Harvard Chad Potvin – Potvin Excavating, LLC Steven Ventresca – Nitsch Engineering Gavin Graham – Nitsch Engineering

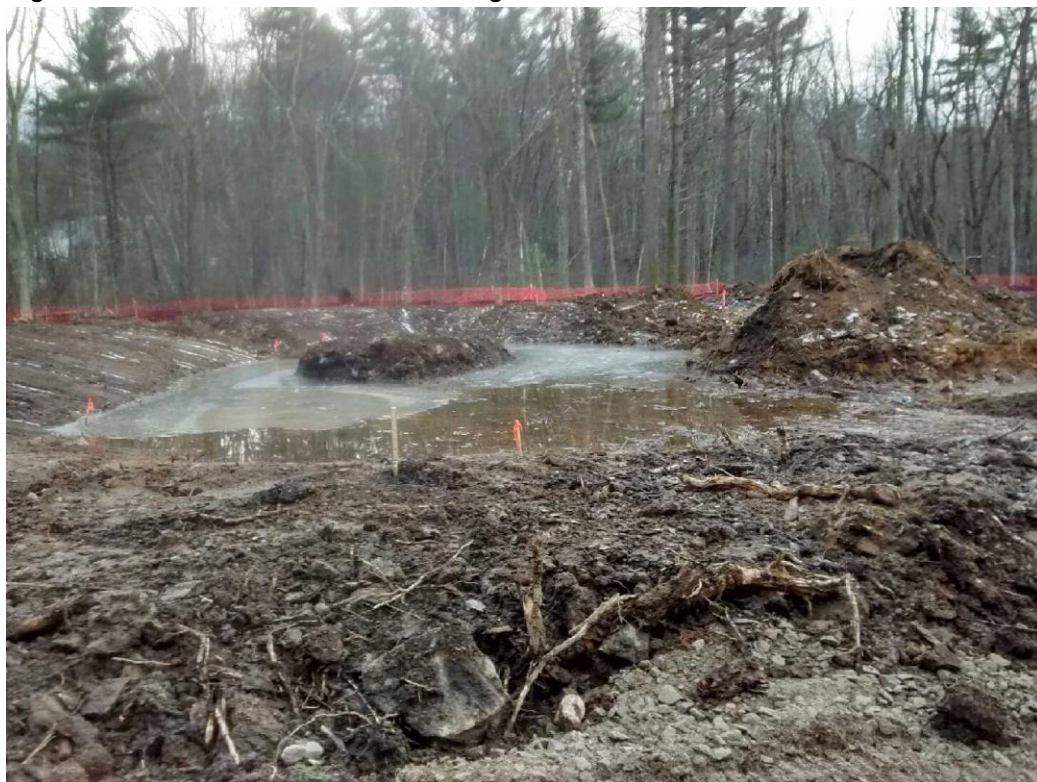
Figure 1: Constructed Wetland with ledge or boulder

There was a large rock unearthed in the Pine Banks constructed wetland that is too big to remove without breaking it into smaller pieces (See Figure 1). Potential solutions include hammer drilling the rock down to the proper grade, dynamite blasting the rock, or increasing the size of the constructed wetland to compensate for the rock being within it. With hammer drilling or dynamite blasting the rock, there are concerns of noise given the proximity to abutters. It was decided that hammer drilling the rock would suffice. If there are any noise concerns, the Contractor and Conservation Agent will revisit other solutions.

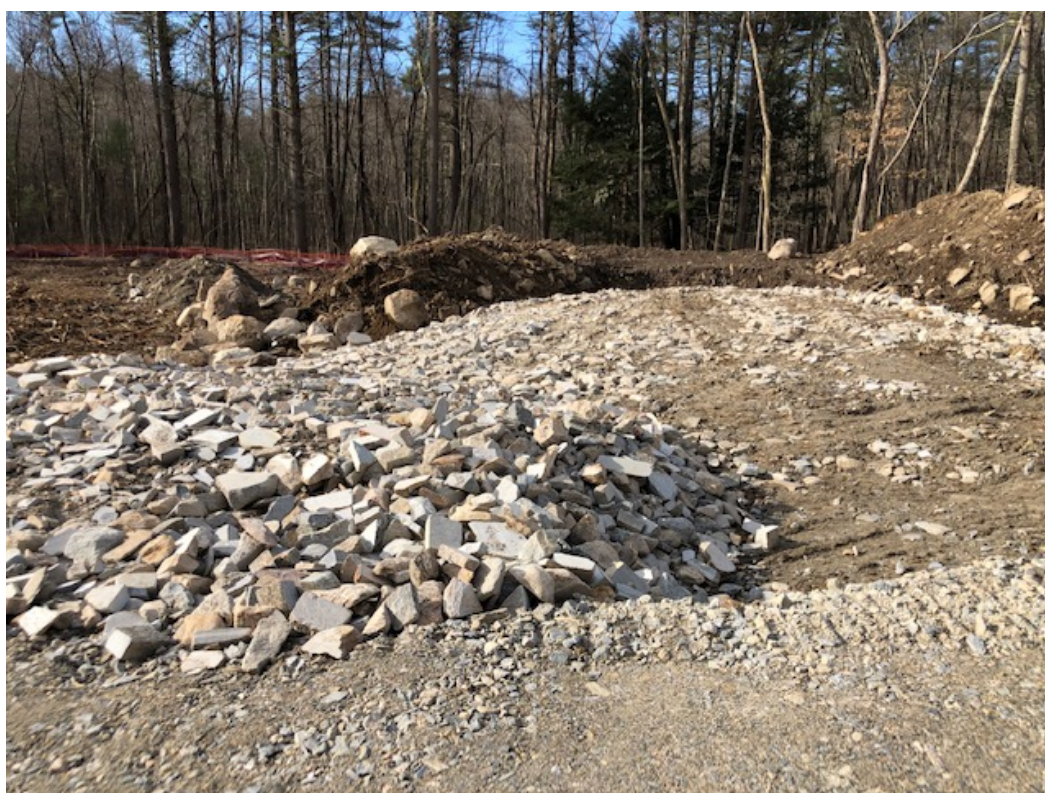
Figure 2: Stone fill outside roadway base

The stone material used for the roadway was also an issue of concern, as previous site visits indicated the stone was too large to be used for subbase (See Figure 2). However, after discussion with the Contractor and Developer (Peter Cricones) it became known that the larger stone material was to be used for the driveway subbase. It was determined that this stone size was suitable for use for this purpose.

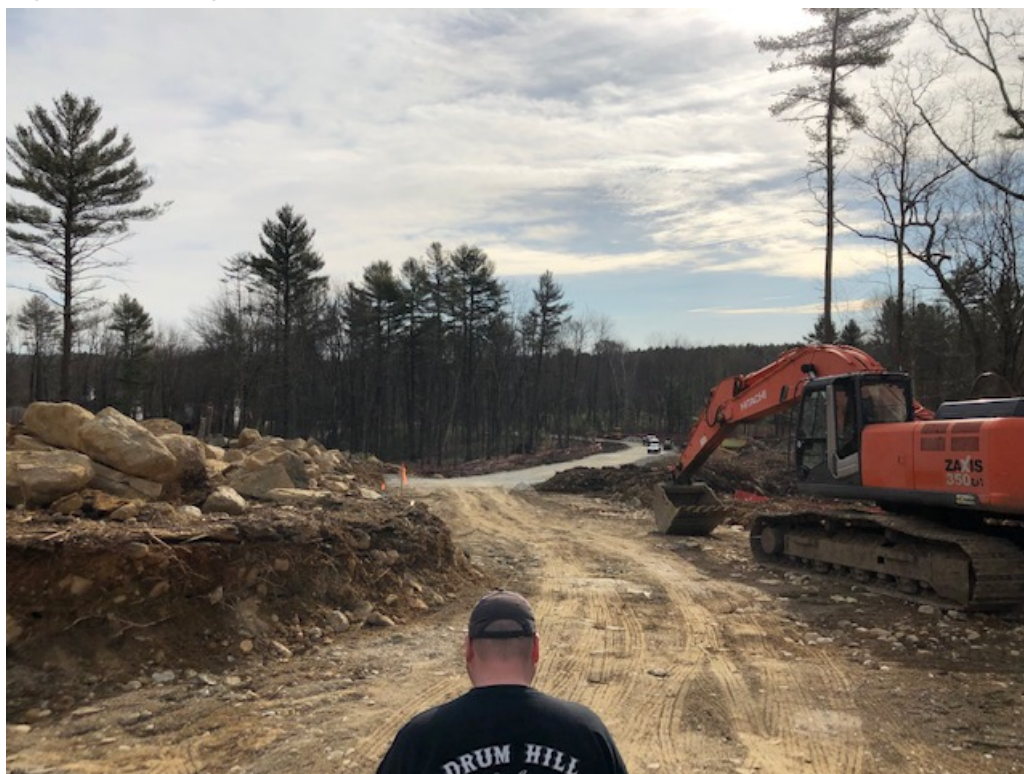
Figure 3: Looking at site from cul-de-sac

The material used for grading the edges of the road was also in question, as it appeared there were too many voids in the material for it to be suitable for the purposes of the design (See Figure 3). After further observation, it was determined the material was suitable for the edges of the road.
