## FIELD REPORT

| Nitsch Project #: | 12808 | Date: | May 15, 2020 |
| Project: | Pine Hill Development | Location: | Harvard, Massachusetts |

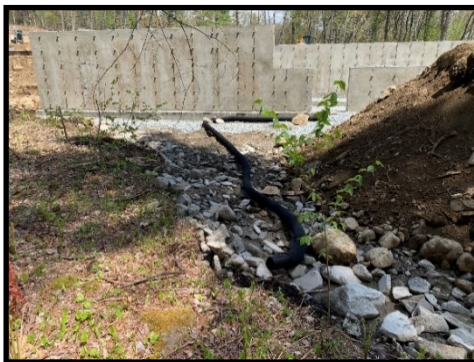
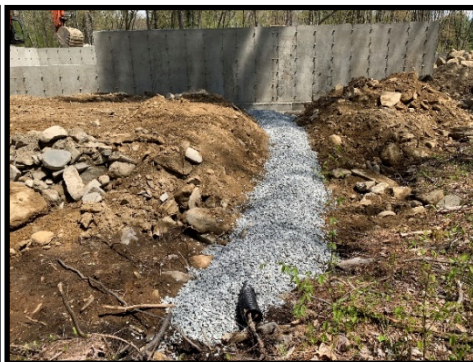
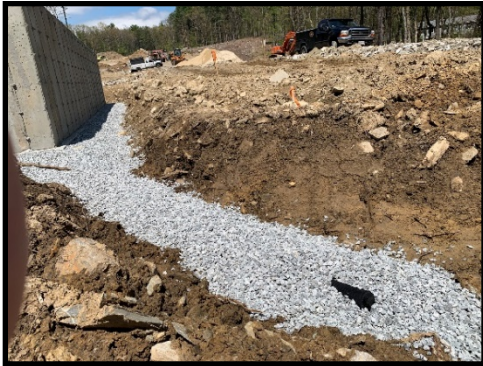
1. Foundation drains were observed in the ground (Pictures 1, 2, and 3). These ran to daylight and directed water away from the site towards the rear of the site behind building 5. It is advised to connect these foundation drains to the closed drainage system such as to minimize the impact of erosion or provide additional stone for mitigation. Nitsch Engineering understands that the foundation drains are not in compliance with the Conservation Order of Commission. The Contractor should review the foundation underdrain with the Conservation Agent and Building Inspector.

1. At bioretention cell near entrance on Stow Road, the Contractor to confirm pipe invert and compare it to bioretention grades such that water flows as intended.
2. Connect foundation drains to closed drainage system or appropriate outfall appropriate with the Conservation Agent and Building Inspector.
3. Implement additional erosion control measures behind the large mound of fill material behind Building 5. It is advised to add wattles in front of and behind the erosion control fence.
4. Repair sections of the erosion control fence that are damaged in the Pine Banks Neighborhood, specifically near the constructed wetlands and behind Building 1.
5. Implement erosion control measures in the bottom of bio-retention system to prevent sedimentation of any partially completed bio-retention systems.

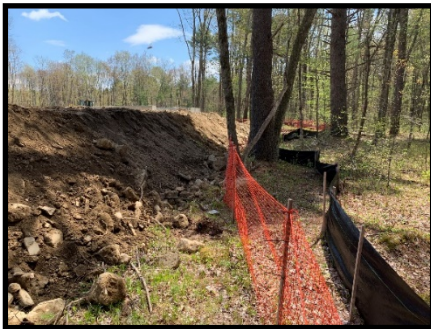
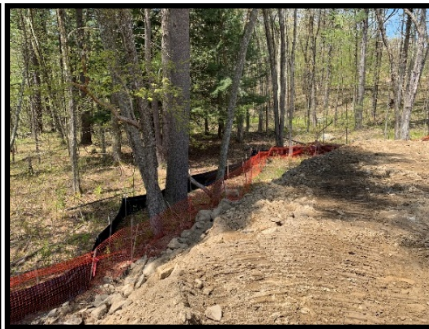
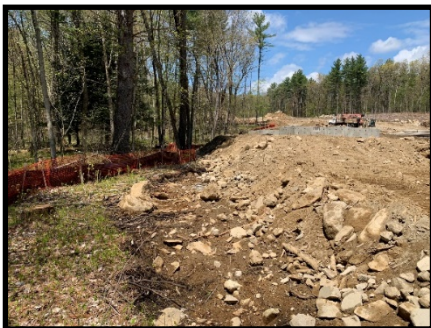
2. There is a large collection of fill material behind Building 5. There are foundation drain pipes running to daylight and discharging water behind this fill pile to the back of the site. It is recommended that these pipes connect to the closed drainage system, and additional erosion control measures are implemented behind this fill pile. Additional Hay Swaddles should be staked to the ground in front of and behind the erosion control fence. See Pictures 5, 6, and 7 below:

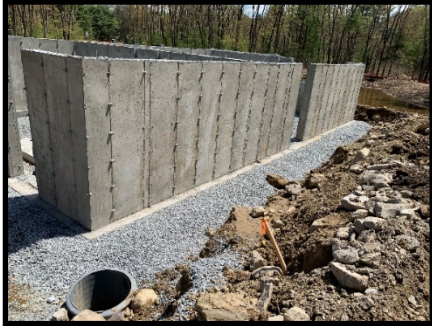
Picture 8

3. Sump Pump kit was observed behind Building 1 (Picture 8).

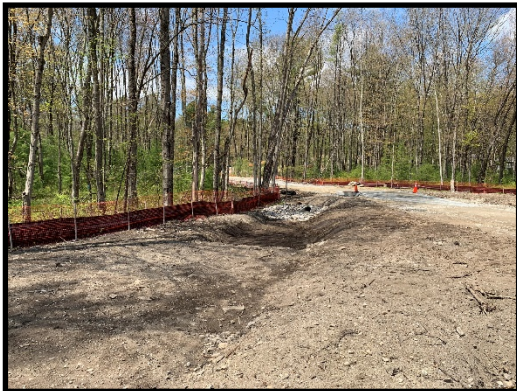
Picture 9

4. Bio-Retention area near entrance to Pine Hill development is graded (Picture 9). Nitsch Engineering recommends erosion control measures in the bottom of the bio-retention systems to prevent sedimentation of any partially completed bio-retention systems.

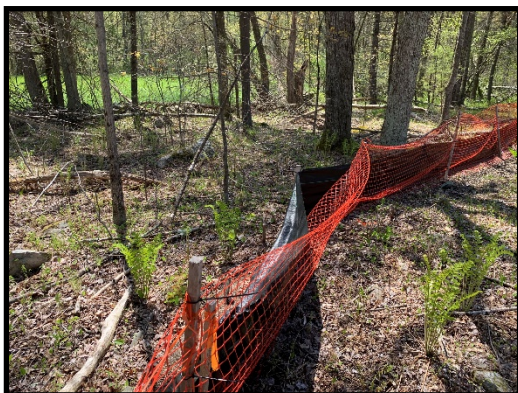
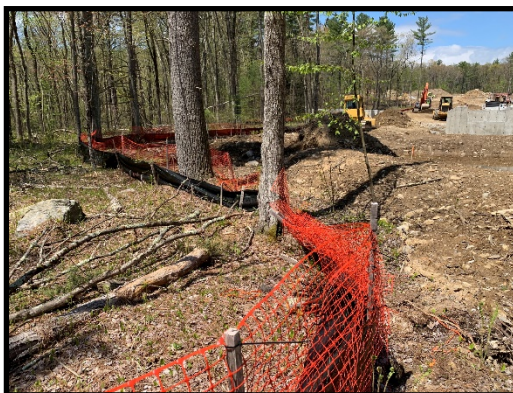
5. In some spots the erosion control fence and hay swaddles had been damaged. It is advised to go through and repair portions of the fence that are damaged (Pictures 10 and 11):

1. Contractor to maintain stabilized construction entrance; and
2. Contractor to maintain erosion control barriers.
