## FIELD REPORT

Nitsch Project #:	12808	Date:	June 12, 2020
Client:	Pine Hill Village, LLC	Time:	2:00PM EST
Project:	Pine Hill Development	Location:	Harvard, Massachusetts
Weather:	Sunny, 82°F		
Present:	Gavin Graham – Nitsch Engineering

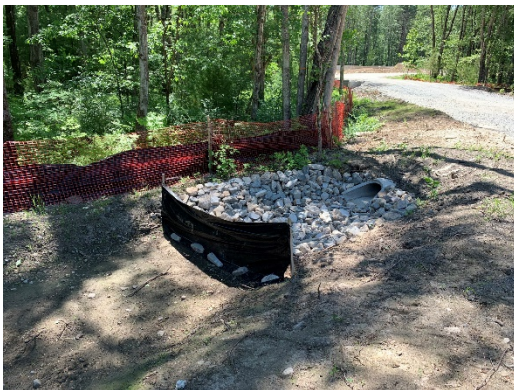
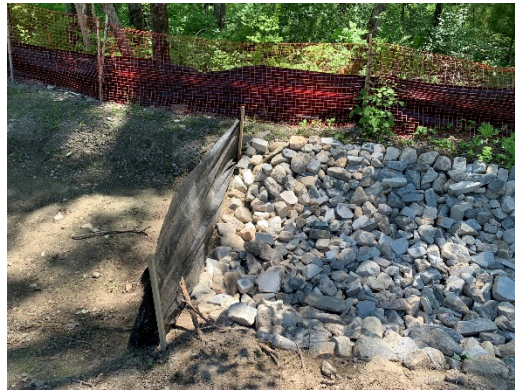
*Picture 1: Bioretention Cell*

- 1) Bioretention Cell near entrance to site has a black fence running across it. The riprap has been extended out to this fence.

1. At the bioretention cell near the entrance to the site, Nitsch Engineering recommends providing straw wattles at the back end of the silt fence for additional support and sedimentation control.
2. At the terminus of additional erosion control measures behind building 5, extend the additional erosion control measures to behind building D (first building in Pine Bank neighborhood after constructed wetland).

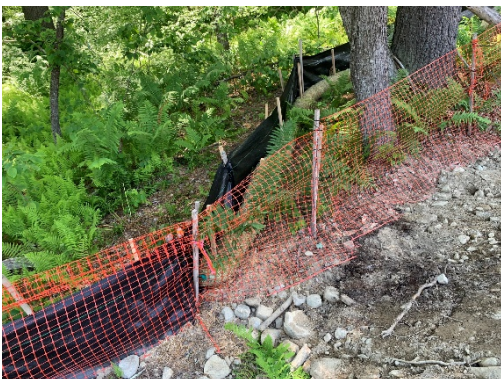
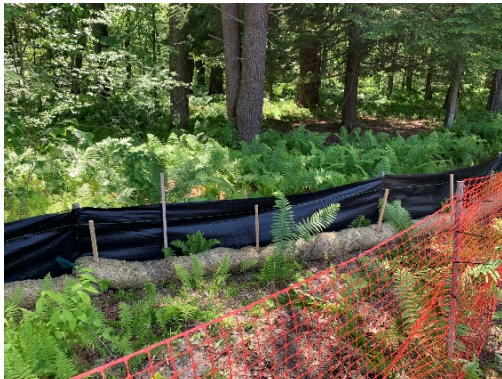
*Picture 3: Erosion Control*

- 2) Additional erosion control measures have been installed behind the building 5.
