## FIELD REPORT

Nitsch Project #:	12808	Date:	August 5, 2020
Client:	Pine Hill Village, LLC	Time:	9:00 AM
Project:	Pine Hill Development	Location:	Harvard, Massachusetts
Weather:	Sunny + 75°F		
Present:	Gavin Graham, Nitsch Engineering

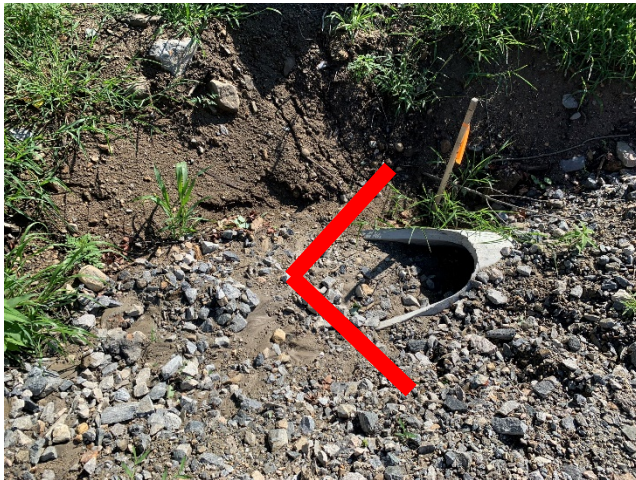
1. Sediment washout was observed in drainage inlets. Nitsch Engineering recommends to jet clean these pipes and to add erosion control in front of these inlets to stop sediment from entering the drainage system.

Picture 1 – Sediment buildup around flared end inlet which drains to constructed wetland.

1. Remove and dispose of sediment from drainage inlets/outlet and within pipe and dispose of properly;
2. Place erosion control at inlets to drainage system; and
3. Replenish hay wattles at erosion control barriers where sediment is flowing off site.

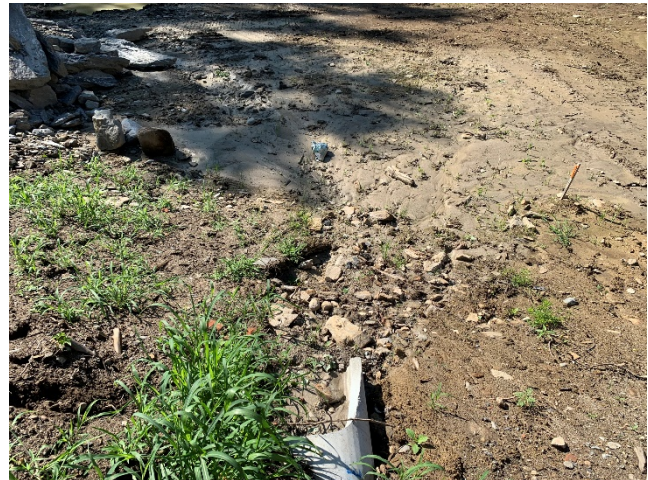
Picture 2 – Sediment entering constructed wetland from upstream inlets.

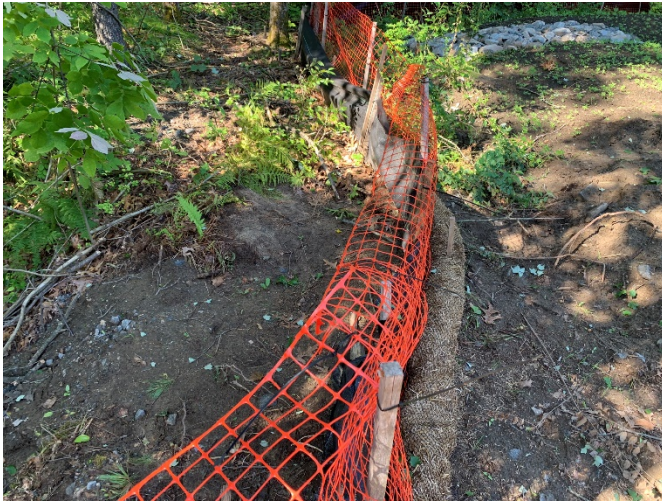
Picture 3 – Some sediment is shown crossing over erosion control barrier offsite. It is recommended hay wattles be replaced on both sides of fence.

1. Nitsch Engineering recommends that the erosion control barriers be replaced where sediment is washing out offsite. Nitsch Engineering recommends that the sediment that washed through the erosion control barrier be removed and disposed of properly.

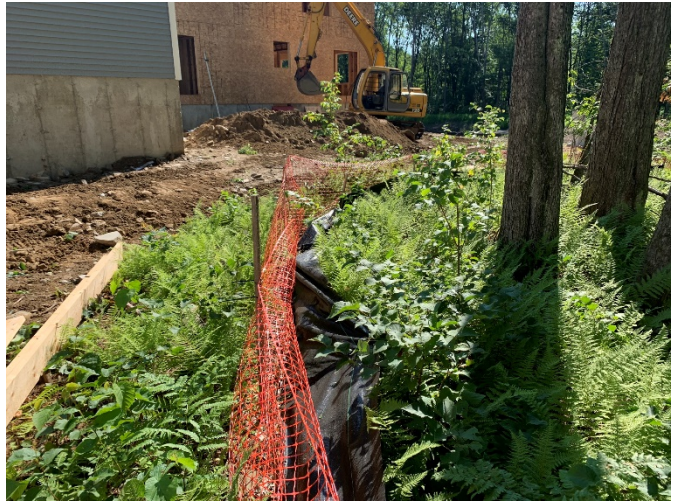
Picture 4 – Erosion control barrier has been damaged.

1. Contractor to maintain stabilized construction entrance; and
2. Contractor to repair and maintain erosion control barriers that are damaged.
