FIELD REPORT

Nitsch Project #:	12808	Date:	November 21, 2019
Client:	Pine Hill Village, LLC	Time:	8:30 AM
Project:	Pine Hill Development	Location:	Harvard, Massachusetts
Weather:	Sunny, 45°F		
Present:	Gavin Graham, Nitsch Engineering

The purpose of this site visit was to observe general site conditions, observe general construction activities, and erosion & sedimentation control measures. The following was noted:

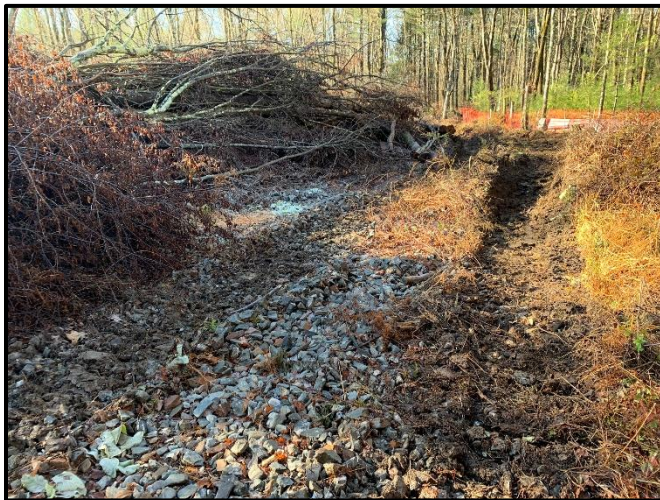
Figure 1

1. Nitsch Engineering observed loose gravel being brought into the construction site through the construction entrance pad. It appeared to be brought in by way of the tree clearing machinery. See **Figure 1** and attached map.
2. There are several locations along the fence where trees/large limbs were cut and fell on the fence, damaging the integrity of the erosion control. These locations are marked on the map and are included in **Figures 2, 3, and 4**.
3. Tree clearing company Burl Land Clearing & Stump Grounding was on site actively clearing out trees. See **Figure 5**.
4. Clearing of trees has commenced and contractor is staying within phase 1 limits. See **Figure 6**.

1. Contractor to maintain stabilized construction entrance and prevent gravel from tracking into the site.
2. Contractor to minimize tree limbs and branches from falling on to and damaging erosion controls.
3. ***Requires further action:** Contractor to repair any erosion control that is damaged or fallen, as soon as possible.
