FIELD REPORT

Nitsch Project #:	12808	Date:	12/12/2019
Client:	Pine Hill Village, LLC	Time:	9:00 AM
Project:	Pine Hill Development	Location:	Harvard, Massachusetts
Weather:	Clear, 25°F		
Present:	Gavin Graham, Nitsch Engineering Liz Allard, Conservation Agent – Town of Harvard Don Ritchie, Conservation Board – Town of Harvard

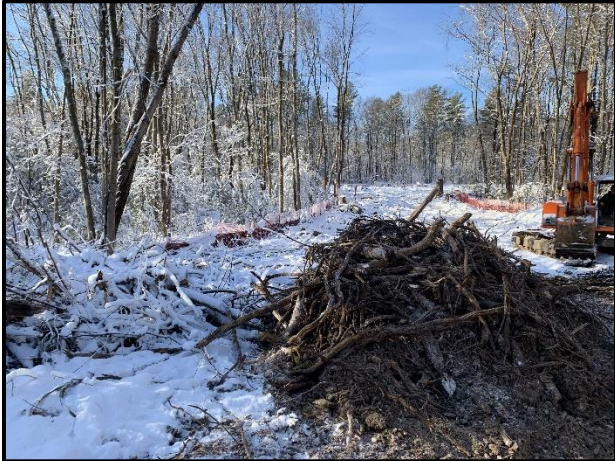
Figure 1 – Site debris being cleared

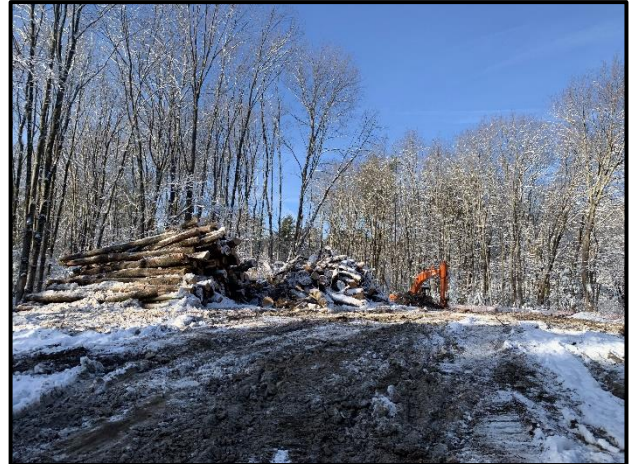
1. Site visit confirmed the presence of excess sediment in the intermittent stream. The stream has steel plates covering it such that construction vehicles can pass over the stream without getting stuck. During the tree removal process, cut down trees were laid down and stored over these steel plates. This is thought to be the source of majority of the sediment in the water; as it rains the water carries the sediment from the trees, over the steel plates and into the stream near the erosion control barrier.

Figure 2 – Trees are stacked for removal; some trees lay over the steel barrier covering the stream.

1. **Requires immediate attention:** Contractor to install additional hay wattle on downstream section of intermittent stream.
2. Developer must provide all parties with weekly updates including construction sequences and a detailed schedule, per conversation with the Town of Harvard. This includes contractors who are working on the site, the Town of Harvard, and representatives of Nitsch Engineering.
3. Do not store construction debris or construction equipment on or near the steel plates covering the intermittent stream.

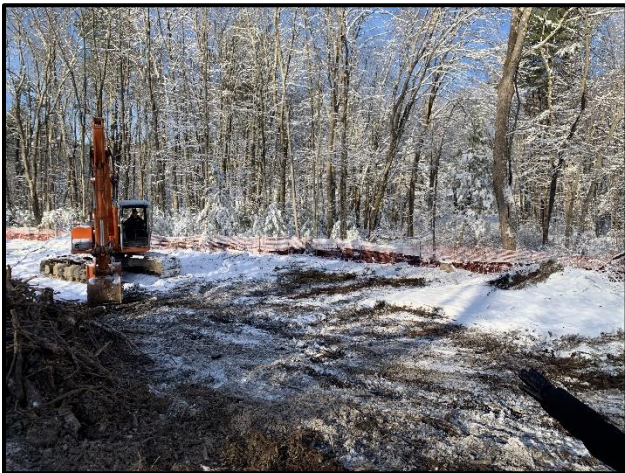
Figure 3 – cleared trees leave behind a tremendous amount of sediment that is susceptible to being washed into the stream.

2. Liz and Don with the Town of Harvard both recommended an additional hay wattle on the downstream side within the stream be installed immediately to capture silt. This needs to be done today (12/12/2019) in order to protect the stream from impending rain in the weather forecast.
