## FIELD REPORT

| Nitsch Project #: | 12808 | Date: | April 6, 2021 |
| Project: | Pine Hill Development | Location: | Harvard, Massachusetts |

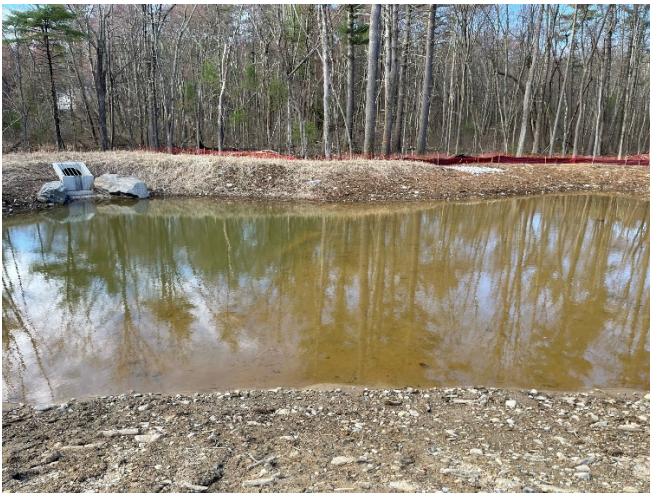
Sediment is visible in the constructed wetland.

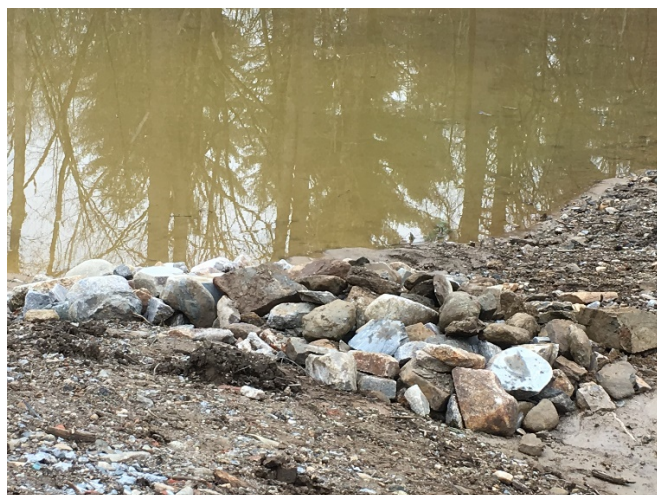
Close up of constructed wetland. Water is murky.

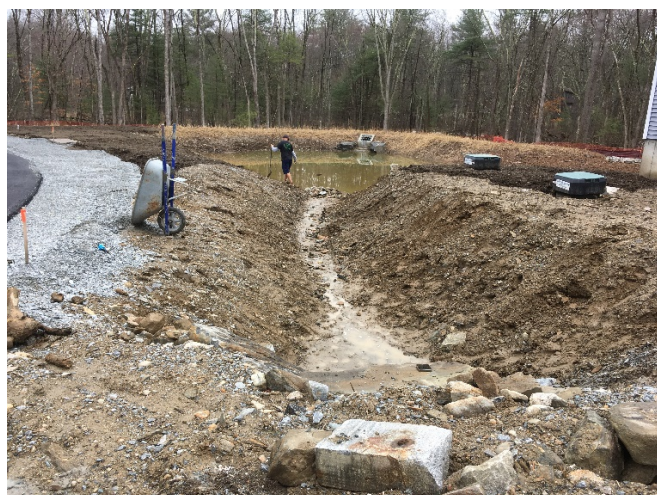
Sediment is entering constructed wetland via drainage pipe system. Nitsch Engineering recommends extending this discharge pipe toward the wetland basin and covering the channel so that it makes a level slope (2% slope) to the roadway shoulder. This would eliminate the steep sloped channel close to the building door.

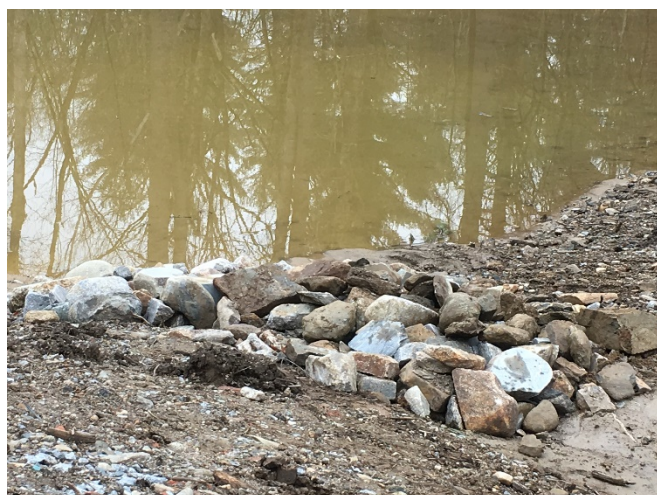
Stone was placed at discharge location to slow stormwater discharge flows and to filter sediment.

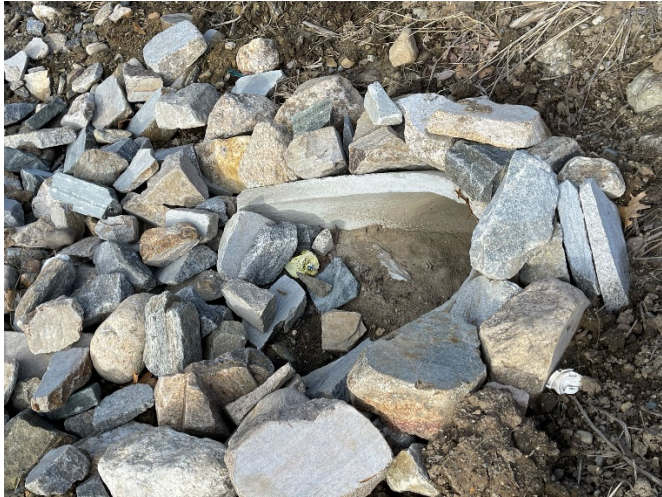
Sediment is entering constructed wetland. Nitsch Engineering recommends the Contractor stabilize upstream areas to prevent sediment from entering the drainage pipes. Sediment in the discharge pipe should be removed and disposed of properly.

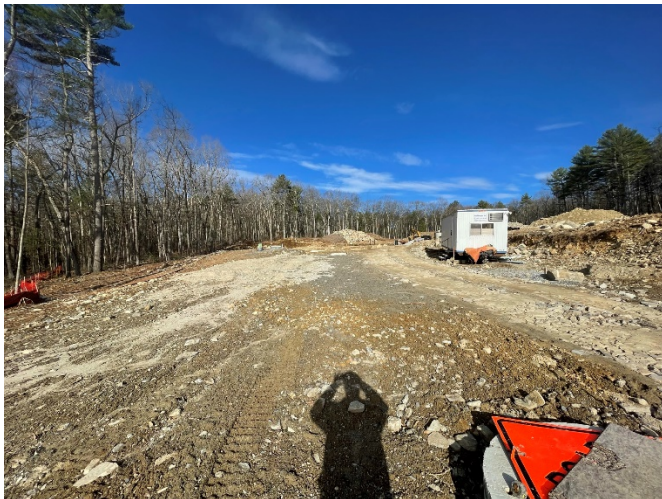
It appears that sediment is being washed away over the exposed slopes onsite. Nitsch Engineering recommends that the Contractor provide erosion control measures along the non-stabilized slopes at the top and mid-slope of exposed surfaces to minimize erosions.

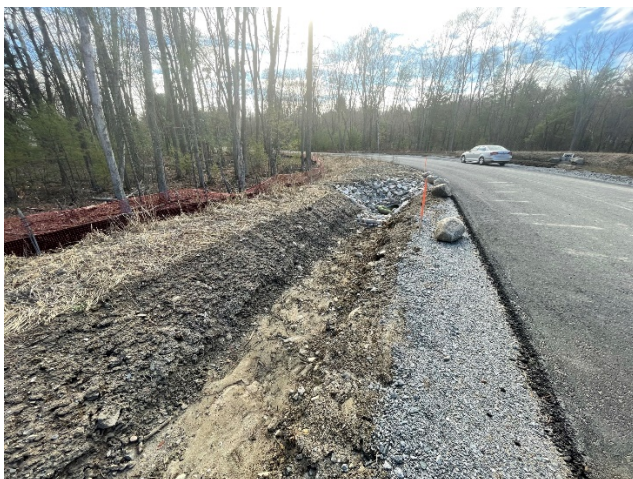
Swale has sediment buildup in the bottom of the channel. Nitsch Engineering recommends that this sediment be removed and disposed of properly prior to planting/seeding.
