**Town of Harvard  
Self-Evaluation and Transition Plan  
December 2022**

**Center for Living & Working, Inc.  
Michael Kennedy, ADA Access & Advocacy Coordinator  
18 Chestnut Street – Suite 540, Worcester, MA 01608  
and  
James M. Mazik, AICP - Consulting Services  
188 Lower Westfield Road, Holyoke, MA 01040**

# **TOWN OF HARVARD – SELF-EVALUATION AND TRANSITION PLAN TABLE OF CONTENTS**

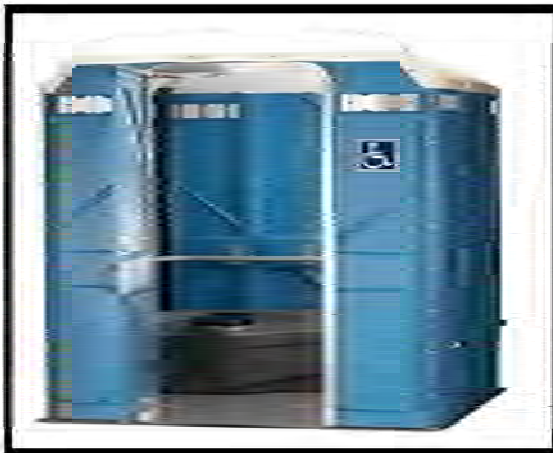
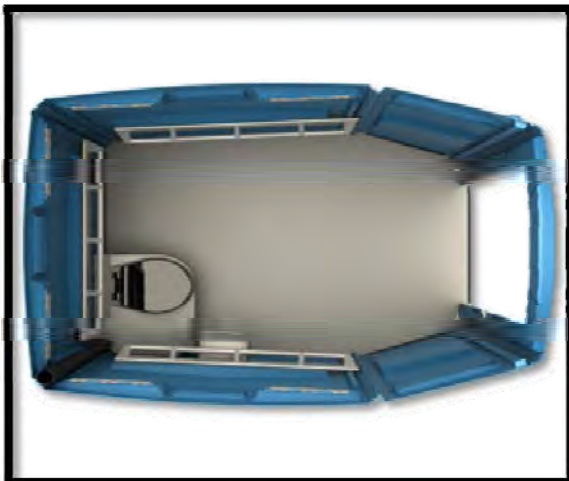
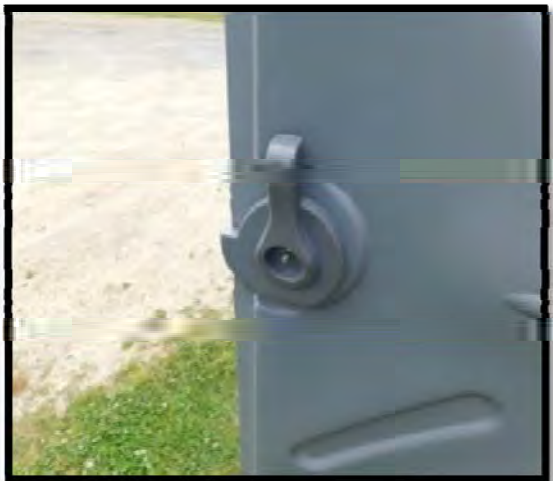
### Representative Examples of an ADA Compliant Portable Toilet

If the Town provides portable toilets for short-term events or for seasonal use, then they must be “ADA Compliant”. **An important distinction to note is that “ADA Compliant” is not synonymous with “Wheelchair Accessible.”** Wheelchair Accessible usually indicates a ramped or ground level entrance with a wide enough door for a wheelchair to gain entry. Clearances; setbacks; and dispenser, grab bar, and water closet heights do not necessarily meet ADA or 521 CMR Standards. “ADA Compliant”, however, generally means reinforced construction; ramped or ground level and wheelchair accessible entrance; spring loaded magnetic door that closes automatically; reinforced grab bars; dispensers, grab bars, and the water closet at the proper height and near, far and front setbacks; compliant door hardware; and enough interior space for a wheelchair to make a 360 degree turn that all fully comply with the 2010 ADA Standards and/or 521 CMR, whichever is more stringent. Illustrative examples of an “ADA Compliant” portable toilet are shown below.

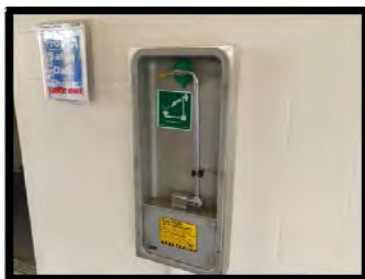
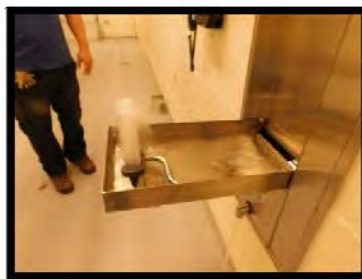
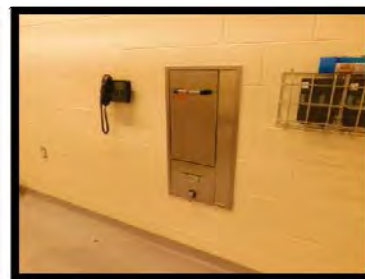
- When a shower/eyewash station is a combination unit, the eyewash should be about 14 inches from the wall to the center-line of the eyewash.
- ADA guidelines state that at least one out of five eyewash or shower stations in a specific area, or at least one, must meet ADA requirements.

Photographic examples of compliant emergency eyewash stations are provided below.

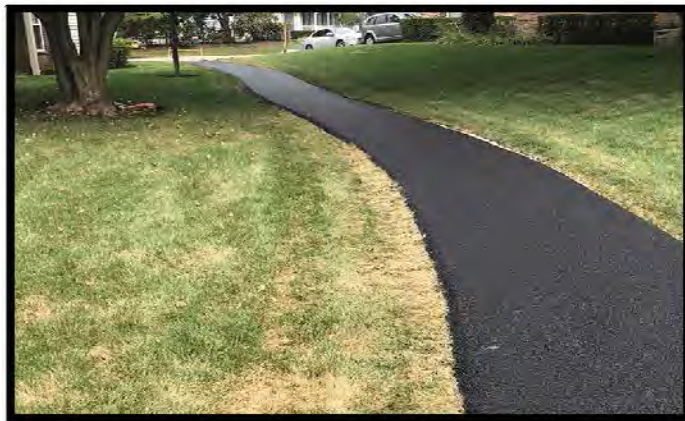
- Pros:
- 1) Durable
  - 2) Relatively inexpensive
  - 3) Requires little maintenance
  - 4) Does not readily deteriorate and has a longer live span

- Cons:
- 1) Is not permeable
  - 2) Subject to heaving and grass/weed infiltration in cracks
  - 3) Added cost due to site preparation requirements
  - 4) Requires periodic crack-filling and re-sealing/re-coating

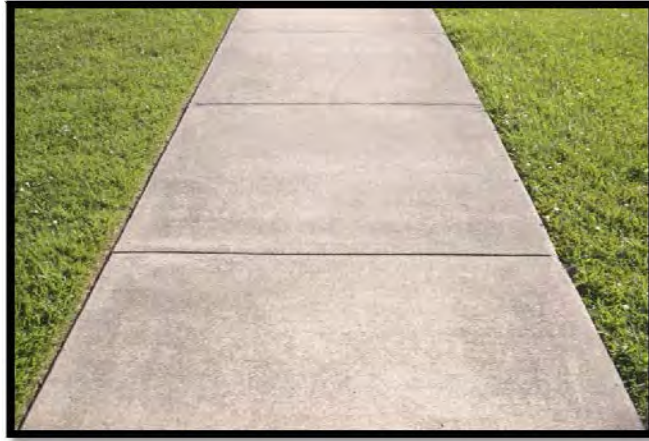
### **Concrete**

Estimated cost per square foot (2022): Up to \$25.00.

- Pros:
- 1) Durable
  - 2) Requires little maintenance
  - 3) Does not readily deteriorate and has a longer live span

- Cons:
- 1) Is not permeable
  - 2) Subject to cracking, edge deterioration, and some heaving

- 3) Is more expensive due to site preparation and construction
- 4) Requires more expensive repair varying from grinding to complete concrete pad replacement

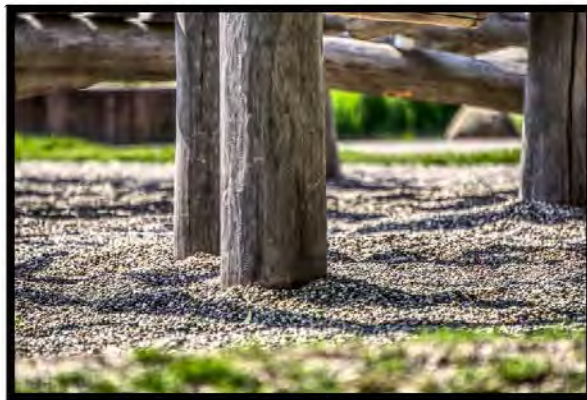
Cons: It can be a hazard if it is thrown by persons in the playground. Some daycare providers have reported that pea gravel fits well in a nostril or an ear, which can result in an unwanted visit to the doctor or emergency room. It also creates a problem for maintenance of the grass and surfaces surrounding the playground. Lawn mowers can throw the gravel significant distances. The material cannot be used if the fall height within the playground is greater than 5 feet.

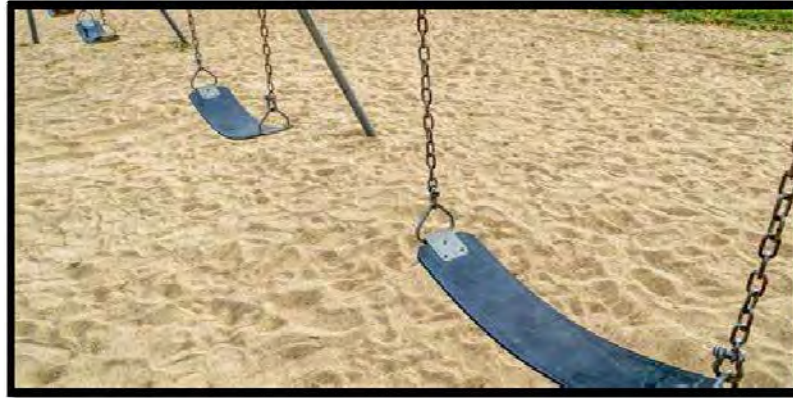
#### **Sand**

Pros: Sand is a very easy product to maintain through simple raking and leveling. . It is also a preferred material to play in by children.

Cons: Cats often use the sand as a litter box which creates a serious health code concern. Broken glass and other debris can also become buried in sand, invisible to the eye, resulting in potential future injuries. Furthermore, in freezing conditions, sand can become as hard as concrete and can only be used after the sun warms the surface or the material is loosened manually. Sand cannot be used if the fall height within the playground is greater than 4 feet.

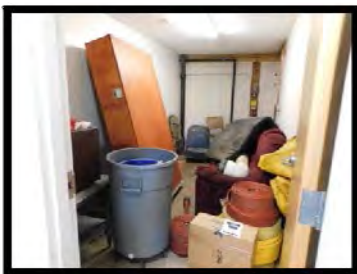
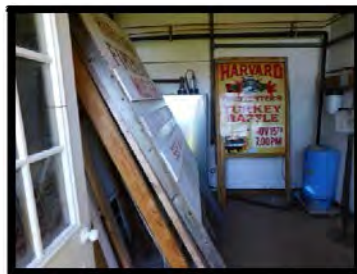
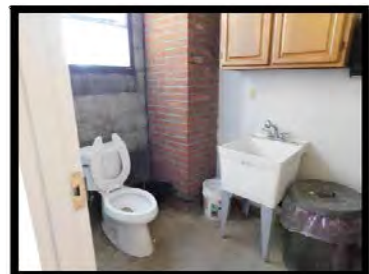
Still River Road Substation. The storage room, boiler room, and bathroom lack tactile designation signage. The boiler room door has non-compliant knob style hardware. The bathroom is wholly non-compliant as it has insufficient clear width at the water closet; lacks grab bars; has a sink that lacks knee clearance, has insufficient clear width, and is too deep; among other areas of non-compliance.

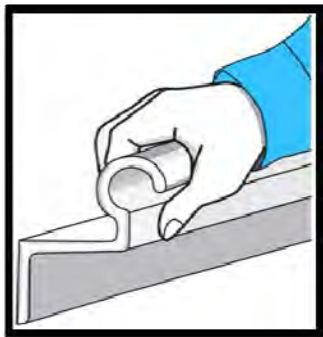
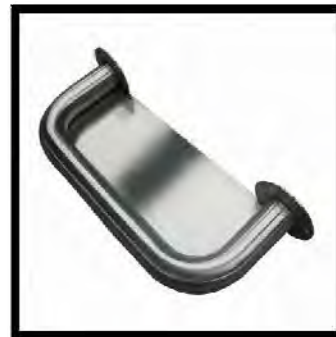
Both the 2010 ADA Standards (S. 604.5 Exception #3) 521 CMR (S. 15.8) provide exceptions for the requirement of grab bars in cells that are specifically designed without protrusions for purposes of suicide prevention. However, in recent years grab bars have been designed so they do not increase suicide risk. As shown, there are several ways for grab bars to be designed with adequate gripping surfaces, while ensuring that nothing can be tied onto them (see below). Consideration should be given, but not required, to install suicide proof grab bars in the accessible cell.

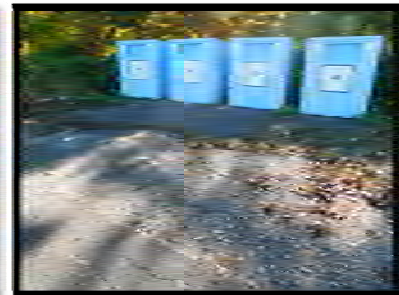
Photo Transfer 3

The book drop donation bins (2) are at a height which exceeds acceptable reach standards under ADA by 15”. The clothing drop donation bins (4) are at a height which exceeds acceptable reach standards under ADA by 5”. In addition, there is no accessible route of travel to the clothing drop donation bins as the surface is gravel and loose stone. [See Photos Transfer 3 and 4.](#)

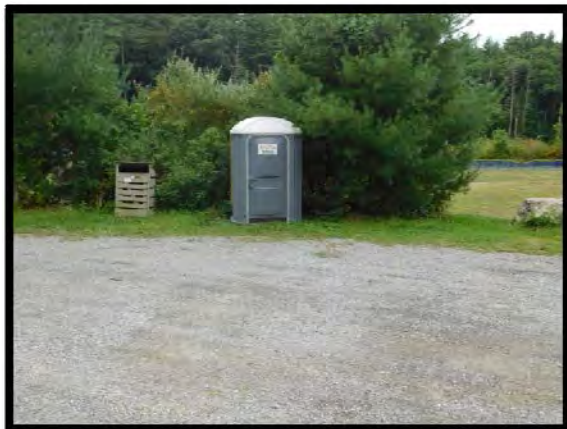
Photo Ann Lees 1

<p><b>Portable Accessible Toilet</b></p> <p>The portable "accessible" toilet is not ADA compliant as the soap dispenser is too high and located over the grab bars; the toilet paper dispenser is too high, is located over the grab bars, and is too close to the front of the toilet; the toilet is ½" too high, 2" too close to the near wall and 9" too close to the door in front of the toilet; and the door closing speed is too fast. In addition, the interior pull device and locking mechanism are constructed in a manner that makes it difficult to operate with a loose grip or closed fist.</p>	308 604.7 604.4 604.2 604.3 309.4 404.2	30.12 30.7.6 30.8.5 30.7.2 26.9 26.11	<p>Replace the existing portable "accessible" toilet with an ADA Compliant toilet such that soap/towel dispensers are no more than 42" a.f.f.; the toilet paper dispenser s/b a minimum of 24" a.f.f. and s/b 7" min. to 9" max. in front of the water closet measured to the centerline of the dispenser; the height of the water closet s/b 17" to 19" a.f.f. to the top of the seat; the water closet s/b 18" from the nearest sidewall, at least 42" from the farthest sidewall, and 42" from the front of the water closet to the nearest wall or fixture; and a door closing speed that is at least 6 seconds. Nothing s/b mounted over the grab bars. The door pull and locking mechanism needs to be modified such that they are both operable with a loose grip or closed fist.</p>	3	2	I	TBD

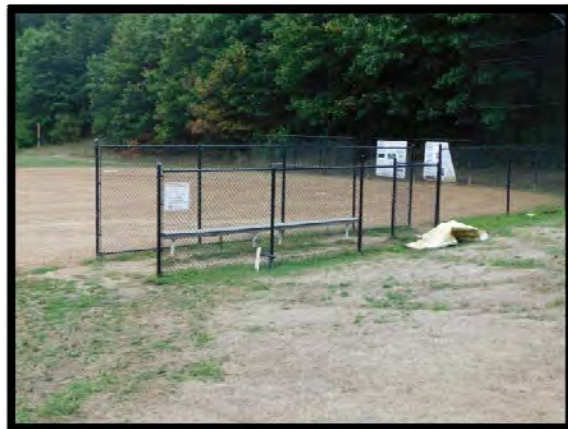
Photo Ann Lees 2

**General Description or Obstacle Which Limits Mobility or Access:** There is no designated accessible parking. There is no accessible route of travel to the ballfield and player’s benches. The accessible route to the portable toilet and waste disposal bin is overgrown. The portable “accessible” toilet has numerous areas of non-compliance including a too fast door closing speed, an interior pull device and locking mechanism that is not easily operable with a closed fist or loose grip, a soap dispenser that is too high and located over the grab bars, a toilet paper dispenser that is located over the grab bars and is too close to the front of the toilet, a toilet that is too high and which does not meet near wall and front clear width requirements.

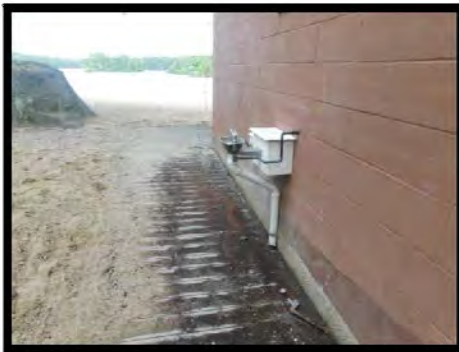
Photo Bare Pond 3

<p><b>Drinking Fountain</b> A "bubbler" on the side of the building lacks knee clearance and is not a "high-low" drinking fountain.</p> <p>See Photo Bare Pond 3.</p>	211 306 602	36	<p>Option #1: Discontinue use of the bubbler.</p> <p>Option #2 – Remove the existing bubbler and replace with a "hi-low" drinking fountain. The drinking fountain must comply as follows:</p> <p>Protruding objects compliance of no &gt; 4" protrusion between 27" and 80" a.f.f. (307); 30"x48" clear space requirement (305), and knee/toe clearance (306). Knee clearance is 9" to 27" a.f.f.; 25" deep max. at 9" a.f.f. or 11" deep min at 9" a.f.f. and 8" deep min at 27" a.f.f. Width of knee clearance s/b 30" wide min (306.3). Toe clearance as part of c.f.s. 17" min – 25" max, 9" high a.f.f., 30" wide (306.2). The spout s/b 15" min from wall and 5" max from the front edge of the unit (602.5). Flow of water 4" high min and spout located max 5" from front (602.6). and with the water flow within 3" from the front edge (36.3). The spout height s/b 36" max. a.f.f. for "low" and 38" min a.f.f. to 43" max a.f.f. for "high". The controls s/b operable w/one fist; no &gt; 5 lbs force (309.4).</p>	2  2	2  3	I  N	\$0  Up to \$3,500+

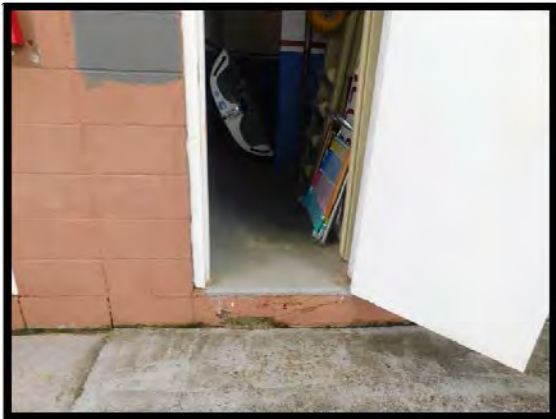
Photo Bare Pond 9

<u>Women's Only</u>							
The stall door to the women's water closet is only 25" wide, swings in, and lacks pull devices.	604.8.1 404.2.7 404.2	30.6.1	Stall doors must be a minimum of 32", doors must open out or slide, the door hinge must be self-closing, pull devices must be on both sides of the door, locking mechanisms must be operable with a loose grip or closed fist, and a coat hook at a height of no more than 48" a.f.f. must be provided.				
See Photos Bare Pond 9, 10, 11, and 12.

<p><u>Recommended Action:</u>          Modify/reconstruct one of the bathrooms to adhere to the above required requirements. It will be necessary to construct a ramp to the bathroom that adheres to Section 405 of the 2010 ADA Standards and Section 24 of 521 CMR. This includes a maximum running slope of 8.3%, paired railings at a height of 34" to 38" a.f.f. (higher) and 18" to 20" a.f.f. (lower), and a ramp width of 48" between railings.</p>				
--	--	--	--	--	--	--	--

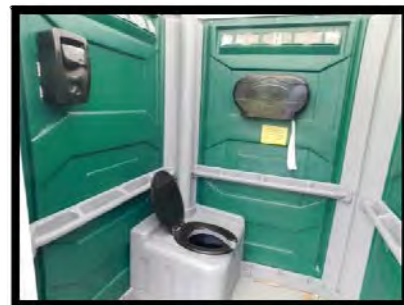
Photo Waite 2

**General Description or Obstacle Which Limits Mobility or Access:** There is no designated accessible parking. There is no accessible route of travel to the soccer field and portable toilet. The portable “accessible” toilet has numerous areas of non-compliance including a too fast door closing speed; an interior pull device and locking mechanism that is not easily operable with a closed fist or loose grip; a soap dispenser that is too high and located over the grab bars; a toilet paper dispenser that is too high, is located over the grab bars, and is too close to the front of the toilet; a toilet that is too high and which does not meet near wall and front clear width requirements.

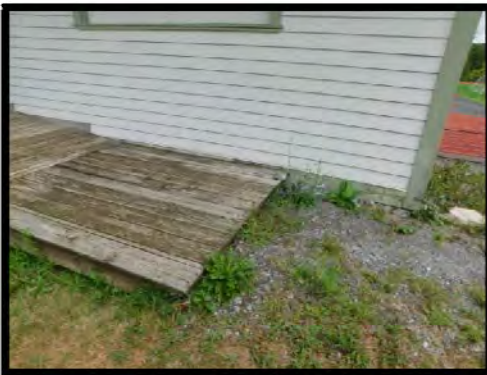
Photo Harvard Field 3

The exterior door and 2 interior doors have non-compliant knob-style hardware.	404.2	26.11	Replace the hardware with lever-style hardware.	2	2	I	\$225
The 2 interior doors lack tactile designation signage.  See Photos Harvard Field 3, 4, and 5.	703	41	Install accessible compliant tactile designation signage on the latch side of the doors with appropriate finish and contrast and character height and proportions, raised and Brailled characters should also be included. Tactile characters on signs s/b 48" min. a.f.f.. from the baseline of the lowest character and 60" max. a.f.f. to the baseline of the highest character. Under 521 CMR, signage s/b 60" a.f.f. to the centerline of the sign. Characters must meet the ADA Standards for character height, finish and contrast, accompanied by Grade 2 Braille (703 ADA Standards).	2	2	I	\$50
<b>Accessible Routes of Travel</b> <b>Bleachers and Benches</b> There is no accessible route of travel to the bleachers and benches on the grass near the parking lot. In addition, there are no level areas for a wheelchair next to the bleachers or benches.	403	22	An accessible route of travel needs to be provided to all areas available to the public. Construct an accessible route of travel fully to the bleachers, benches, and McCurdy Memorial and bench area. The accessible route of travel must be compliant with width (48" per 521 CMR) and slope (2% max. cross, 5% max. running) requirements as well as changes in level surface (no > than ¼" unbeveled or between ¼" and ½" beveled w/a slope of no > 1:2). Create an approach and wheelchair level area at the bleachers. The space should be 36" wide x 60" deep per wheelchair. If a front/rear approach, the depth can be reduced to 48" as opposed to 60" for a side approach. Construction options include compacted stone dust, asphalt or similar surfaces that meet the requirement of stable, firm, and slip resistant. Costs will vary depending on material used.	2	2	N	\$1,500 to \$3,500+

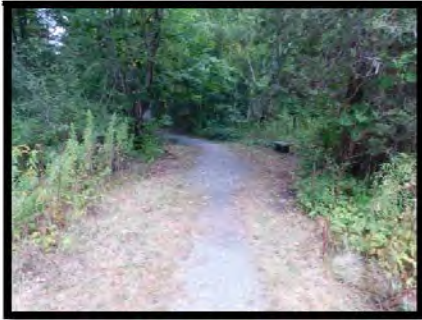
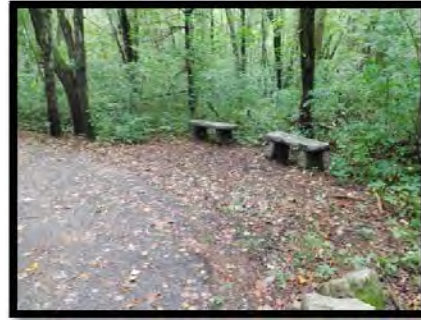
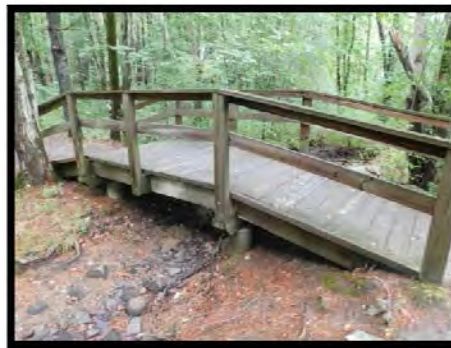
**General Description or Obstacle Which Limits Mobility or Access:** The initial trail segment from the Harvard Park parking area has vegetative overgrowth and a reduced clear width to only 32". Segments of the trail have some coarse stone creating an unstable surface. A bridge at an intermittent stream crossing at the trail head near the playground has running slopes of up to 22%, lacks compliant railings, and has transitional abrupt changes in level surface of up to 1". As there is no maintained accessible route of travel to the stream crossing/bridge from the field and playground area, the cost to construct an accessible compliant stream crossing to successfully meet high water conditions would be excessive, and there is an adjacent accessible route to the recreational trail, no further action to the bridge is required at the present time.

**Recommended Action:** Should the town initiate and expand upon improvements to this property to enhance overall site accessibility and usage, then modifications to the bridge/stream crossing should be considered at that time. Current actions should include maintenance of the existing stone dust trail to remove vegetative overgrowth and ensure a 48" walkway with a minimum 36" clear width. Additional stone dust should be provided as needed and spread and compacted to ensure for a firm, stable, and slip resistant surface.

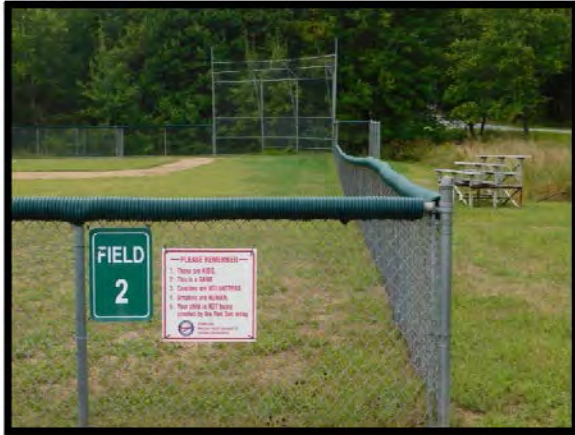
Photo Ryan 1

**General Description or Obstacle Which Limits Mobility or Access:** There is no designated accessible parking. There is no accessible route of travel to the ballfields, bleachers, and player's seating. The accessible route to the portable toilet is overgrown. There are excessive abrupt changes in level surface at the dugout areas and insufficient clear width at the fence openings from the player's seating to the fields. The portable "accessible" toilet has numerous areas of non-compliance including a too fast door closing speed, an interior pull device and locking mechanism that is not easily operable with a closed fist or loose grip, a soap dispenser that is too high, a toilet paper dispenser that is located over the grab bars and is too close to the front of the toilet, a toilet that is too high and which does not meet near wall and front clear width requirements.

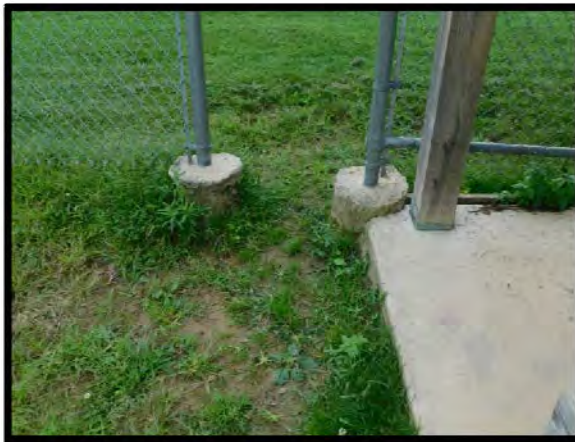
Photo Ryan 3

<p><b>Portable Accessible Toilet</b></p> <p>The portable "accessible" toilet is not ADA compliant as the soap dispenser is too high; the toilet paper dispenser is located over the grab bars and is too close to the front of the toilet; the toilet is ½" too high, 2" too close to the near wall and 10" too close to the door in front of the toilet; and the door closing speed is too fast. In addition, the interior pull device and locking mechanism are constructed in a manner that makes it difficult to operate with a loose grip or closed fist.</p> <p>See Photos Ryan 4.</p>	308 604.7 604.4 604.2 604.3 309.4 404.2	30.12 30.7.6 30.8.5 30.7.2 26.9 26.11	Replace the existing portable "accessible" toilet with an ADA Compliant toilet such that soap/towel dispensers are no more than 42" a.f.f.; the toilet paper dispenser s/b a minimum of 24" a.f.f. and s/b 7" min. to 9" max. in front of the water closet measured to the centerline of the dispenser; the height of the water closet s/b 17" to 19" a.f.f. to the top of the seat; the water closet s/b 18" from the nearest sidewall, at least 42" from the farthest sidewall, and 42" from the front of the water closet to the nearest wall or fixture; and a door closing speed that is at least 6 seconds. Nothing should be mounted over the grab bars. The door pull and locking mechanism needs to be modified such that they are both operable with a loose grip or closed fist.	3	2	I	TBD

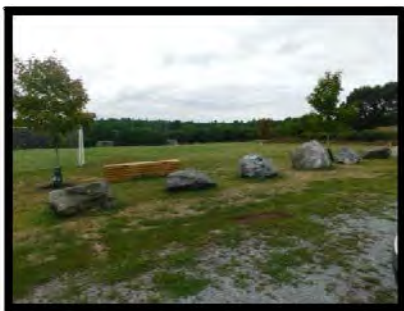
Photo Depot 1

**General Description or Obstacle Which Limits Mobility or Access:** There is no designated accessible parking. There is no accessible route of travel to the soccer fields, player’s benches, bleachers, portable toilet and waste disposal bins. There are no level areas for a wheelchair at the bleachers. The portable “accessible” toilet has numerous areas of non-compliance including a too fast door closing speed; an interior pull device and locking mechanism that is not easily operable with a closed fist or loose grip; a soap dispenser that is too high and located over the grab bars; a toilet paper dispenser that is too high, is located over the grab bars, and is too close to the front of the toilet; a toilet that is too high and which does not meet near wall and front clear width requirements.

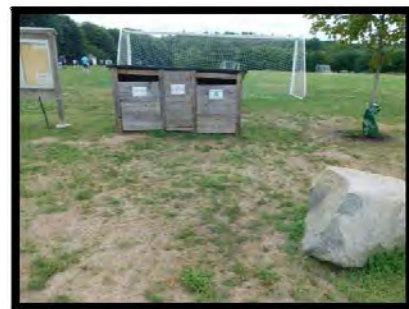
Photo Depot 2

<p><b>Portable Accessible Toilet</b></p> <p>The portable "accessible" toilet is not ADA compliant as the soap dispenser is too high and located over the grab bars; the toilet paper dispenser is too high, is located over the grab bars, and is too close to the front of the toilet; the toilet is ½" too high, 2" too close to the near wall and 10" too close to the door in front of the toilet; and the door closing speed is too fast. In addition, the interior pull device and locking mechanism are constructed in a manner that makes it difficult to operate with a loose grip or closed fist.</p>	308 604.7 604.4 604.2 604.3 309.4 404.2	30.12 30.7.6 30.8.5 30.7.2 26.9 26.11	Replace the existing portable "accessible" toilet with an ADA Compliant toilet such that soap/towel dispensers are no more than 42" a.f.f.; the toilet paper dispenser s/b a minimum of 24" a.f.f. and s/b 7" min. to 9" max. in front of the water closet measured to the centerline of the dispenser; the height of the water closet s/b 17" to 19" a.f.f. to the top of the seat; the water closet s/b 18" from the nearest sidewall, at least 42" from the farthest sidewall, and 42" from the front of the water closet to the nearest wall or fixture; and a door closing speed that is at least 6 seconds. Nothing should be mounted over the grab bars. The door pull and locking mechanism needs to be modified such that they are both operable with a loose grip or closed fist.	3	2	I	TBD

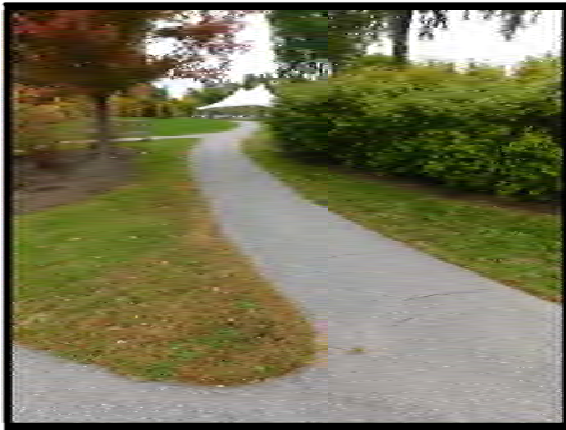
Photo Field 1

**General Description or Obstacle Which Limits Mobility or Access:** The paved walkway to the field area(s) has a running slope of up to 5.3% to 5.4% in a few locations. The granite/brick steps from the library parking to the field area lack railings. There is no accessible route of travel to the field areas as the surface is grass only.

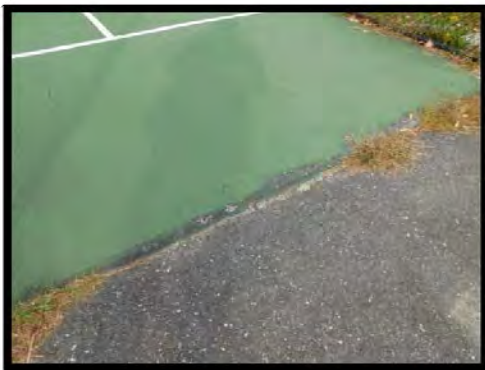
Photo Courts 1

**General Description or Obstacle Which Limits Mobility or Access:** There are up to 2” abrupt changes in elevation into the basketball and tennis courts. The chain link gate into the tennis courts is not smooth at the base. The 2 benches and 2 picnic tables are not on an accessible route of travel, there is no level area for a wheelchair at the benches, and the picnic tables lack compliant knee depth.

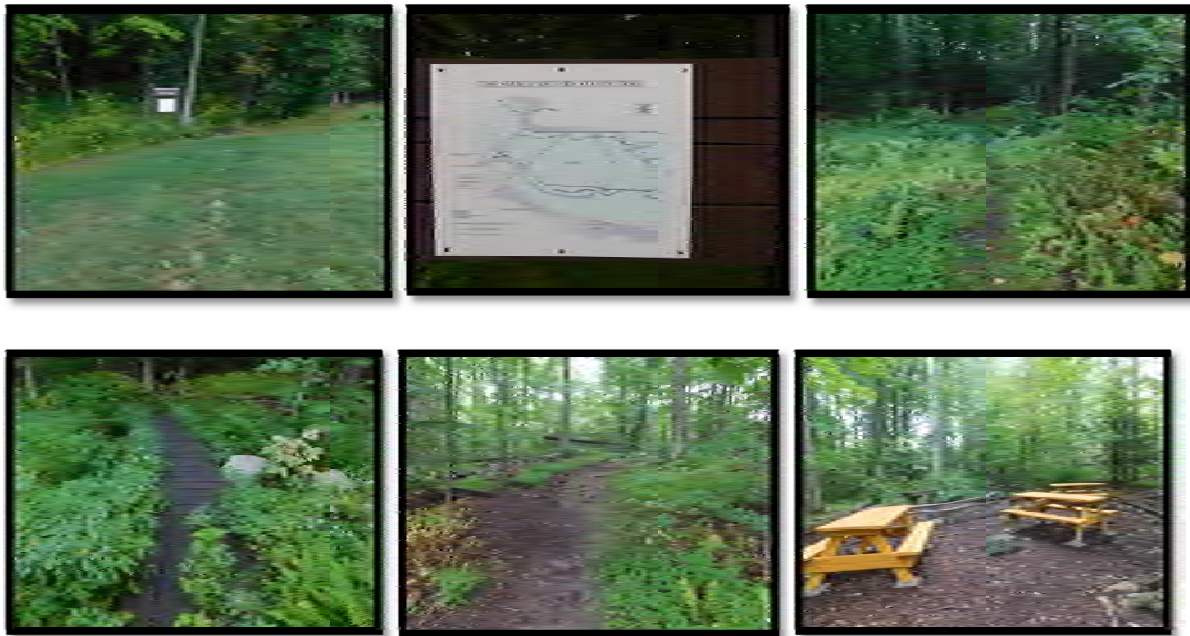
Photos of Hildredth Elementary School Outdoor Classroom and Nature Trail

As the cost to construct an accessible route to the “classroom” area would far exceed the use of the facility and the benefit gained, no further construction modifications should be considered. However, reasonable accommodations or a relocation of “outdoor classroom” services to an accessible outside location would be required if necessitated by a mobility limited student who cannot navigate the nature trail.

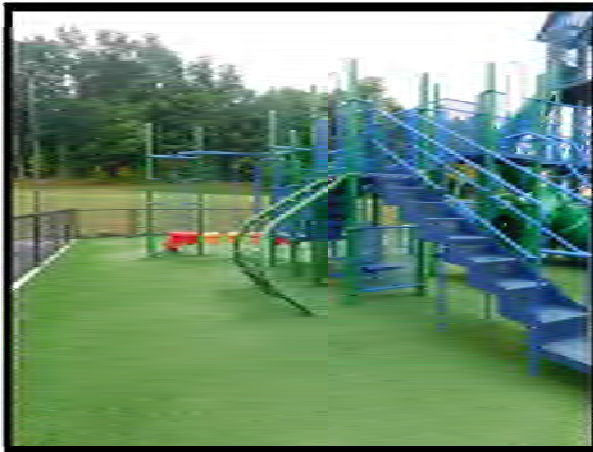
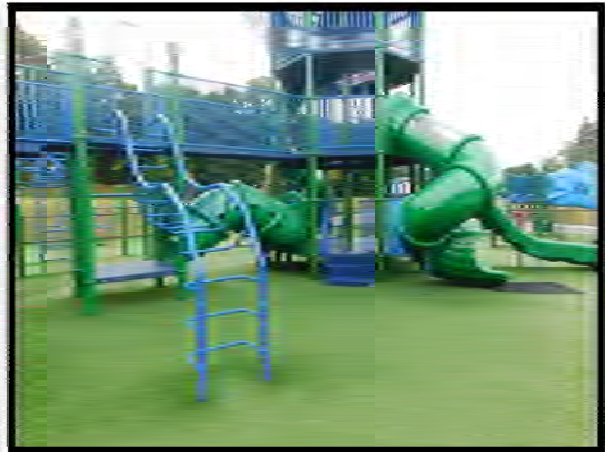
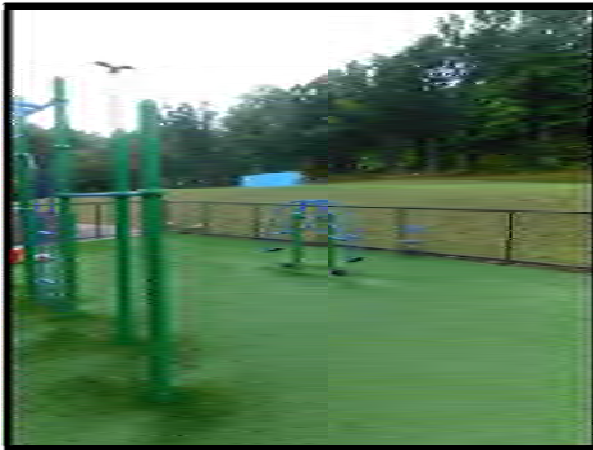
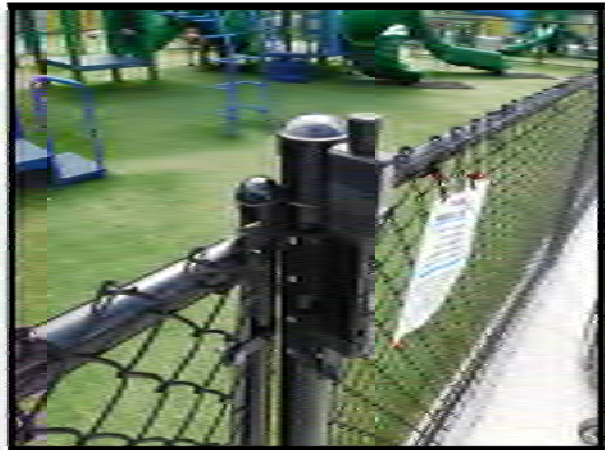
Photos of Hildredth Elementary School Playground

**General Description or Obstacle Which Limits Mobility or Access:** The playground is accessible with an accessible route of travel and compliant ground surfaces. The two chain link gates to the playground are not smooth at the base on the push side of the gates. The opening/locking mechanisms for the gates are too high and require pinching and twisting of the wrist. Although play equipment is on an accessible route of travel, the playscapes and ground components offer little in terms of accessible features. It is recommended that accessible features be added to the playscapes, ground components, and swings.

<u>General Description of Obstacle</u>	<u>2010 ADAAG</u>	<u>MAAB 521 CMR</u>	<u>Type of Action to be Taken</u>	<u>P</u>	<u>F</u>	<u>TF</u>	<u>Cost Estimate</u>
<p><b><u>Exterior Chain Link Gates to Playground</u></b>                      The gates to the playground do not comply with the 2010 ADA Standards for a smooth surface within 10 inches of the ground on the push side for the full width of the gate. In addition, the gates have operating hardware that is 4½" too high and requires pinching and twisting of the wrist.</p> <p>See Photo HES 6.</p>	404.2.10 308.2 308.3 309.4	NA 6.5 6.6 39.5	Remove the gates or install smooth plating at the base of the gates. Replace the opening and closing hardware with hardware that can be operated with a loose grip or closed fist and is at a height of no more than 48" a.f.f.	2	2	I	Up to \$350

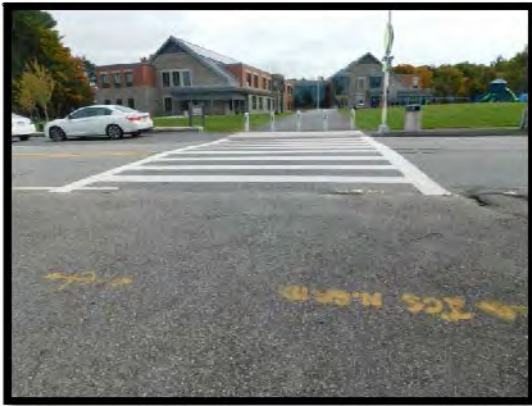
Photo 1

- There is no detectable warning strip on the crossing from the elementary school to the library fields and Bromfield Field. **See Photo 1.**
- There is no detectable warning strip on one side of the crosswalk at the elementary school main entrance driveway. **See Photo 2.**
- The crosswalk across Massachusetts Avenue at the Bromfield School entrance empties into sand and soil on one side and grass and soil on the opposite side with no curb ramps or detectable warning strips. **See Photo 3.**
- There is signage for a crosswalk near Pond Road across Massachusetts Avenue but no formal crosswalk or curb ramps exist.

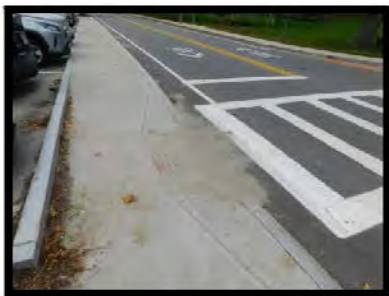
Photo 4

- There is an accumulation of sand and debris at the curb cut at Still River Road on the general store side. [See Photo 4.](#)
- The telephone guy wire in the sidewalk on the Large Common side is a protruding object on the approach from Elm Street. (*Note: Guy wires should be a straight vertical and attached to the telephone pole with an accompanying support arm*). [See Photo 5.](#)

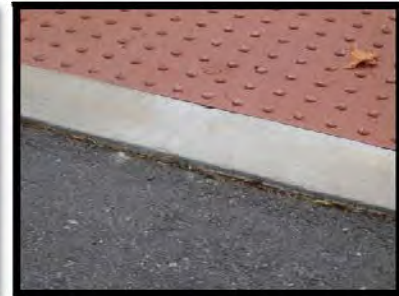
Photo 6

- The telephone guy wire at the end of the sidewalk on Elm Street is a protruding object
- The curb cuts on both sides of Still River Road near the Congregational Church and Elm Street have ½” unbeveled abrupt changes in level surface at the transition from asphalt to concrete. [See Photo 6.](#)

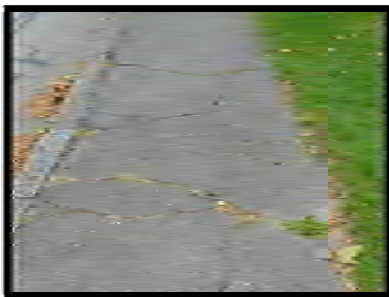
Photo 7

- The asphalt sidewalk on Elm Street is deteriorated and has numerous areas of heaving. [See Photo 7.](#)
- The telephone pole in the middle of the sidewalk on Elm Street reduces the clear width to 19” and 22” respectively, which is far less than the minimum required 36”. [See Photo 8.](#)

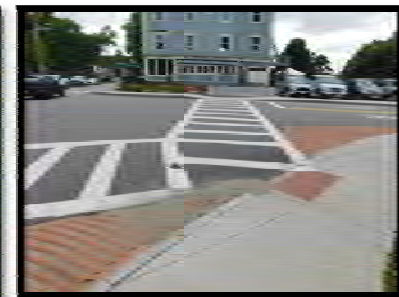
Photo 9

- The crosswalk across Still River Road near Ayer Road from the Large Common to the General Store is an apex-type curb ramp with one curb ramp serving 2 separate crosswalks. (*Note: When site constraints prevent the installation of a perpendicular curb cut or a parallel curb cut with a level landing an apex curb cut is allowed*). It is not clear if such constraints are met at this curb ramp and crosswalk. [See Photo 9.](#)

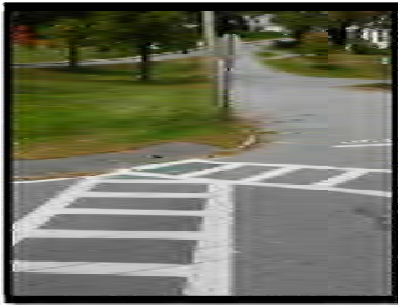
Photo 10

- There are 3 apex type curb ramps/cross walks. [See Photo 10.](#)
- None of the curb ramps (5) have detectable warning strips. [See Photo 11.](#)
- The crosswalk across Fairbanks Street at Old Littleton Road empties into 7" granite curbing on one side and grass/dirt on the opposite side. In addition, catch basins with openings of greater than 1½" are located on both sides in the middle of the cross walk at the edge of the street. [See Photo 12.](#)
- The curb ramp on the Small Common side from the crosswalk across Fairbanks lacks a level landing. [See Photo 10.](#)
