Feasibility and Space Needs Study

# HARVARD FIRE HEADQUARTERS

HARVARD, MASSACHUSETTS

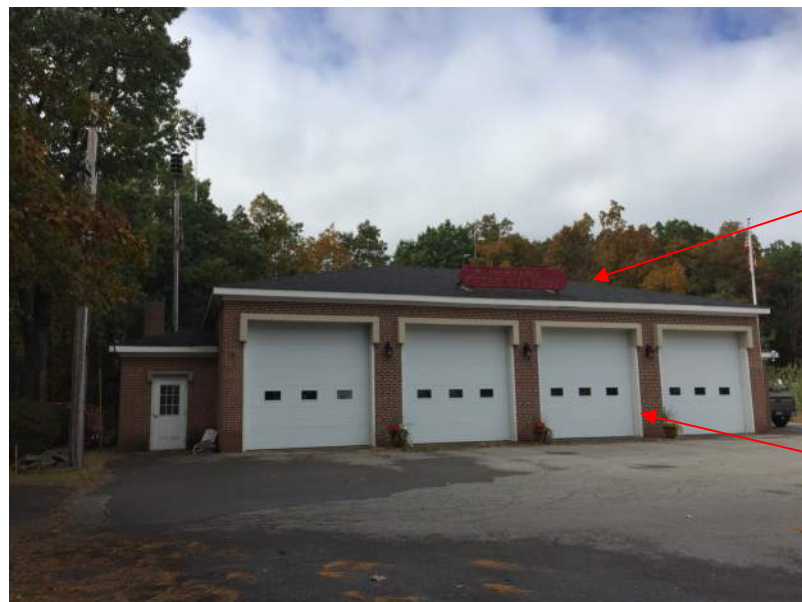
Slope steel joist  
roof system

Typical masonry  
load bearing walls

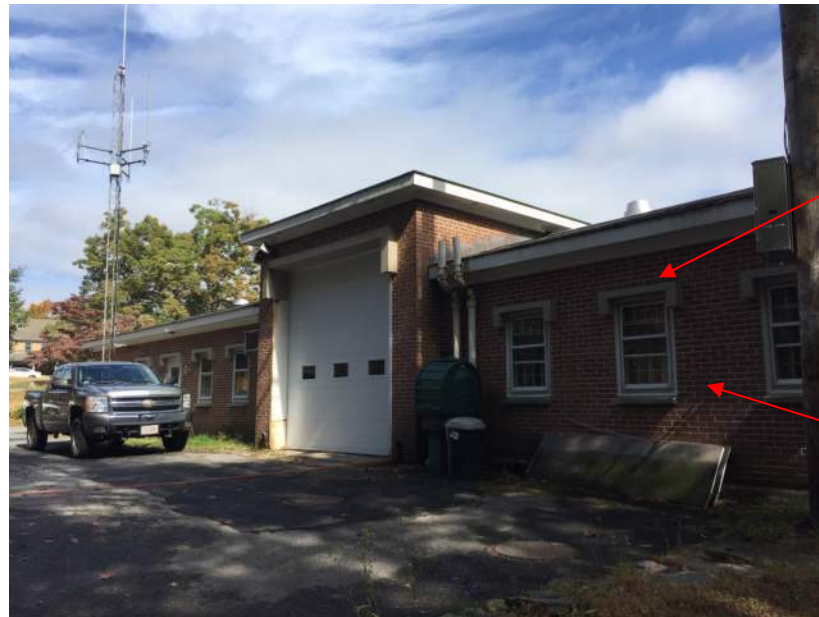
**West Elevation Photo 3**

Precast window  
lintels typical

Typical masonry  
load bearing walls

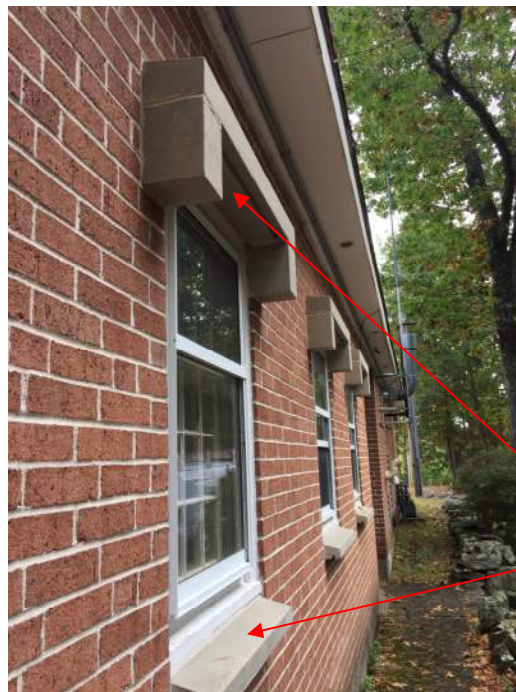
**Existing precast lintels and sills Photo 5**

Precast window  
sill and lintel

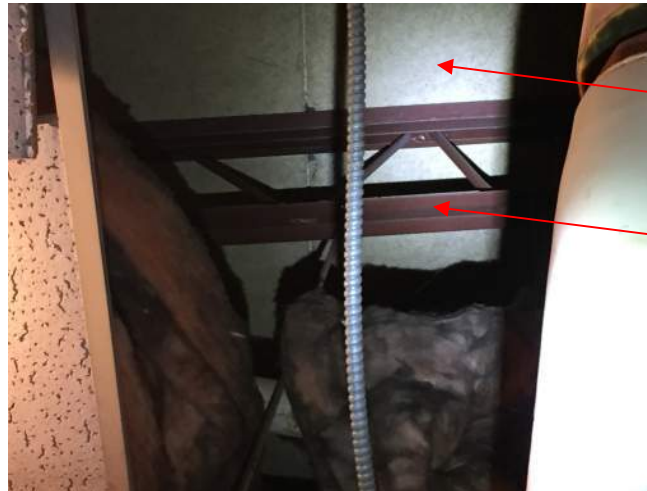
**Sloped roof joists and Tectum roof decking Photo 6**

Tectum roof decking

Existing open web  
steel roof joists

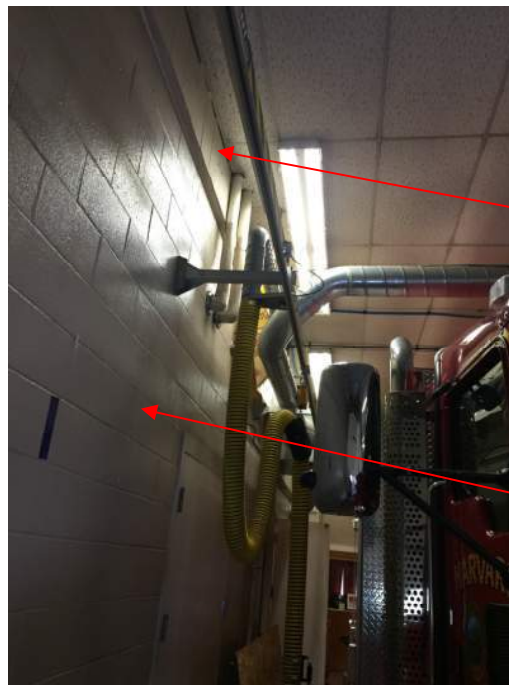
1. The 6" existing bearing walls are unreinforced and would need to be upgraded. The existing 6" un-reinforced masonry wall has very low shear resistance when the walls are used in a bearing shear wall configuration as they are in this building.
2. The connection of the 8" continuous bond beam to the lower 6" load bearing wall interface would need to be addressed. Refer to photo 10 attached below.
3. The front (east) elevation has large garage door openings with only 3' wide masonry wall pilasters in between each door thus there is very low lateral resistance in this end wall.

Transition between 6"  
and 8" masonry wall,  
refer to photo 10 below

6" load bearing  
masonry wall

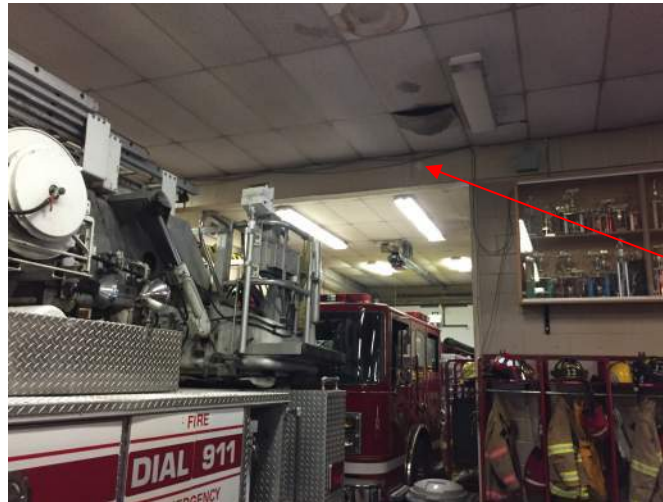
**Masonry beam over rear bay wall opening Photo 8**

Reinforced  
masonry beam

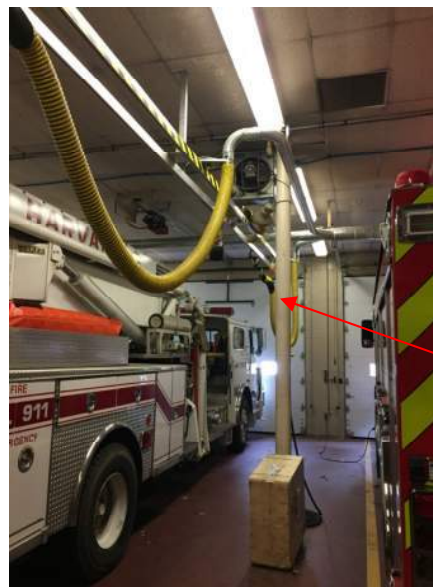
**Interior column inside the apparatus bay Photo 9**

Typical steel column  
support typical of 3  
locations inside the  
apparatus bay

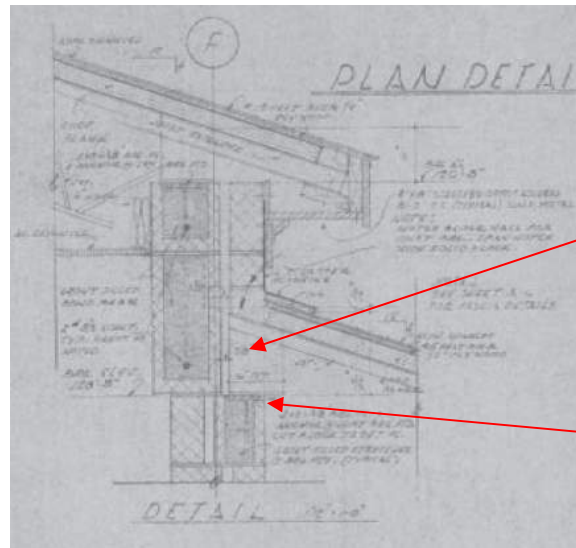
**Existing 8" masonry stacked on top of 6" Photo 10**

8" CMU upper wall stacked and not mechanically connected to the 6" CMU below

The 4" brick veneer is used to support vertical loading of the low roof

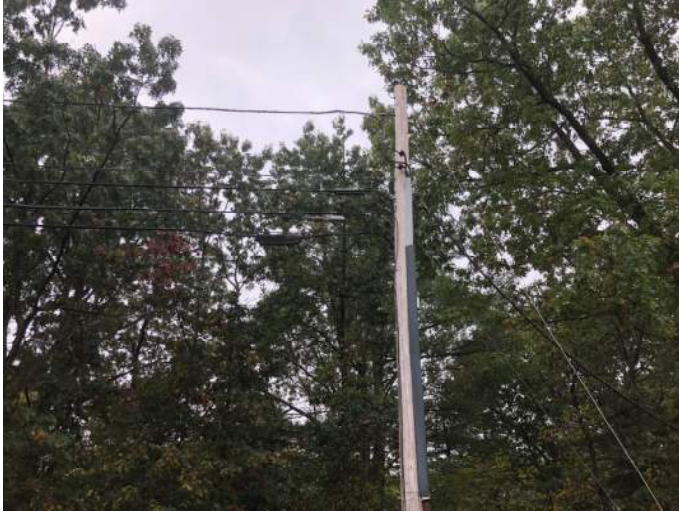
Utility Riser Pole

1. The building is served by an underground electrical service fed via an existing utility pole which is located adjacent to the southeast corner of the building.

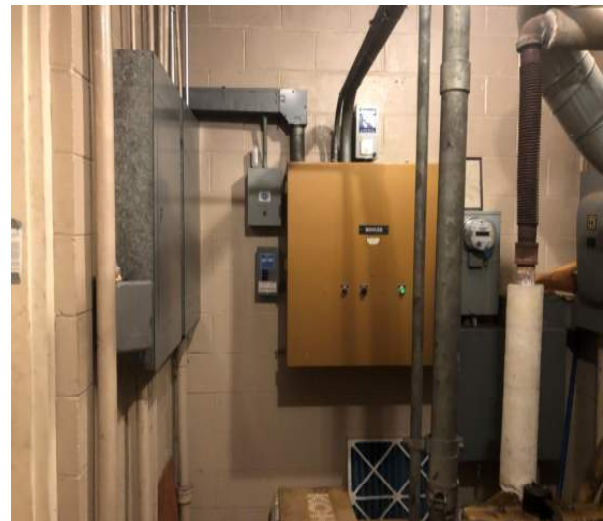
Electrical Equipment in Mechanical-Electrical Room

2. The electrical service is rated 300 amperes, 120/240 volt, 1 phase, 3 wire. The main disconnect switch, utility C/T cabinet and meter, automatic transfer switch/generator, and the building electrical panel are located within the building's mechanical-electrical room. The electric service conductors are routed from the main disconnect switch via the automatic transfer switch. This arrangement connects the panel and all associated loads to the generator (except the Plymovent system), however the standby generator can only provide 104 amperes.

3. The building is equipped with a single double-tub electrical panel which serves all loads/equipment (except the Plymovent system). The panelboard appears to be original to the building's construction and currently does not have space for the installation of additional circuit breakers (panel is full). It

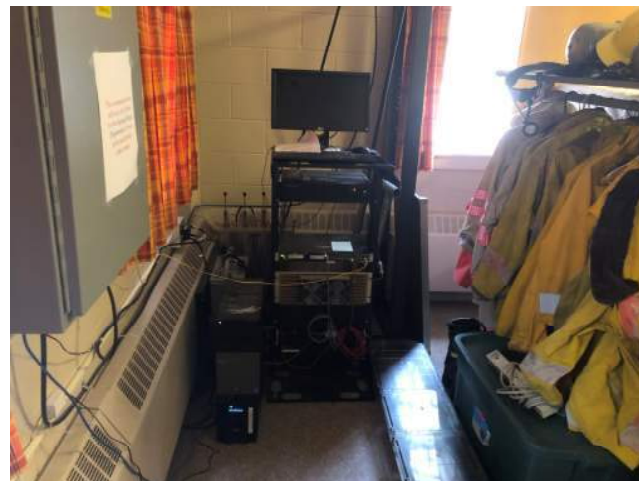
Tel/Data Equipment Rack

1. The telephone and data services to the building originate at the utility pole located at the southeast corner of the building. Tel/data service cables are routed overhead from this pole into the building's hose room and is distributed from this location to rack mounted equipment in the bunk room.

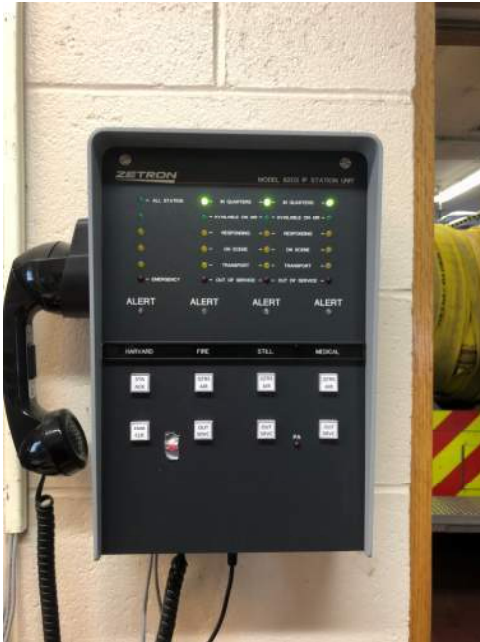
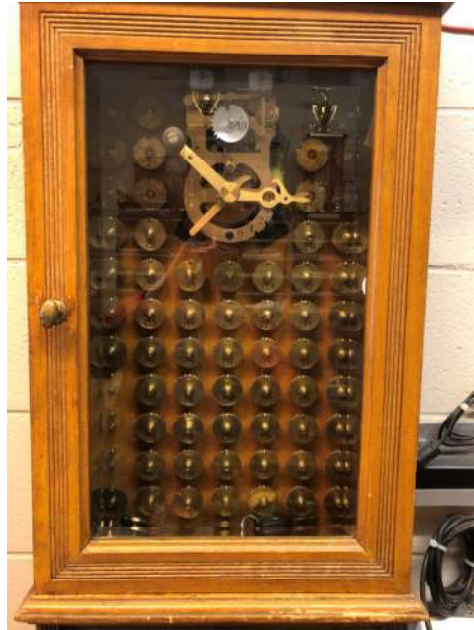
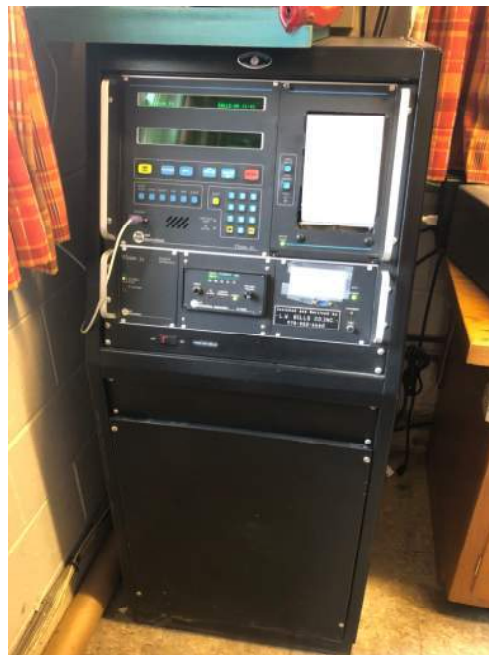
Control Room Fire Alarm Monitoring Equipment

2. The building's tel/data equipment rack is located in the southwest corner of the bunk room along with radio transmission filtering/equipment. Central fire alarm monitoring/receiving equipment for the Town's master boxes is located within the control room.

3. In general, tel/data system wiring appears to be adequate, although installed in a somewhat haphazard manner in a few locations.

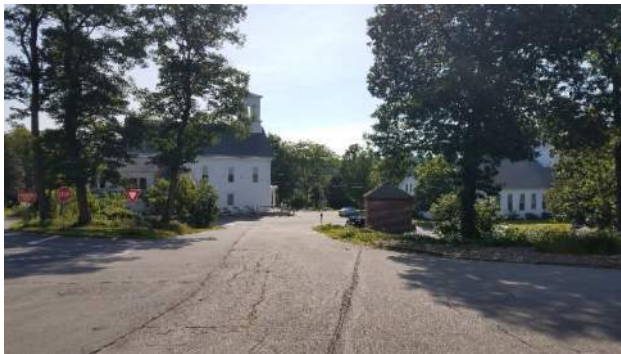
The site can be accessed from Ayer Road via an unnamed one-way drive just north of Town Hall or from Elm Street, which is also one-way and come in from the south. Fire response vehicles must navigate a 360-foot course to Ayer Road consisting of a ten (10) percent grade change, a slalom like zigzag between the Town Hall and First Congregationalist Unitarian Church and parking lots with potential vehicular or pedestrian conflicts along the way. Site lines at Ayer Road are approximately 250 feet to the north and 300 + feet to the south toward the intersection of Fairbank Street and Ayer Road

*Apparatus access drive down from Station*

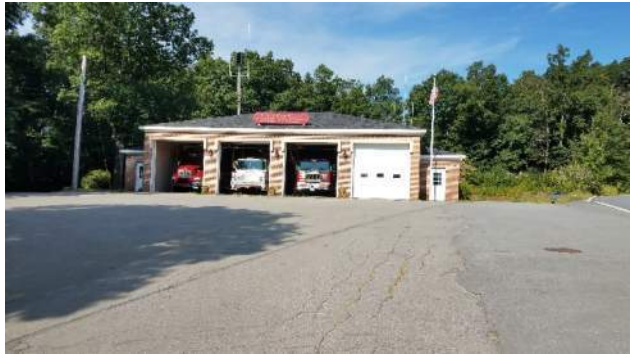
*Station front and apron area*

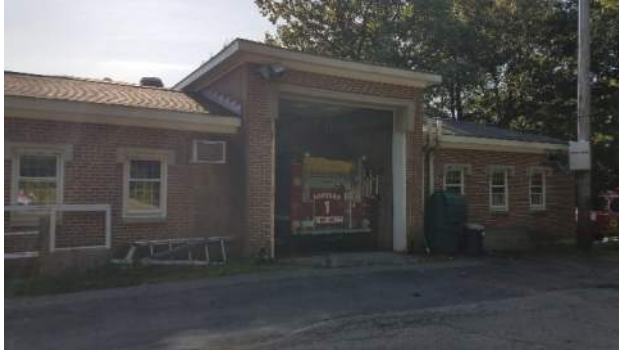
*Rear of Station, trash cans.*

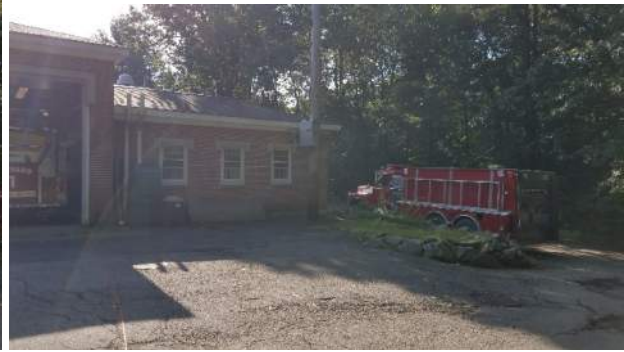
*Fire apparatus parked outside.*

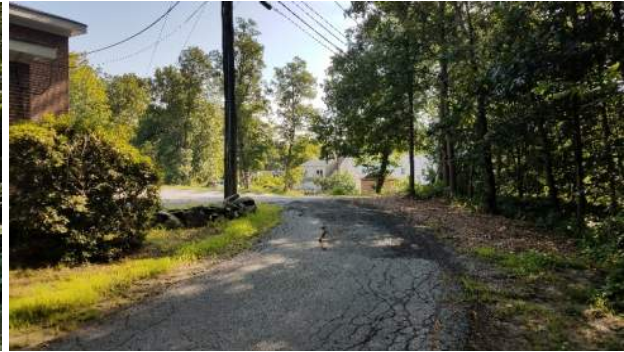
*Binder course visible.*
