## SELECT BOARD

Tuesday, December 7, 2021

**Department of Public Works Facility  
Garage, Facility Analysis and Space  
Needs Assessment  
Harvard, Massachusetts  
November 3, 2021**

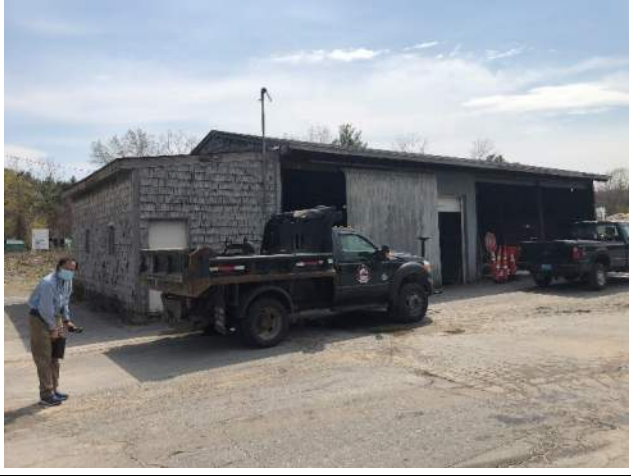
1.

The Pole Barn Storage Garage is a single-story wood frame structure in poor condition with various additions over the years to accommodate the increasing variety and quantities of materials and equipment. Date of original construction is unknown and there are no existing documentation of the building.

General view of the Pole Barn / Storage Garage.
2.

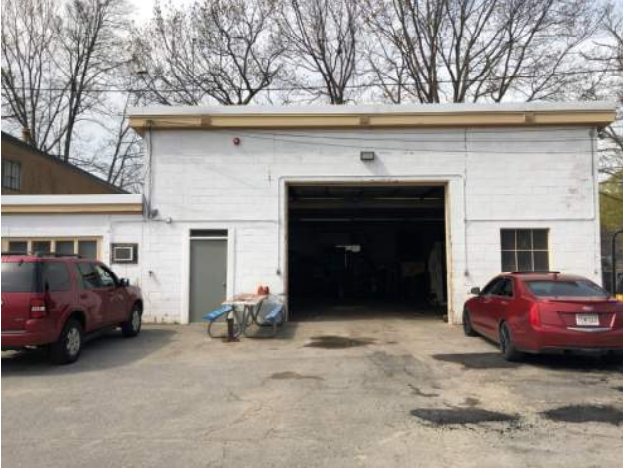
1.

The mechanic's service garage is the oldest building on site according to DPW. There are no existing conditions drawings to verify date of construction. It is single-story constructed of single wythe concrete masonry block walls with fixed wood single plane glazed windows. (refer to Photograph 1). There is one (1) garage bay with and a motorized overhead metal door. There is a small office in the rear for the mechanic. There are parts and tool storage scattered throughout the garage. The low ceiling in the mechanic garage restricts servicing larger vehicles on the auto floor lifts. (refer to Photograph 2).

General view of mechanic's service garage.
2.

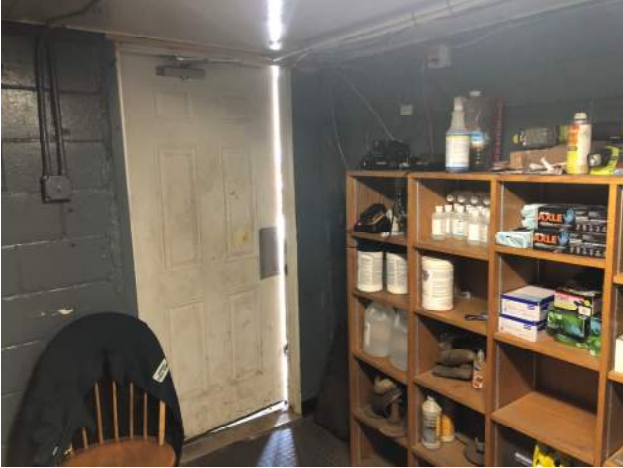
The building is connected to the office and locker space via a corridor. (refer to Photograph 3). According to existing documentation. The original "ballasted" roof was replaced with single ply membrane roof and R-30 roof insulation installed around 2010. The roof drains directly grade without perimeter gutters or downspouts. Overall, the building is in a deteriorated condition, it is drafty and uncomfortable for the staff.

Wood door from garage to the office locker space/corridor.

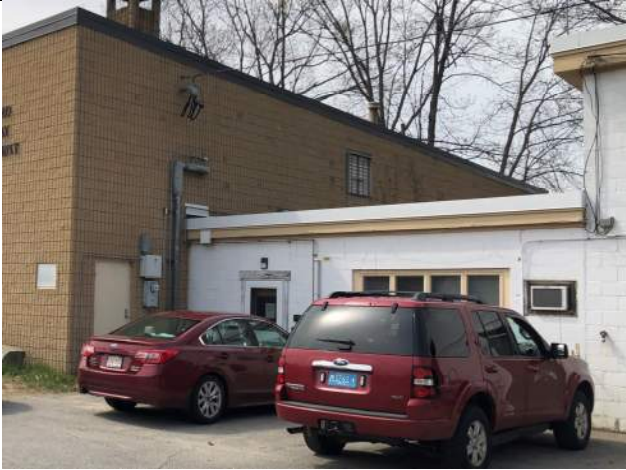
<p>1.</p>

<p>General view of the DPW Office "Connector" Building</p>
<p>2.</p>

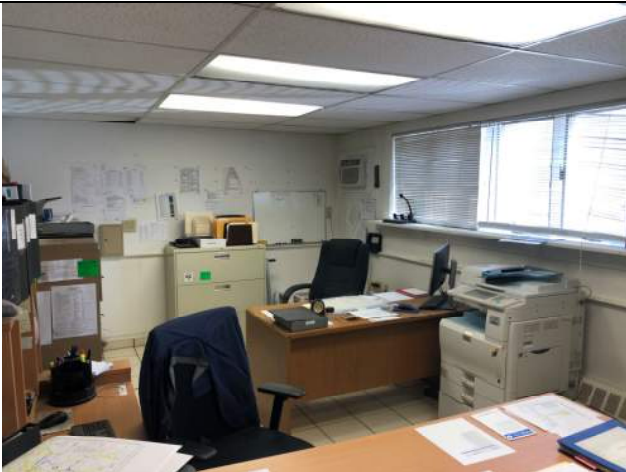
In general, the office storage capacity is inadequate with the office storage overflow located in the corridor. The use of the corridor for locker room changing area and for storage creates an egress safety hazardous condition. There is also the use of lack of privacy for the location of the lockers in the corridor.

<p>The DPW office includes two (2) desks for the DPW director and the foreman, and filing storage and copy machine</p>
<p>3.</p>

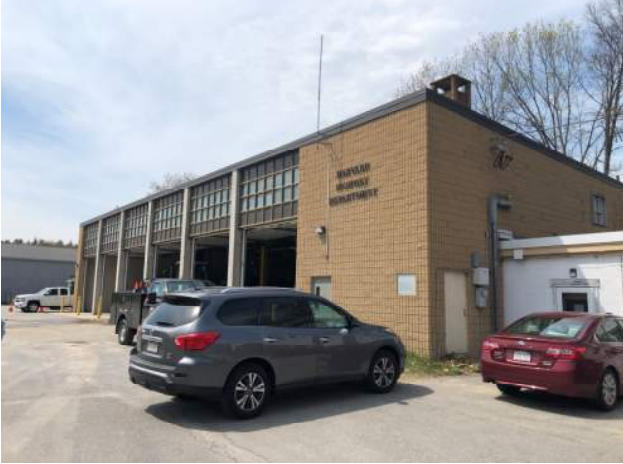
<p>1.</p>

<p>View of the Six Bay Vehicle Storage Garage adjacent to the Office “Connector” Building</p>
<p>2.</p>

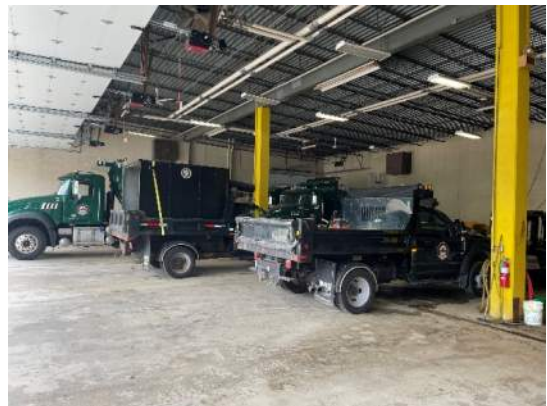
5. New Pole Barn: No heating, ventilating or air conditioning is planned.
6. Existing boiler, piping, etc. that has been abandoned in place in the mechanical room will be removed in its entirety.

**Six Bay Vehicle Storage Garage Propeller Wall Fan  
Abandoned Hot Water System  
Covered Propeller Wall Fan**

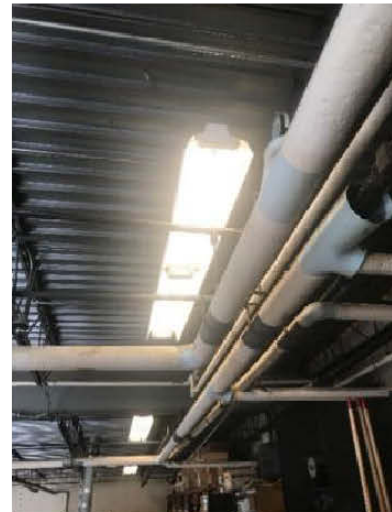
**Industrial Fluorescent Strip Lighting – Six Bay Vehicle Storage Garage**

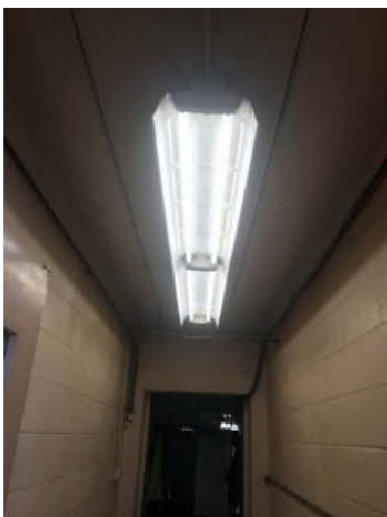
**Industrial Fluorescent Fixture - Corridor**

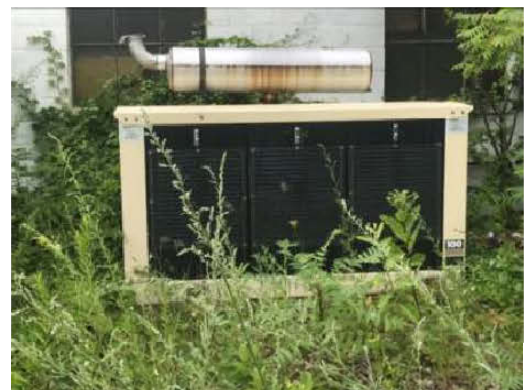
- Exit signs are illuminated (with the exception of one) but coverage is not adequate. The exit signs have approached their expected useful life.
- There is an existing exterior weatherproof enclosed propane generator, located in the exterior fenced-in area adjacent to the Mechanic's Service Garage. The generator was manufactured by Kohler. The rating of the generator is 100KW, 120/240V, 1-phase. The generator backs up the entire facility except the air compressors. The employees manually shut off the breakers for the compressors. It appears to be in good working condition, is maintained annually, exercised weekly, was installed in 2000. Continuing the maintenance and exercising, the generator has an additional 12 to 15 years of expected life. The generator turns on automatically when there is a utility outage, via the existing 400 Amp Kohler Automatic Transfer Switch. The ATS also appears to be in good condition with an additional 12 to 15 years remaining.

**100 KW, 120/240V 1-Phase Generator – Exterior Fenced -In Area**
