Exterior Conditions Assessment
Harvard Town Hall
Harvard, Massachusetts

Prepared for
The Town of Harvard
May 2011

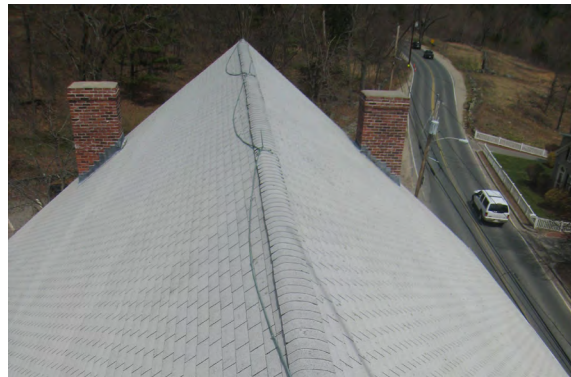
The asphalt shingles are weathered but have not reached the end of their anticipated life-cycle. There are areas of the roof where the shingles have raised as a result of the asphalt bonding giving way. There is also one section of missing shingle on the octagonal roof. Given the grade of shingle used on the roof we would anticipate that through minor maintenance the roofing could be expected to last another five years.

Main asphalt shingle roof with lightning protection system

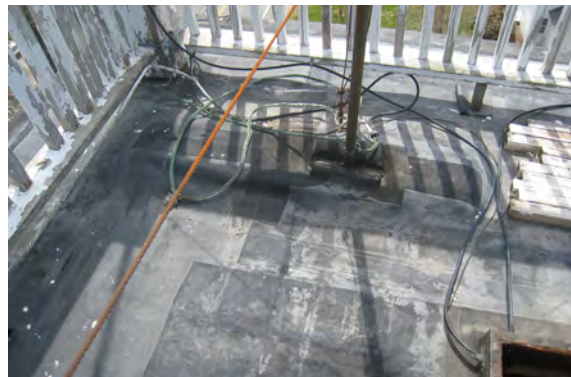
Black membrane roof on tower

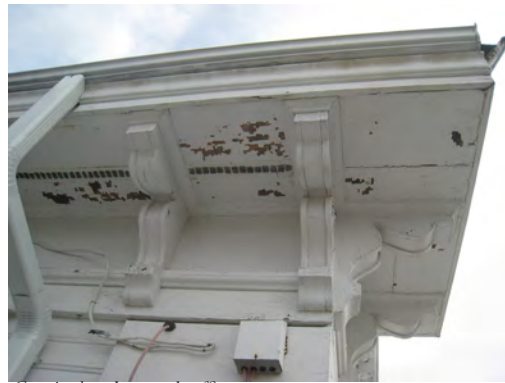
Cornice brackets and soffit.

We were able to observe and test the soundness of the soffit and eaves from the lift provided by the Town. Aside from the aforementioned rake and cornice deterioration, the soffit boards appeared generally sound with limited shrinkage separation between some boards. The paired brackets, some of which were reportedly replaced recently, proved to be in good condition except at the southeast corner where the southernmost brackets on the east side will need to be replaced.

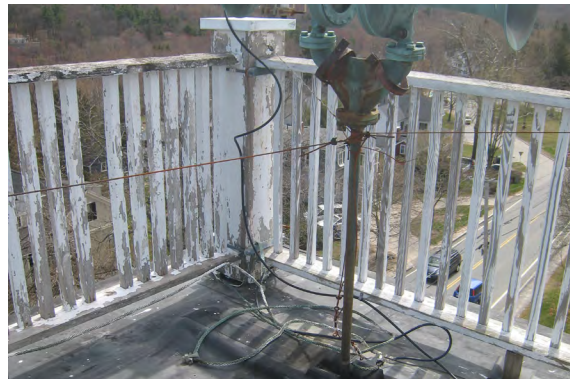
Weathered balustrade on tower.

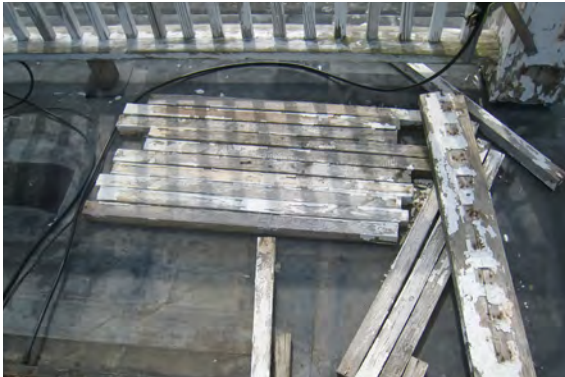
Balusters on tower roof

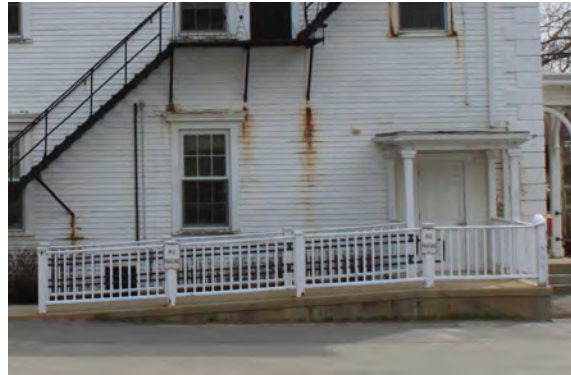
The wood railings of the two west entrances and the porch over the accessible entrance are rapidly deteriorating. These features were constructed of a low quality wood, probably fast growth softwood that does not hold up against the harsh weather of the North East. In fact, we saw more deterioration of these newer elements than of the 140 year- old wood features used in a similar manner. The bases of all the posts show specific areas of wear. This is an extremely vulnerable detail where the end grain of the wood sits upon a concrete base and absorbs water through the unfinished open end. There is also significant deterioration where the hand rails meet the posts.

Concrete ramp with wood hand rails on west elevation

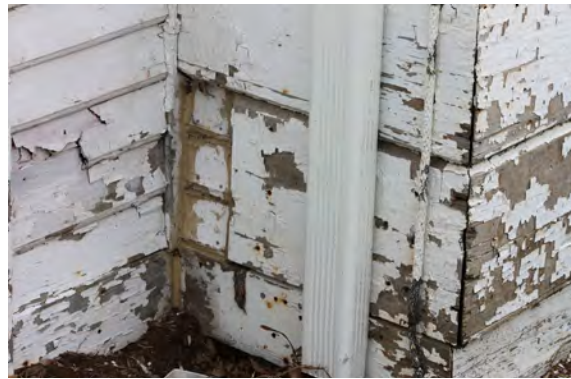
The quoins at the four main corners of the building are deteriorating. Of the four quoin locations, the southeast corner shows the most damage. Many of the quoins have been repaired with wood consolidant and sealant at their mitered corners, which have opened up over time. These repairs have begun to fail, allowing water to infiltrate into the sheathing behind and rot the quoins.

Consolidant material on wood clapboards

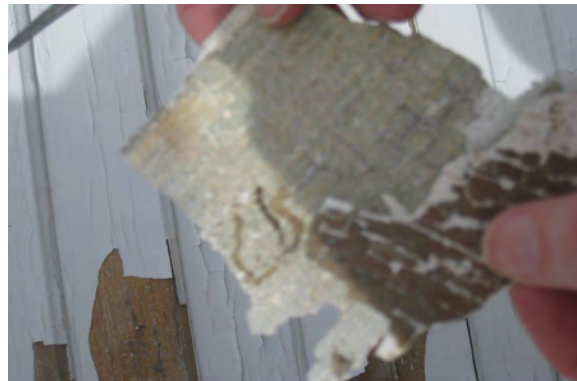
The likely culprit behind the paint failure is moisture. As damp air migrates through the interior wall it is trapped by the paint layer, which is relatively impermeable. The trapped moisture eventually causes failure of the adhesion of the paint to the wood. Modern latex based paints are less vapor permeable than oil based paints. Latex paints provide protection from external moisture but do not allow internal moisture to escape. Compared to historic oil based paints, latex paints also provide a weaker bond to the wood substrate, which may explain why the most recently painted side of the building is in the worst condition.

Piece of peeled paint

It is necessary to address the root cause of the paint failure prior to any further painting campaigns. Moisture migration through the walls is typically a sign of one or a combination of the following: water infiltration through holes in the building envelope; moisture caused by human activity such as bathroom and kitchen use, or even simply breathing; or rising dampness from a wet basement. Our survey of the building envelope showed no signs of water infiltration through the roof or wall systems and no leaking was reported during our investigation. While there are several bathrooms in the building and numerous full time employees, the amount of moisture introduced by these factors is unlikely to be responsible for the significant failures we are seeing. It therefore seems possible that rising dampness from the basement contributes to the cause of the paint failure.

Preventing future paint failure will require addressing moisture travel. In a substantial building renovation there will be opportunity to introduce interior vapor barriers.
