### TOWN OF HARVARD ZONING BOARD OF APPEALS AGENDA WEDNESDAY NOVEMBER 30, 2022 @ 7:00pm

Harvard Zoning Board of Appeals c/o Ms. Liz Allard Zoning Administrator 13 Ayer Road Harvard, MA 01451 RE: Nitsch Project #4095 Trail Ridge Construction Cost Estimate Harvard, Massachusetts

#### RE: Pine Hill Village Status Report Update

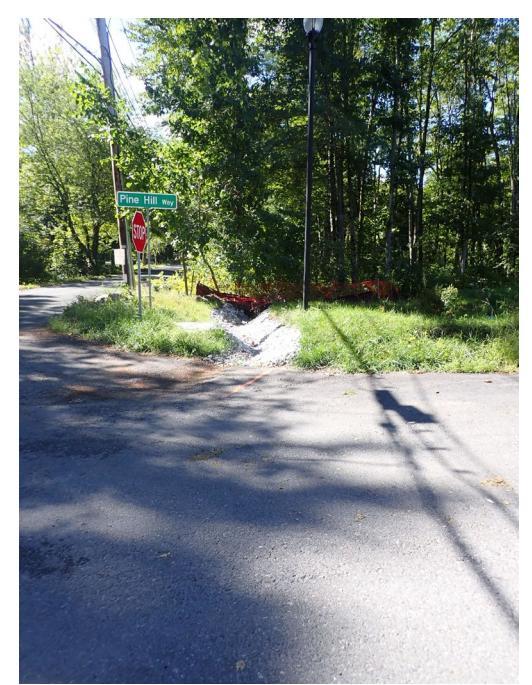
**Conservation Request:** Repair the drainage swale at the entrance off of Stow Road as shown in the detail provided by Markey & Rubin, Inc., dated December 1, 2021.

**Conservation Update:** The repair has not been completed. Haybales used to reduce silt from entering the drainage channel cause water to back-up within the swale leading to the channel.

**Updated Answer 10/20/2022:** The swale has been updated (regraded and stone lined) as per plan from Ian Rubin. **Conservation Update 11/10/2022:** Work completed as requested

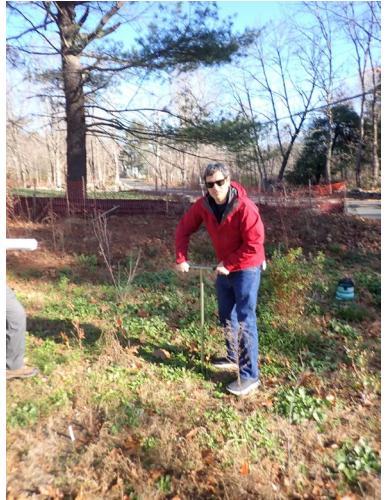
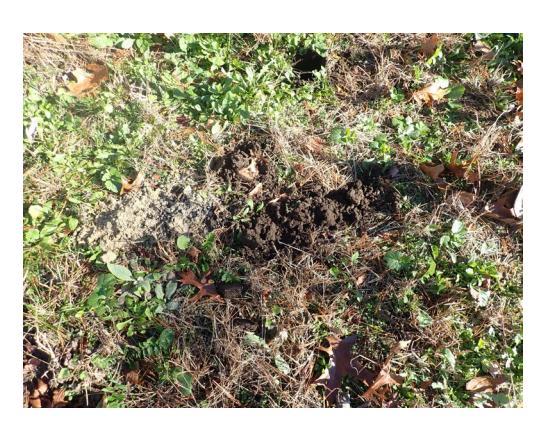
Conservation Request: Verify material to construct Rain Gardens #22 and 23

**Answer:** Bioretention soil mix was used. Please see attached for the receipts for the material that was used. **Conservation Update:** The material used to construct the rain gardens includes more than a bioretention seed mix. The Commission is seeking core samples be taken and witnessed by the Commission or the Nitsch Engineering to verify installation was done according to the approved plan.

**Conservation Update 11/10/2022:** Verification of materials used to construct the rain gardens was completed by Steve Ventresca, of Nitsch Engineering

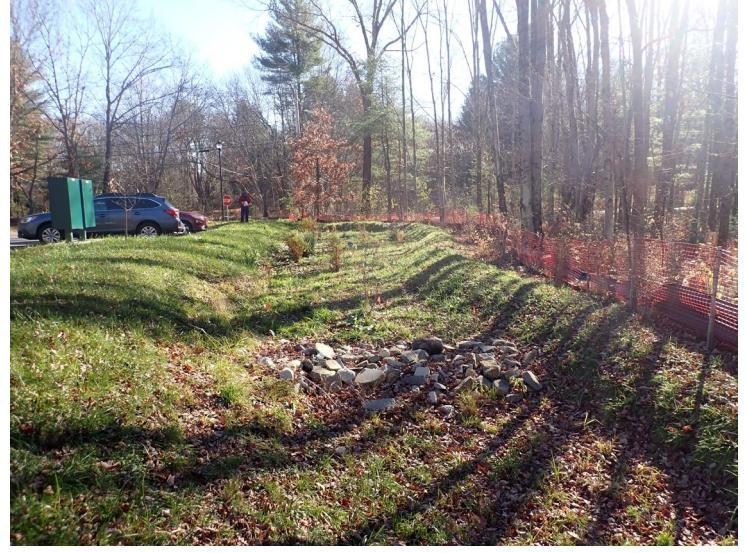
**Conservation Request:** Bioretention cell only has one riser pipe; detail shows two; verify one pipe is sufficient. **Answer:** Dan Boudreau is working on a letter to verify that one pipe is sufficient.

**Updated Answer 10/0/2022:** See attached letter from Dan Boudreau dated May 25, 2022 for the verification **Conservation Update 11/10/2022:** The stormwater model used to design the bioretention cell should be run again with only one riser pipe in order to provide clear evidence that one riser pipe is sufficient. This information shall be provided to Nitsch Engineering for review. In addition, the elevation of the forebay shall be compared to that of the rain garden as they appear to be of different elevations. The Notice of Intent Landscape Fencing and Planting Plan shows an elevation of 257 for the bottom of the forebay and rain garden and a rim of 257.8

**Conservation Request:** The rain gardens raisers have flat grates as opposed to rounded grates as shown on the approved detail; verify flat grates are acceptable

Answer: Dan Boudreau is working on a letter to verify that flat grates are acceptable.
Conservation Update: Verification has not occurred
Updated Answer 10/20/2022: The flat grates have been changed so that they are all rounded.
Conservation Update 11/10/2022: Request satisfied

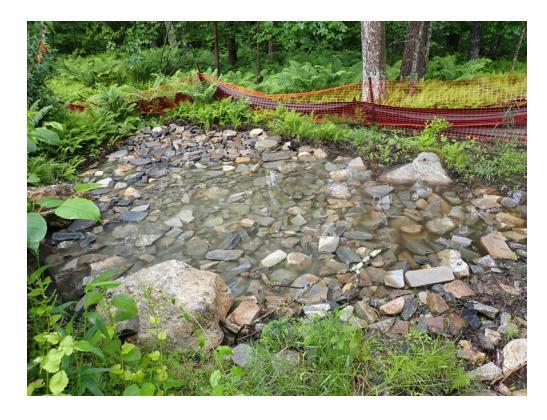
**Conservation Request:** The installation of the energy dissipation at the outlet at the constructed wetland should be verified with approved detail

**Conservation Update 11/10/2022:** The letter from Ian Rubin did not clarify the issue, which is the Conservation Agent, along with Nitsch Engineering, believes the energy dissipator is not deep enough to function as designed.

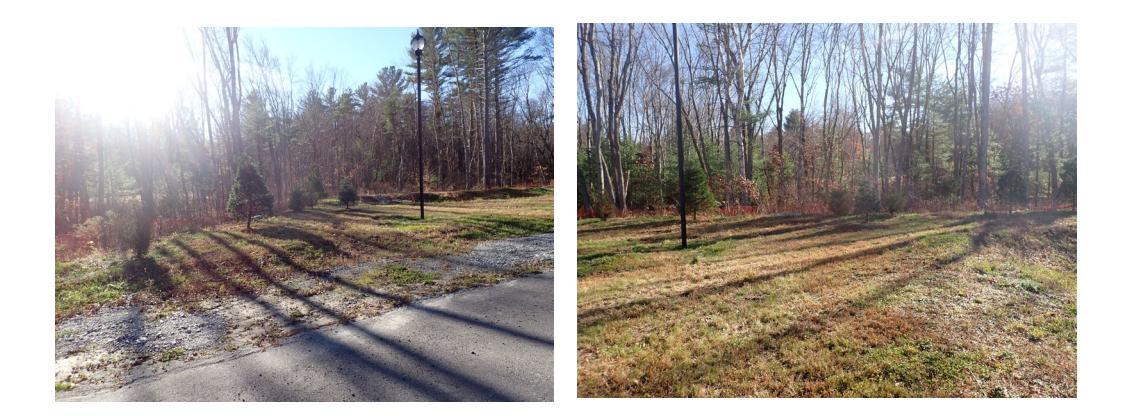
**Conservation Request:** Plantings around the constructed wetland are not consistent with the approved plan and some of the trees are dead; replacement plantings shall be in a random pattern.

**Answer:** Any dead trees or shrubs will be replaced in the spring and will be replaced in a random pattern. **Conservation Update:** Plantings have been replaced, however the area is well over grown and should be maintained to help reduce the spread on invasive plants.

**Conservation Update 11/10/2022:** Recommend this area be periodically mowed along with lawn areas around the units as part of the routine maintenance of the site and reduce the growth and spread of invasive plants.

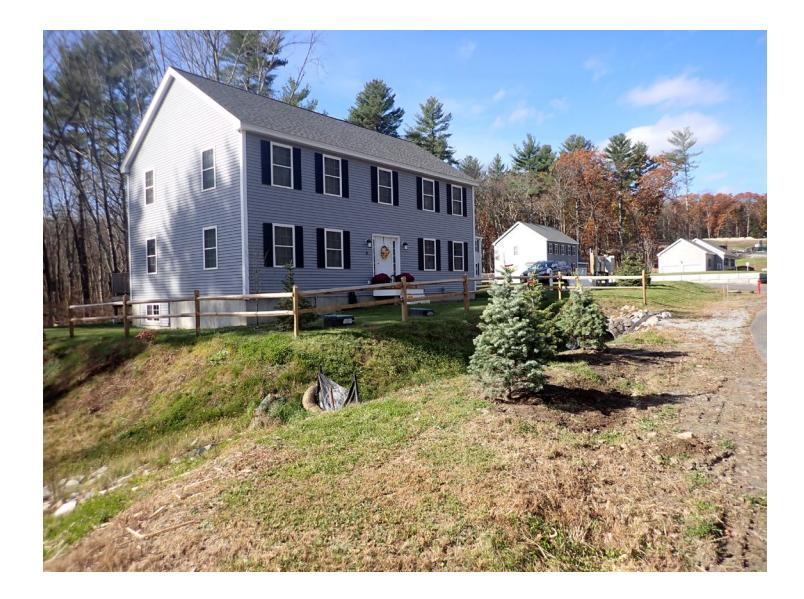
**Conservation Request:** Additional planting required in front of Units 1A and B as shown on the approved plan. **Answer:** Yes, this will be done per plan.

**Conservation Update:** Plantings are still not in accordance with the approved plan. **Updated Answer 10/20/2022:** The plantings have been installed. **Conservation Update 11/10/2022:** Work completed as requested

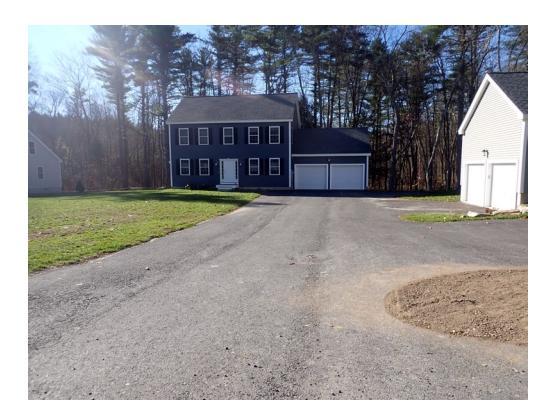
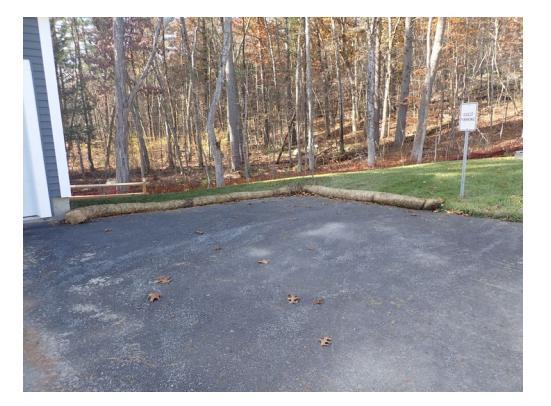
**Conservation Request:** Silt on the driveway for units 5 and 7 shall be removed before occupancy. **Answer:** This has been done

**Conservation Update:** Although a berm was installed at the entrance to the driveway silt continues to collect on the driveway between units 5 and 7 as water pools in that area during heavy rain events. The silt sock installed on the edge of the driveway near unit 5 has been removed without approval from the Commission. Silt laden waste is passing over grassy area before accumulating at the edge of the existing erosion control barrier.

**Conservation Update 11/10/2022:** Improvements made up hill of this site have eliminated silt accumulating in the driveway. The pooling of water will continue until the final coat is installed on the driveway. The silt sock has been replaced as requested.

**Updated Answer 10/20/2022:** A new hay wattle has been installed. Will install check dams on the shoulders of the roadway between stations 7+00 to +950. See Ian's plan page when the final coat of pavement gets put on.

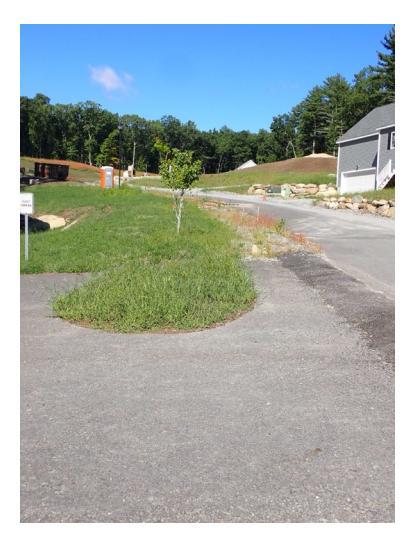
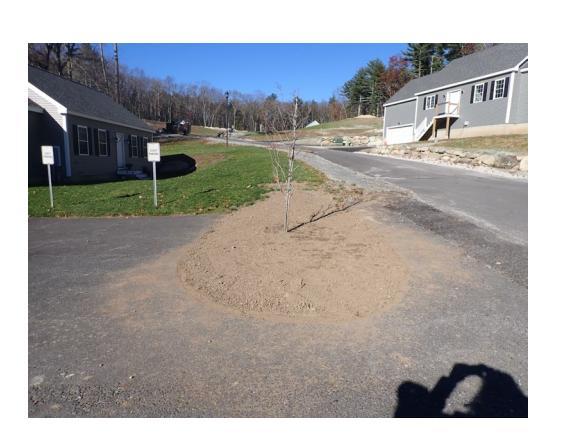
Conservation Request: An additional parking space has been installed at units 5 and 7 this pavement shall be removed and replaced with loam and seed as well as the planting as shown on the approved plan.
Answer: The pavement at the additional parking space that was installed at units 5 and 7 has been removed. It will be replaced with loam and seed as well as the planting as shown on the approved plan weather dependent.
Conservation Update: Although the excess pavement was removed in early 2022 no other activity has occurred to rectify the issue.

**Updated Answer 10/20/2022:** This area has been hydroseeded and the tree has been installed. **Conservation Update 11/10/2022:** In September when the Conservation Agent was on site the area had been stabilized with grass, however during review of the site on November 10, 2022 the Agent observed the newly planted tree, but there was no longer any grass. Re-hydroseed area for compliance.

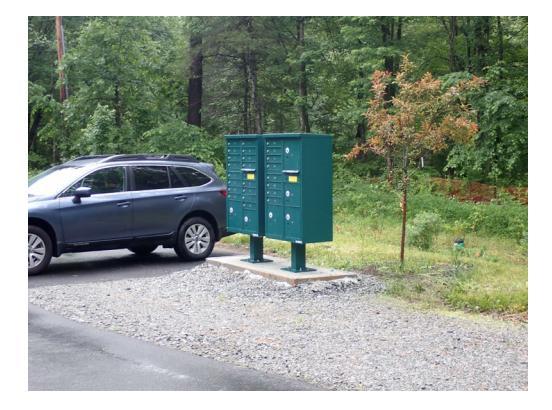
**Conservation Update:** A mail kiosk has been added to the west side of the visitor park at the entrance to the development, but was not on the approved plan. This addition was not approved by the Commission, nor the Zoning Board of Appeals.

**Conservation Update 11/10/2022:** The Conservation Commission will be issuing a fine in the amount of \$300.00 for this violation of the approved plans under the Order of Conditions.

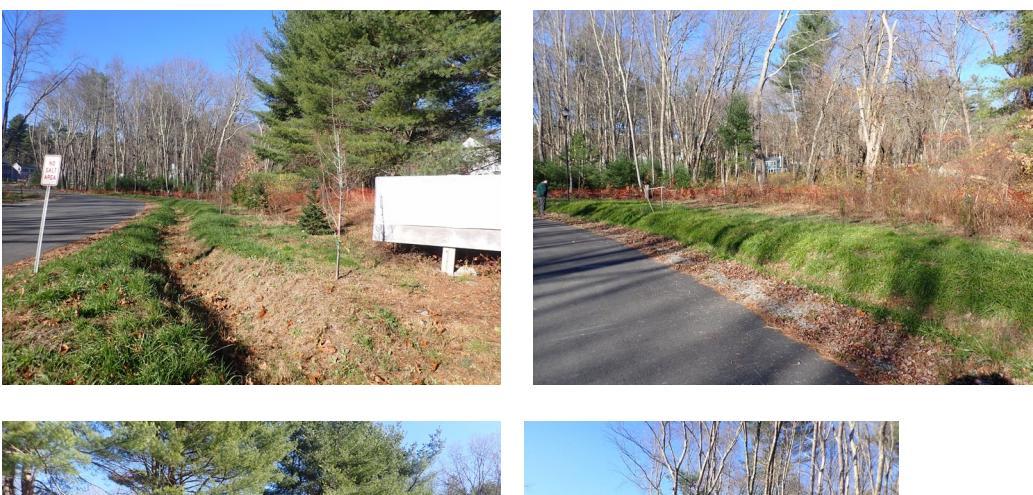
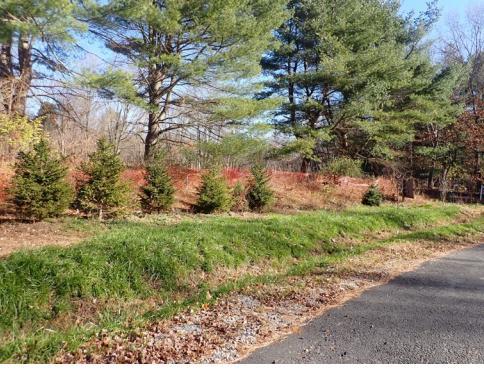
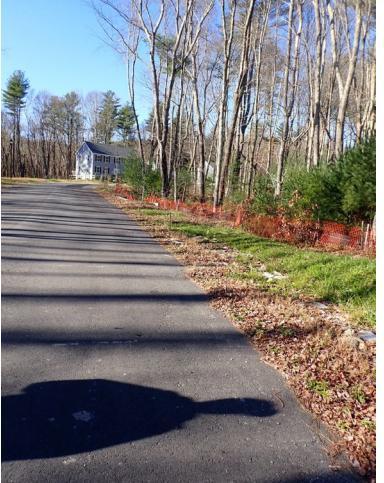
Members of the Conservation Commission along with its Agent had spent a considerable amount of time on the site over the years prior to development. The site was originally free from invasive plant species. Since the addition of fill onto the site invasive plant species have been identified on the site, including Japanese Knotweed, Garlic Mustard and Black Locus. The Commission is concerned these invasives will spread into the wetland resource areas on and off the site, including a vernal pool on the adjacent lot, as well as the forested area around the development. The Commission is requesting a plan be prepared to rectify the issue.

**Conservation Update 11/10/2022:** Management Plan by Ruby Environmental was approved by the Commission. Photos above show areas that previously included invasive plant species. As stated above the Commission recommends these areas be maintained with mowing at the same time the lawn areas of the units are mowed in order to reduce the growth and spread of invasive plants. A progress report form Ruby Environmental shall be provided for the Commission's review.

**Answer:** Ruby Environmental Services Inc. has been contracted to provide annual invasive species management plan, which includes spraying/cutting. This plan has been presented and approved to the Commission and the first treatment (fall portion of the contract) was done on 10/3/2022.

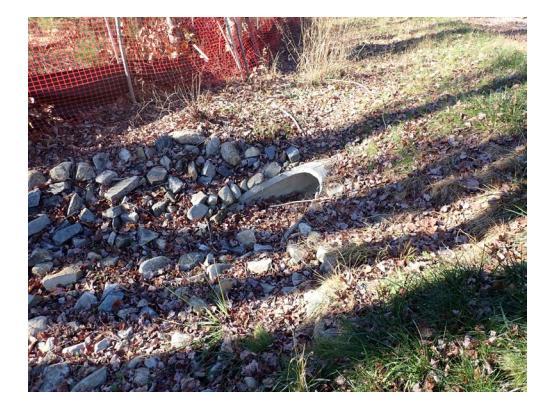
The lower Bio-Retention Cell is receiving silt during rain events. Areas in which stormwater is flowing shall be

stabilized to reduce silt from entering this cell.

Answer: Waddles were removed out of the pipes and the pipes were cleaned Conservation Update 11/10/2022: Outfall remains free of silt; continue to monitor for compliance.

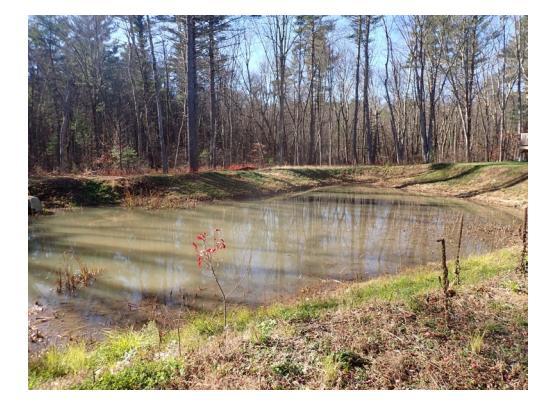
The constructed wetland is acting a sediment basin during construction, however silt in this basin has reached levels that should be addressed to avoid adverse impacts to the wetland resource areas.

**Conservation Update 11/10/2022:** A dewatering plan has been approved by the Commission and may proceed.

**Answer:** A dewatering plan of this area has been approved by the Conservation Commission to allow for the removal of silt within this basin.

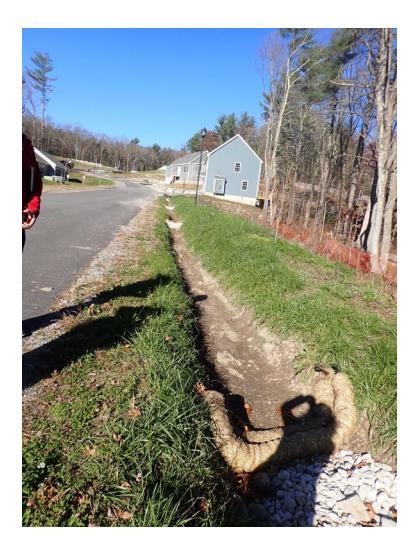
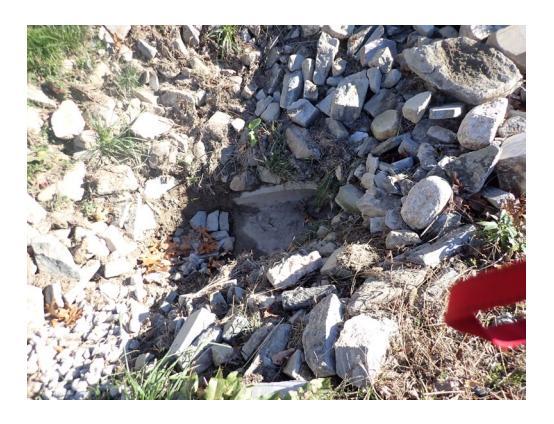
Parabolic Channel 7 (PS7) was designed to be a series of step pools along the main road of the development. As constructed this channel is one long channel that has been stabilized sporadically similar to PS8. Proper installation and maintenance of this and all of the Parabolic Channels shall be adhered to.

**Conservation Update 11/10/2022:** Outfall remains free of silt; continue to monitor for compliance. The swale itself had originally been proposed as step pool. Although the check dams installed along the swale will slow the flow of water during heavy rain events the Agent would recommend the step pools be installed to better control water within the swale. If it is the desire of Mr. Cricones to keep the swale as constructed the stormwater model shall be run again to prove it will function to control stormwater.

Answer: The swale has been cleaned and the check dams have been installed in a series of step pools.

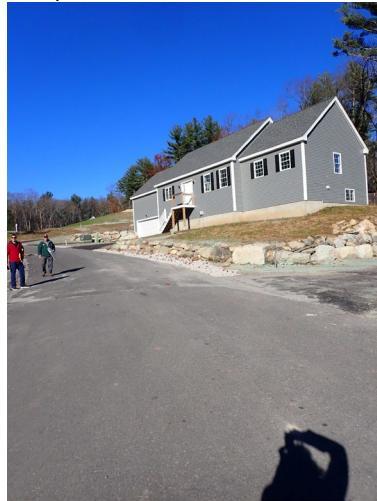
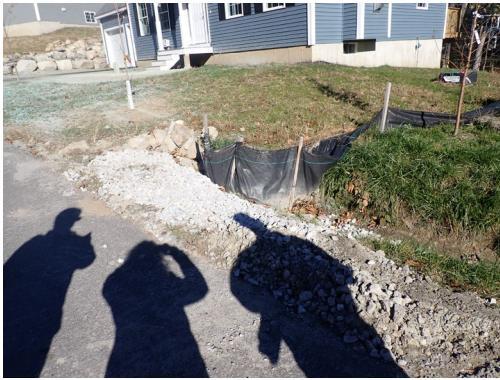
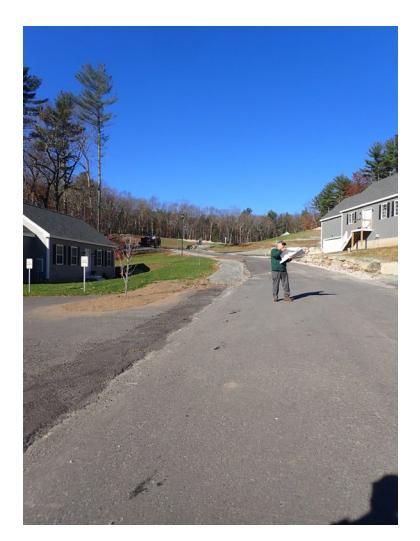
A major cause of siltation with the Parabolic Channels and Constructed wetland is the uncontrolled runoff from the upper portion of the site. A plan to properly control stormwater runoff shall be submitted to the Commission for their review.

**Conservation Update 11/10/2022:** These areas have stabilized as detailed above. Monitor for continued compliance.

**Answer:** We have added more check dams every couple hundred feet up the roadway on the side along with adding 3" crushed gravel on the right side of the road going up the hill. The fact that the driveways have been paved and the whole site has been hydro seeded has also greatly reduced this issue. Any material that ends up in the parabolic swale 1 has been and will continued to be cleaned out if anything goes in there. We have also added more check damns in front of it and within it
