OFFICE OF THE
CONSERVATION COMMISSION

DATE: July 12, 2022

RE: Pine Hill Village Status Report

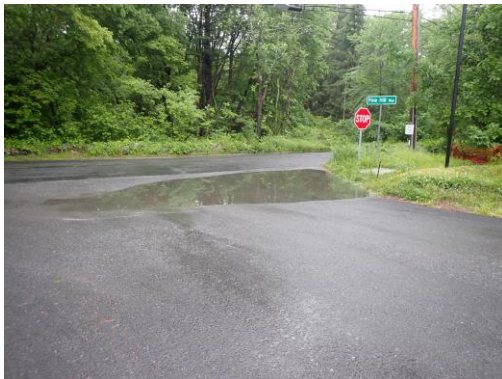
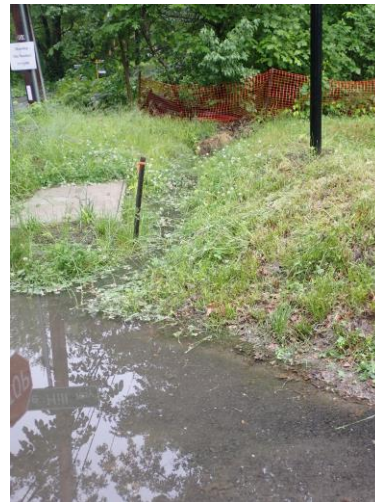
Conservation Request: Repair the drainage swale at the entrance off of Stow Road as shown in the detail provided by Markey & Rubin, Inc., dated December 1, 2021.

Conservation Update: The repair has not been completed. Haybales used to reduce silt from entering the drainage channel cause water to back-up within the swale leading to the channel.

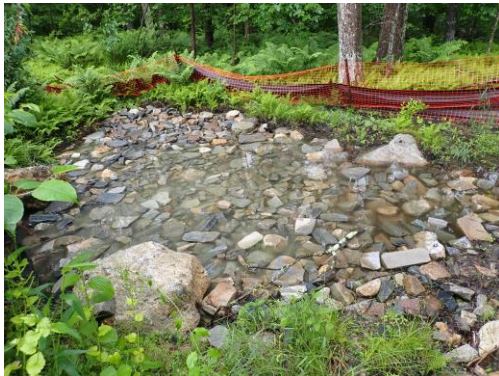
Conservation Request: The installation of the energy dissipation at the outlet at the constructed wetland should be verified with approved detail

Conservation Update: Verification has not occurred

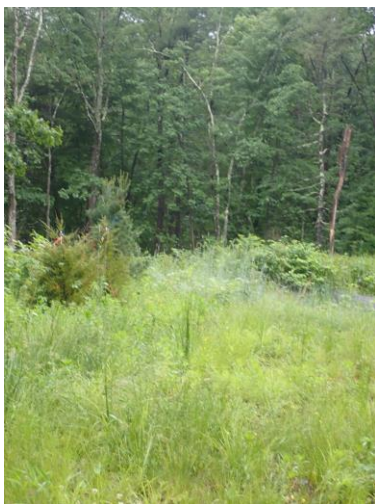
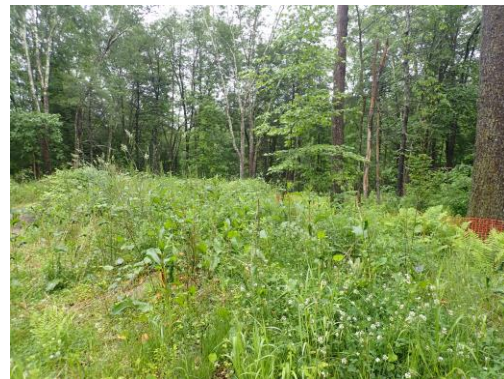
Conservation Request: Plantings around the constructed wetland are not consistent with the approved plan and some of the trees are dead; replacement plantings shall be in a random pattern.

Conservation Update: Plantings have been replaced, however the area is well over grown and should be maintained to help reduce the spread on invasive plants.

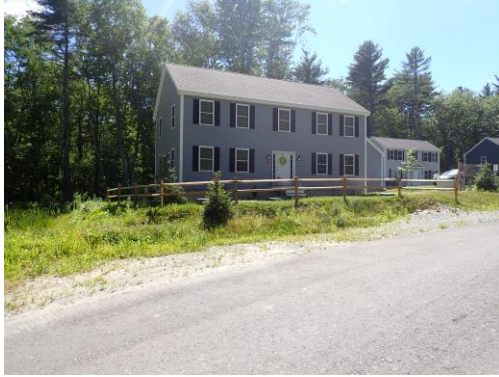
Conservation Request: Additional planting required in front of Units 1A and B as shown on the approved plan.

Conservation Update: Plantings are still not in accordance with the approved plan.

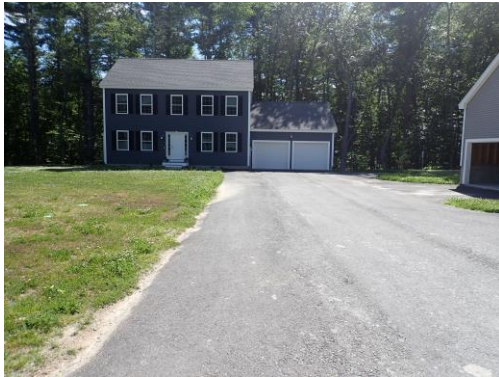
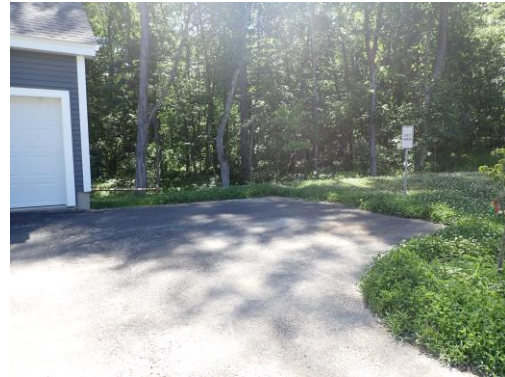
Conservation Request: Silt on the driveway for units 5 and 7 shall be removed before occupancy.

Conservation Update: Although a berm was installed at the entrance to the driveway silt continues to collect on the driveway between units 5 and 7 as water pools in that area during heavy rain events. The silt sock installed on the edge of the driveway near unit 5 has been removed without approval from the Commission. Silt laden waste is passing over grassy area before accumulating at the edge of the existing erosion control barrier.

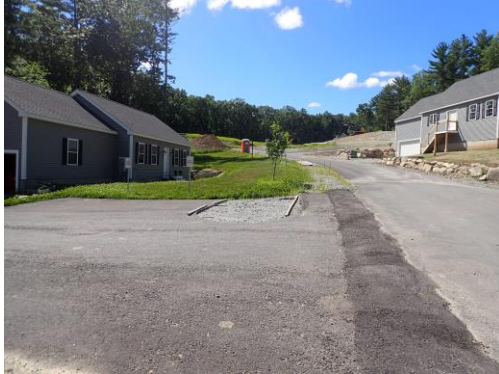
Conservation Request: An additional parking space has been installed at units 5 and 7 this pavement shall be removed and replaced with loam and seed as well as the planting as shown on the approved plan.

Conservation Update: Although the excess pavement was removed in early 2022 no other activity has occurred to rectify the issue.

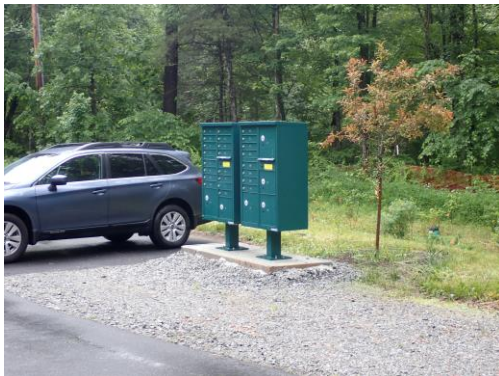
Conservation Update: A mail kiosk has been added to the west side of the visitor park at the entrance to the development, but was not on the approved plan. This addition was not approved by the Commission, nor the Zoning Board of Appeals.

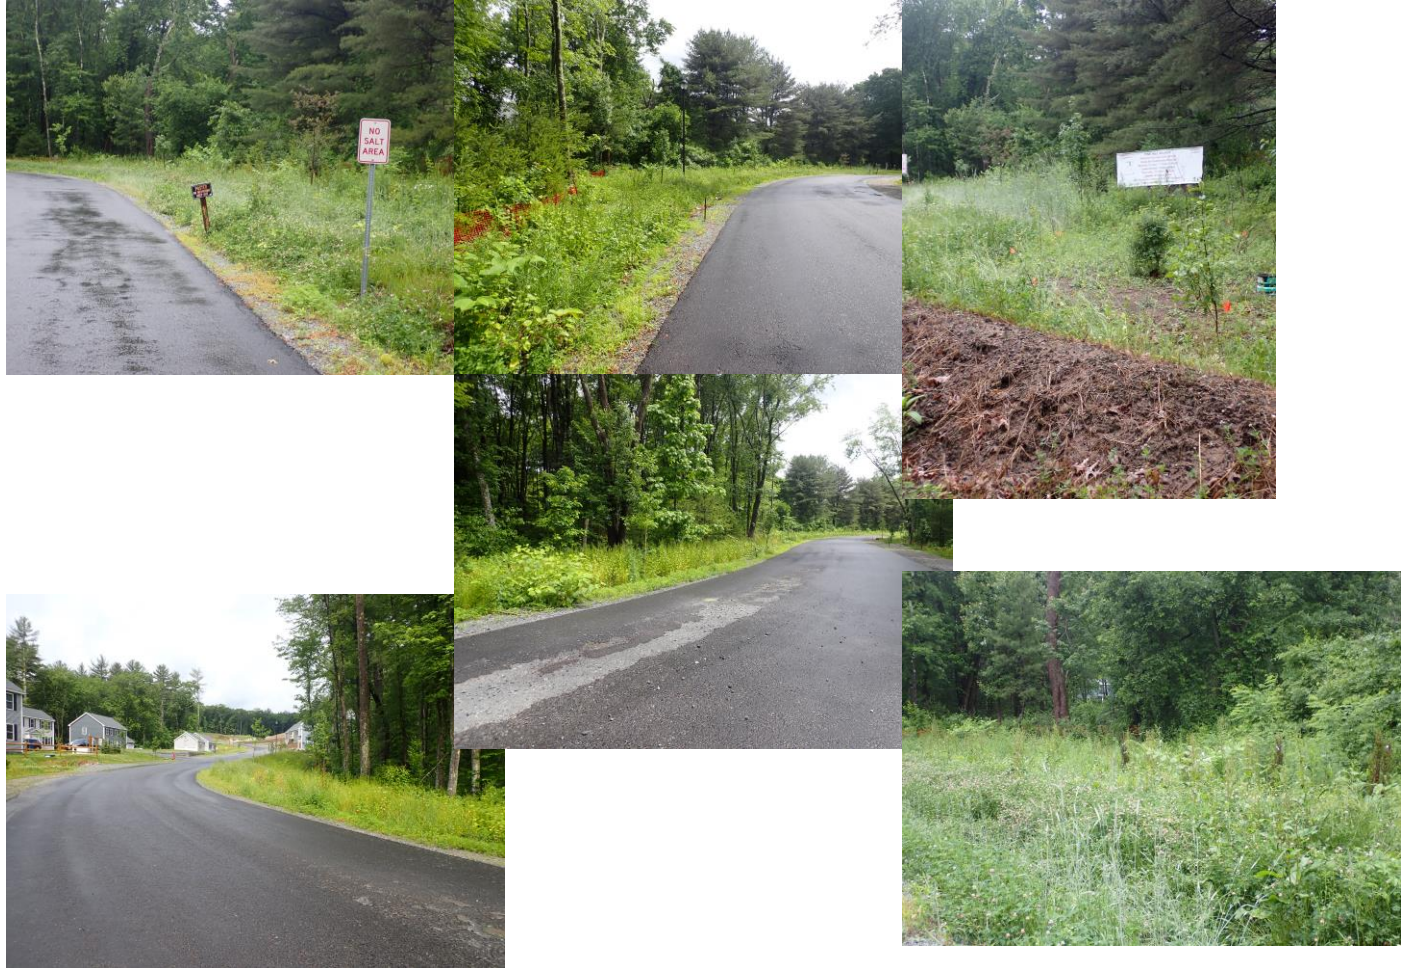
In general, the common areas on the site are not being maintained cause unwanted over growth around the installed landscaping.

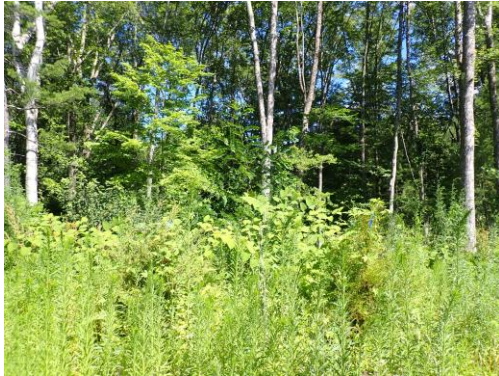
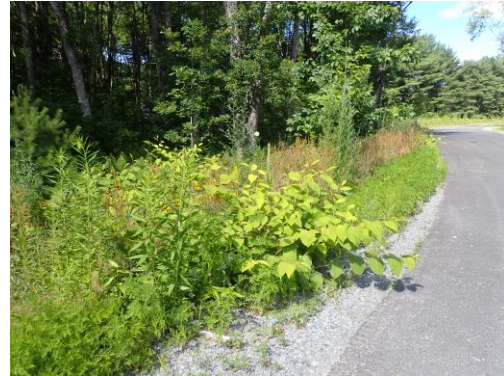
Members of the Conservation Commission along with its Agent had spent a considerable amount of time on the site over the years prior to development. The site was originally free from invasive plant species. Since the addition of fill onto the site invasive plant species have been identified on the site, including Japanese Knotweed, Garlic Mustard and Black Locust. The Commission is concerned these invasives will spread into the wetland resource areas on and off the site, including a vernal pool on the adjacent lot, as well as the forested area around the development. The Commission is requesting a plan be prepared to rectify the issue.

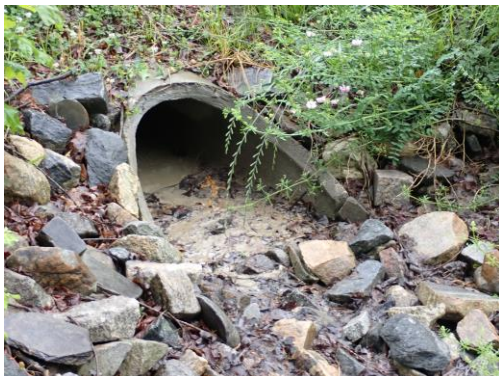
The lower Bio-Retention Cell is receiving silt during rain events. Areas in which stormwater is flowing shall be stabilized to reduce silt from entering this cell.

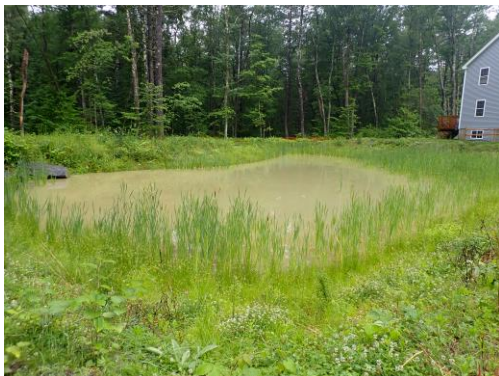
The constructed wetland is acting a sediment basin during construction, however silt in this basin has reached levels that should be addressed to avoid adverse impacts to the wetland resource areas.

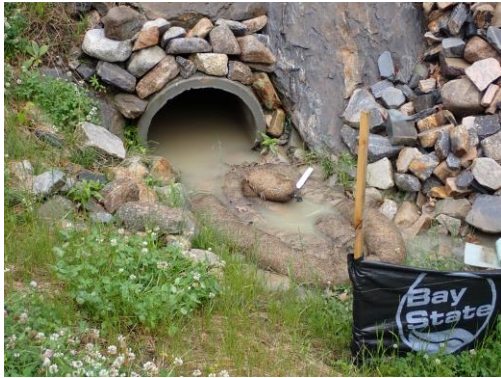
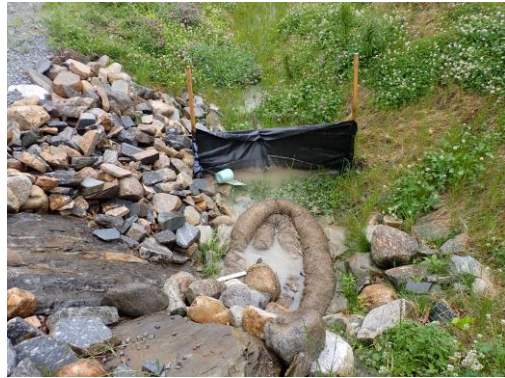
Parabolic Channel (PS8) in front of Building #1 is constantly full of silt. Stabilization of issue with riprap, erosion control barriers and silt sacks have only exacerbated the problem. Proper installation and maintenance of this and all of the Parabolic Channels shall be adhered to.

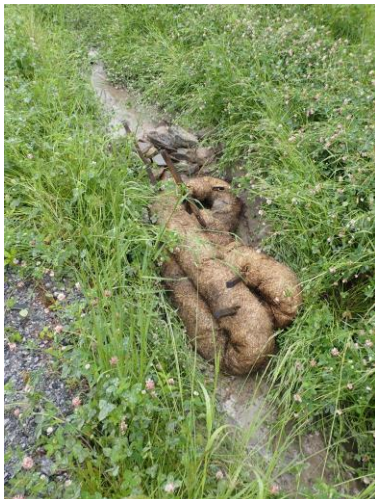
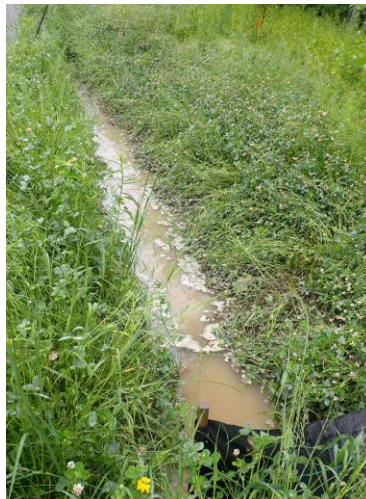
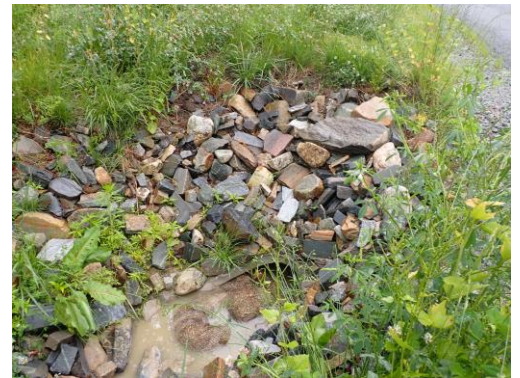
Parabolic Channel 7 (PS7) was designed to be a series of step pools along the main road of the development. As constructed this channel is one long channel that has been stabilized sporadically similar to PS8. Proper installation and maintenance of this and all of the Parabolic Channels shall be adhered to.

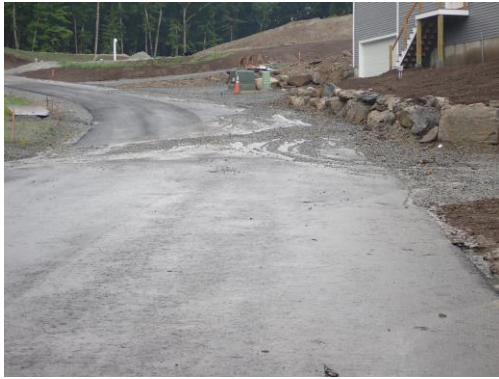
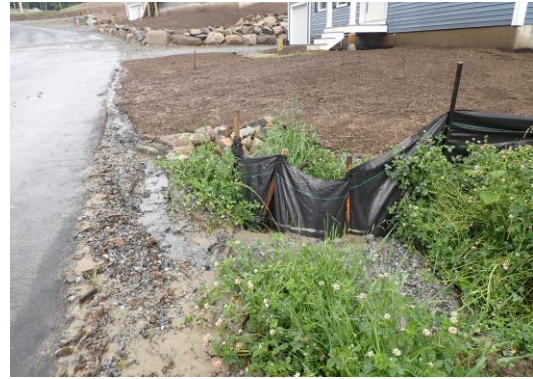
A major cause of siltation with the Parabolic Channels and Constructed wetland is the uncontrolled runoff from the upper portion of the site. A plan to properly control stormwater runoff shall be submitted to the Commission for their review.
