FIELD REPORT

Nitsch Project #:	12808	Date:	March 10, 2022
Client:	Pine Hill Village, LLC	Time:	10:00 am – 10:45 am
Project:	Pine Hill Development	Location:	Harvard, Massachusetts
Weather:	46°F Sunny		
Present:	Liz Allard – Conservation Agent / Town Planner Donald Ritchie – Chair, Conservation Commission Steven Ventresca – Nitsch Engineering Basel Alhadidi – Nitsch Engineering

The purpose of this site visit was to observe general site conditions for the Pine Hill Village project located off Stow Road in Harvard, MA. Nitsch offers the following observations:

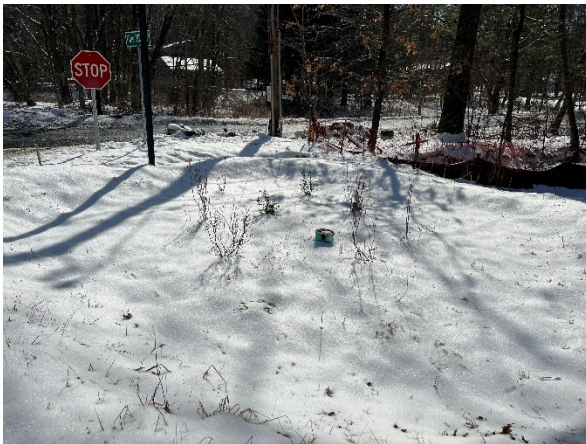
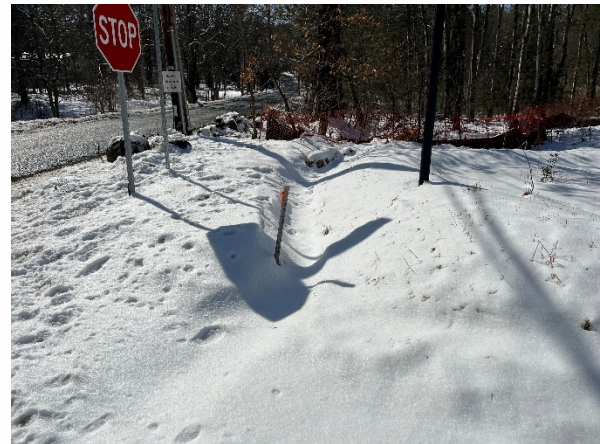
- As stated in previous report, the Contractor must continuously maintain the installed bio-retention systems at the project entrance by removing weed and overgrowth from adjacent vegetation. Any plants that are dead in the constructed bio-retention systems must be replaced in kind and the plants must last at least one (1) growing season prior to Homeowner's Association acceptance.

3. Maintain the installed bio-retention systems at the driveway entrance by removing weeds and replanting any dead shrubs or plantings that were part of the bio-retention system. This will be continuous maintenance task until the development is turned over to the HOA.

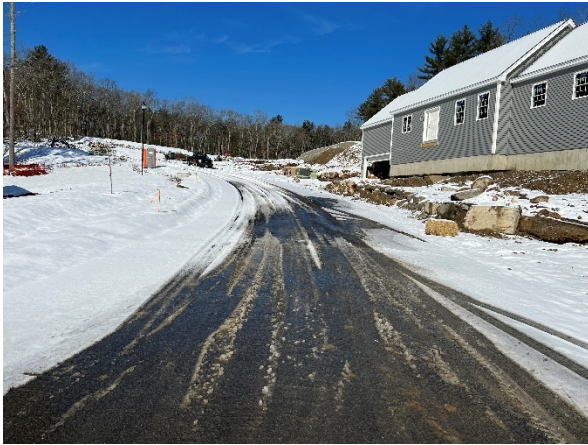
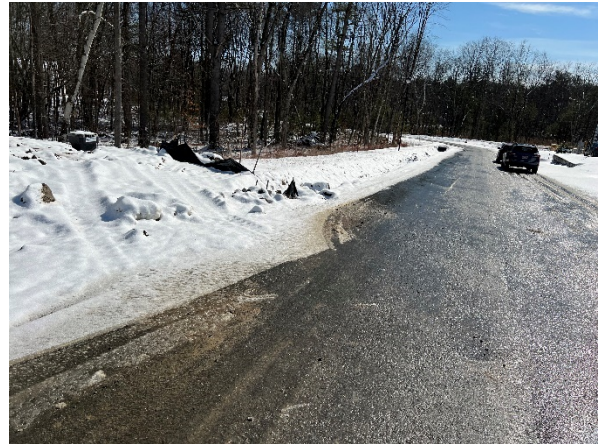
- The Contractor shall continue to monitor, stabilize, and repair any on site erosion at the roadway shoulders and provide new wattles and bales being used for erosion control in stone swales and along grassed swales. Also, Contractor shall provide erosion control measures along the non-stabilized slopes near the Sun Rise area.

2. The Contractor to provide erosion control measures along the non-stabilized slopes at the top and mid-slope of exposed surfaces to minimize erosion.

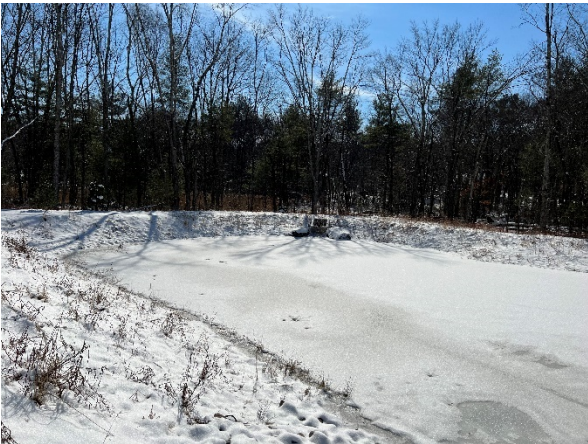
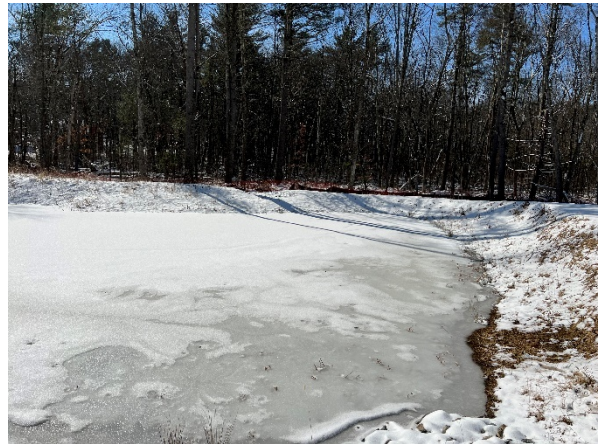
3. The Contractor shall discuss how and when to remove sediment in the constructed wetland prior to final planting with the Conservation Agent. Also, Contractor to confirm if the splash pad for the construction wetland was re-established per the approved plans.

4. Contractor to re-establish the outlet rip rap to the constructed wetland per the approved detail which indicates a level spreader type splash pad, where there is a slight depression to pool water prior to discharge toward the wetland.

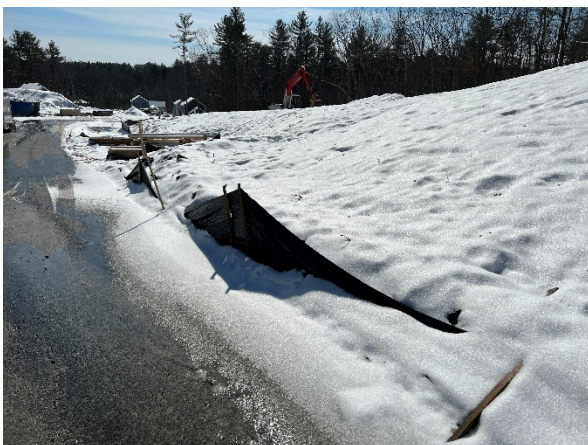
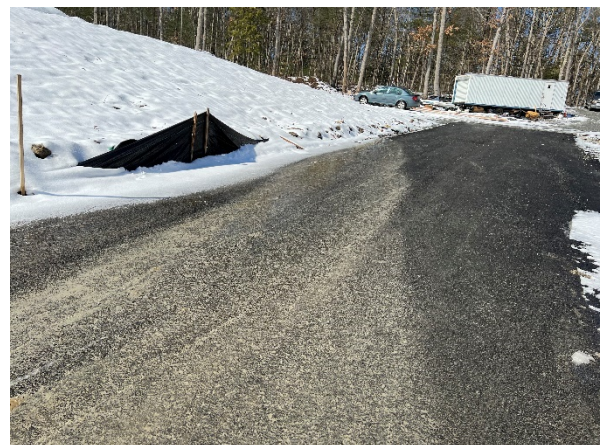
4. Nitsch noticed that some parts of the silt fence near the RG#10 and RG#11 were damaged. It was causing a sediment washout as shown in the photo below. Nitsch recommends replacing or resetting these damaged sections of sit fence.

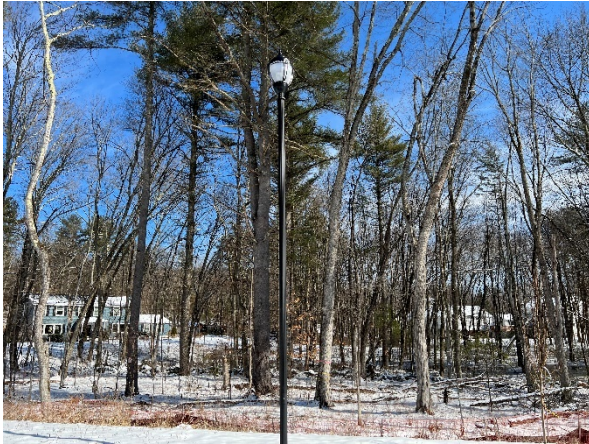
5. The installed street light does not match the light in the approved plan. The Contractor shall provide the lighting cut sheet which shall show that the light meets Dark Sky lighting requirements and request an administrative change with the ZBA. The Contractor shall confirm the lighting pole height matches or is lower than the approved plans and that the LED output matches a warmer tone between 2,700 to 3,000 Kelvin (K).

1. Replace streetlight with new LED light and conform with Dark Sky requirements.
2. Provide sketch and narrative for driveway and parking area in comment #8.

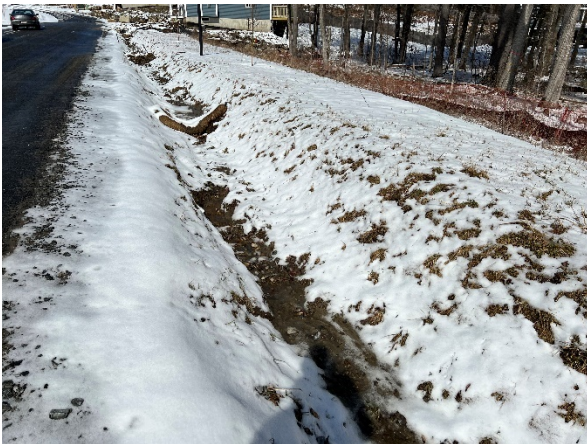
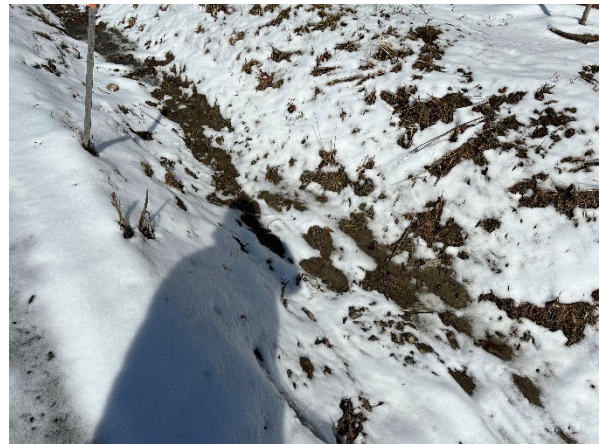
6. Swale next to the driveway has sediment and washout from the construction area, swale and check dams shall be cleaned of sediment and disposed of properly.

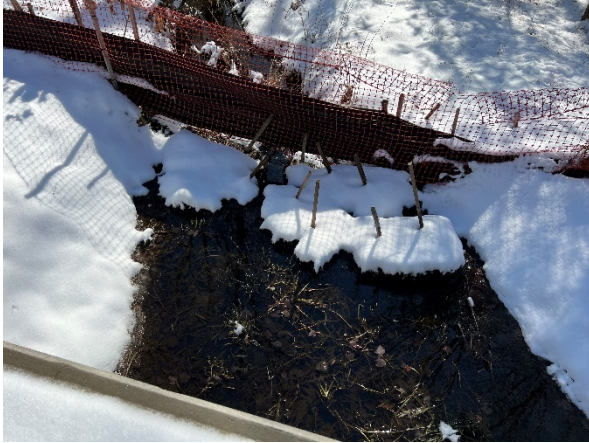
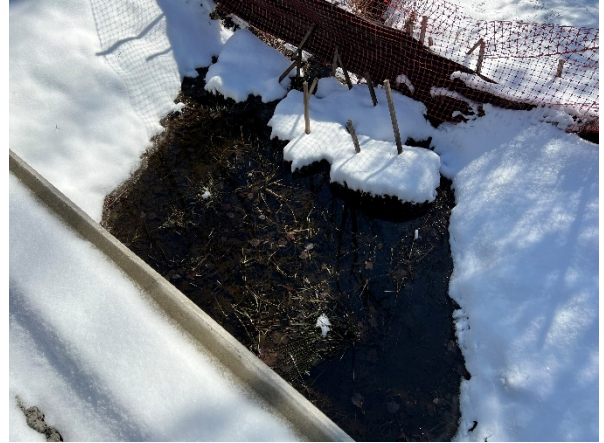
7. Contractor shall remove Hay Bales and silt fence near the culvert so the stream could naturalize. Contractor to observe stream for any potential sedimentation during the remaining construction phases.

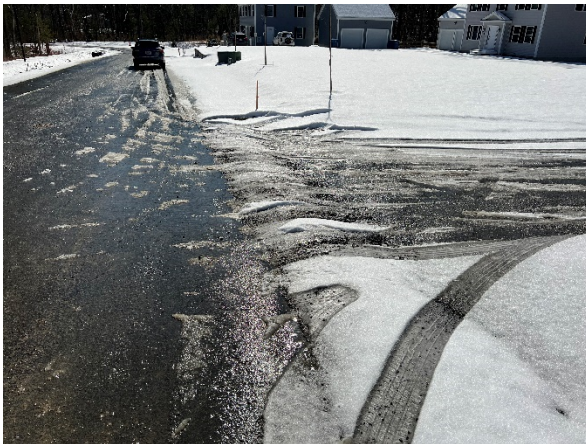
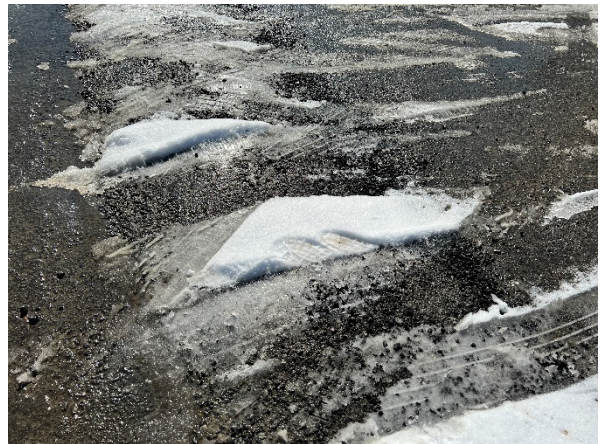
8. Contractor had built a bump or asphalt curb along the access road to the houses 5 and 7 to prevent stormwater and sediment from running in to the driveway. Contractor to provide a sketch approved by the design engineer, and a written statement to show how this solution is adequate in the interim construction condition and in the final condition. Also, it appears that the installed ramp had eroded in some area.

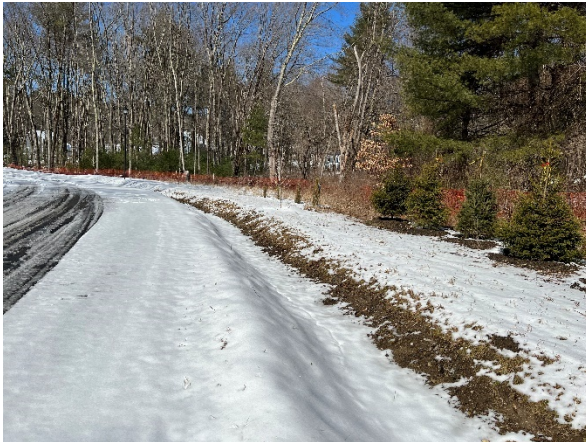
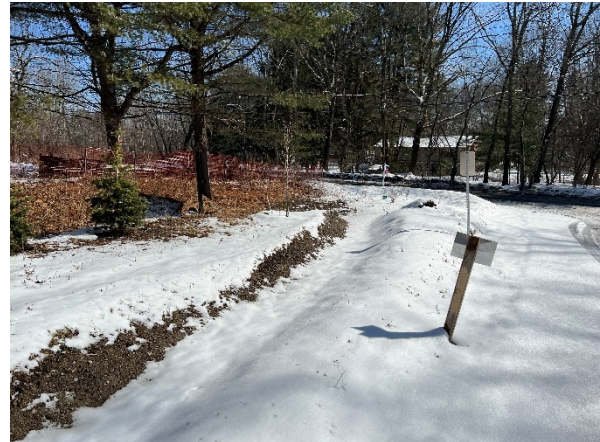
9. The contractor to conform if the swale PS9 leading toward Rain Garden (RG) #22 still has a negative slope. The swale shall slope toward the bioretention system as per the approved plans.
