FIELD REPORT

Nitsch Project #: 12808 Date: April 21, 2021

Project: Pine Hill Development Location: Harvard, Massachusetts

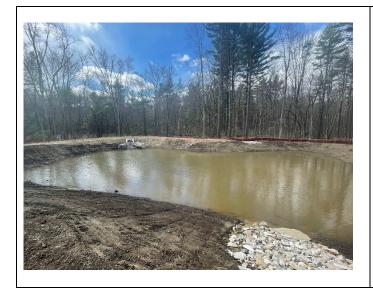
Sediment is visible in the constructed wetland.

- 1. The Contractor to install erosion controls prior to the constructed wetland to minimize sedimentation into drainage systems and the constructed wetland.
- 2. Extending discharge pipe (that drains to constructed wetland adjacent to road) toward the wetland basin and covering the channel so that it makes a level slope (2% slope) to the roadway shoulder.
- 3. The Contractor to provide erosion control measures along the non-stabilized slopes at the top and midslope of exposed surfaces to minimize erosions.
- 4. The sediment in swale be removed and disposed of properly prior to planting seeding.

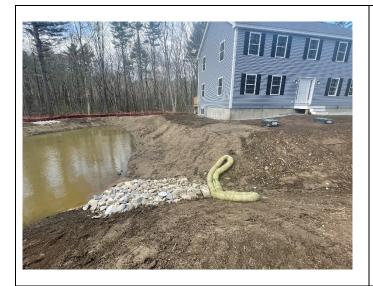
The Contractor has placed hay wattles at outlet locations.

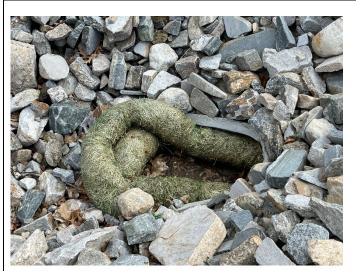
A closeup of hay wattle placed in an outlet of the closed drainage system.

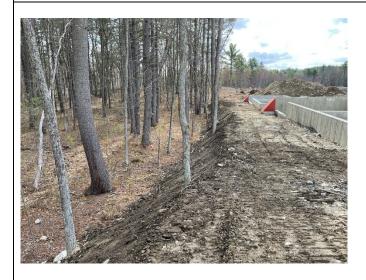
Raised ground towards the back of the site with no stabilization measures to prevent sediment runoff into surrounding wetlands. Nitsch Engineering recommends erosion control fence to be placed behind raised ground surface to avoid sediment runoff.

- 1. Erosion control fence to be placed behind raised ground surface to avoid sediment runoff.
- 2. Establish a suitable substrate at stream crossing.

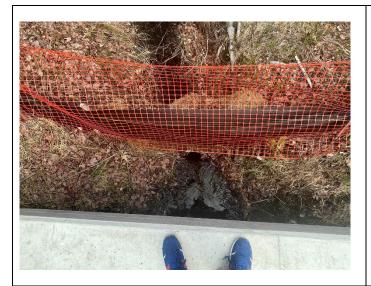
Visible siltation at intermittent stream crossing. Nitsch Engineering recommends establishing a suitable substrate at the crossing.

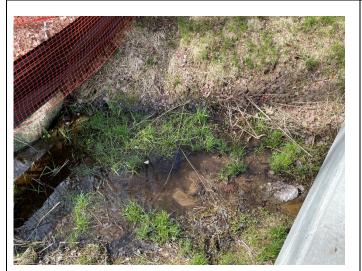
Visible siltation at intermittent stream crossing. Nitsch Engineering recommends establishing a suitable substrate at the crossing.

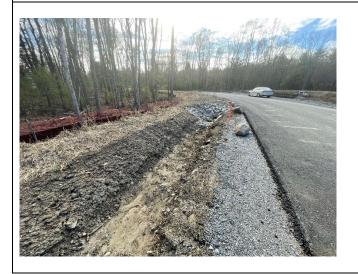
Swale has sediment buildup in the bottom of the channel. Nitsch Engineering recommends that this sediment be removed and disposed of properly prior to planting/seeding.
