SELECT BOARD AGENDA Tuesday, May 23, 2023 7:00pm

Feasibility and Space Needs Study

HARVARD FIRE HEADQUARTERS

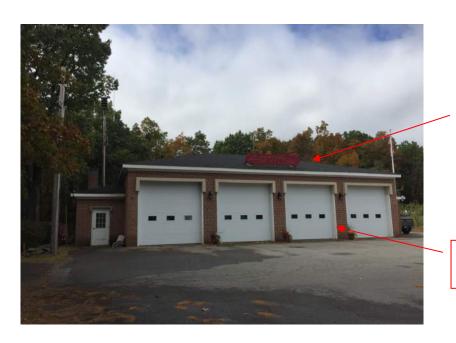
Slope steel joist roof system

Typical masonry load bearing walls

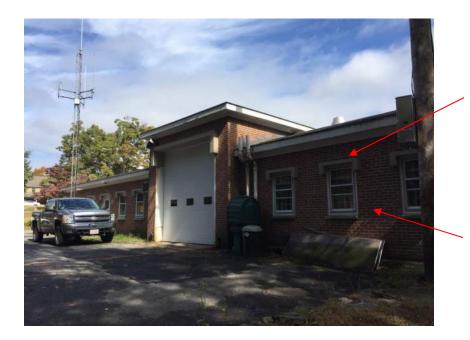
West Elevation Photo 3

Precast window lintels typical

Typical masonry load bearing walls

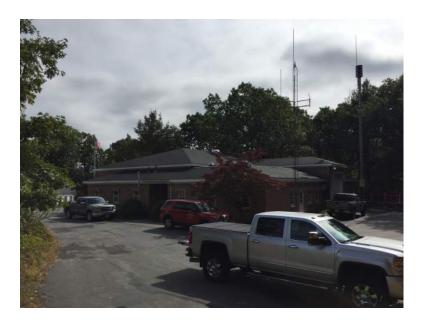
North Elevation Photo 4

Waves in the shingles were observed one the north side. It appears that the roof deck may have begun to delaminate. Further investigation is required.

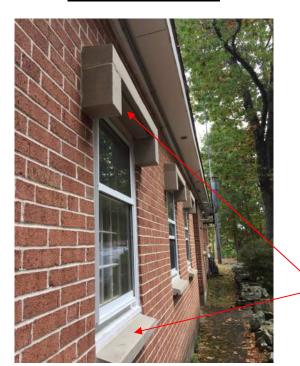
Existing precast lintels and sills Photo 5

Precast window sill and lintel

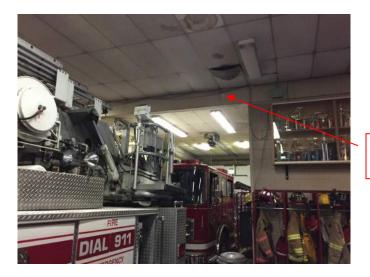
Masonry beam over rear bay wall opening Photo 8

Reinforced masonry beam

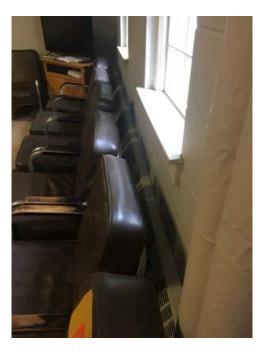
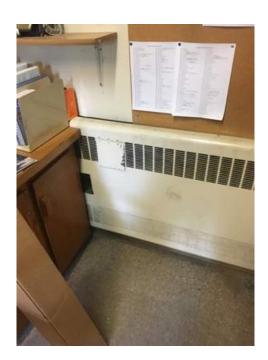
Unit Heater

- 1) Baseboard heaters throughout the building are damaged and covers are missing in several locations. Heating elements are very dirty and covered with debris. Control valves and thermostats appear to be operational but are in poor condition.
- 2) Unit heaters throughout the building are in poor condition with access doors missing or damaged. Heating elements are very dirty and covered with debris. Control valves and thermostats appear to be operational but are in poor condition.

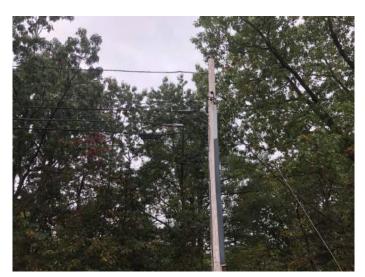
Utility Riser Pole

1. The building is served by an underground electrical service fed via an existing utility pole which is located adjacent to the southeast corner of the building.
